1020 PENNSYLVANIA AVENUE
MIAMI BEACH, FL 33139

On August 29, 2013, Mr. Victor Rodriguez, on behalf of Mr. Manfred Knoll president of MFK Group, retained Raul Vivas, P.E. to inspect and evaluate the Pennsylvania property located at 1220 Pennsylvania Avenue in Miami Beach, Florida. The purpose of our inspection and evaluation was to determine the existing condition of the structure and serviceability for human occupancy. Our professional opinions are based upon observations and knowledge of structural behavior of a masonry bearing wall construction.

CONCLUSIONS AND REPAIR RECOMMENDATIONS

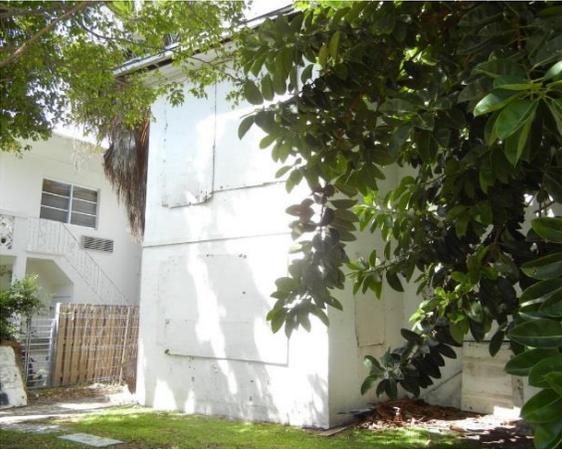
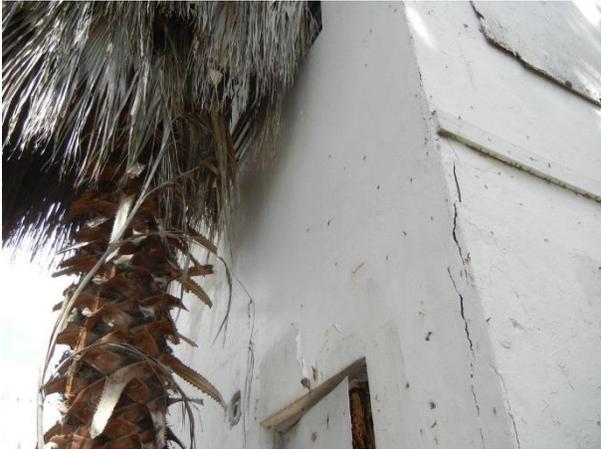
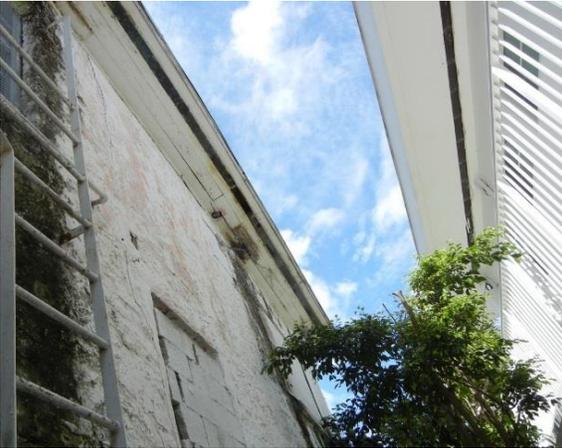
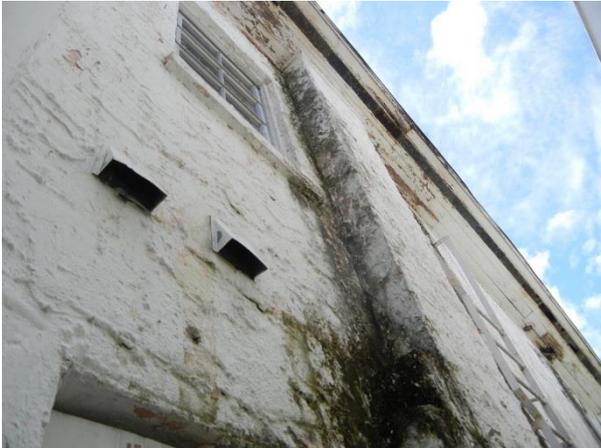
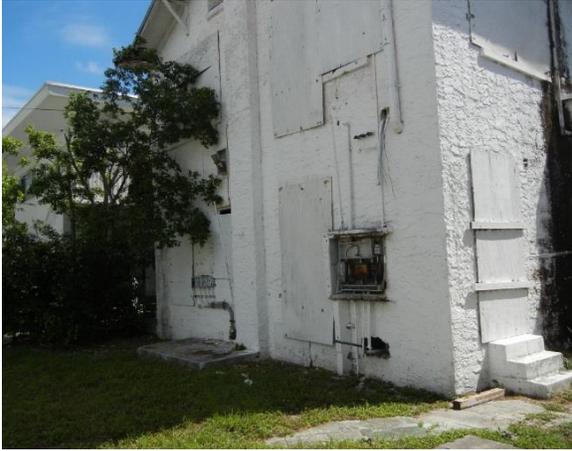
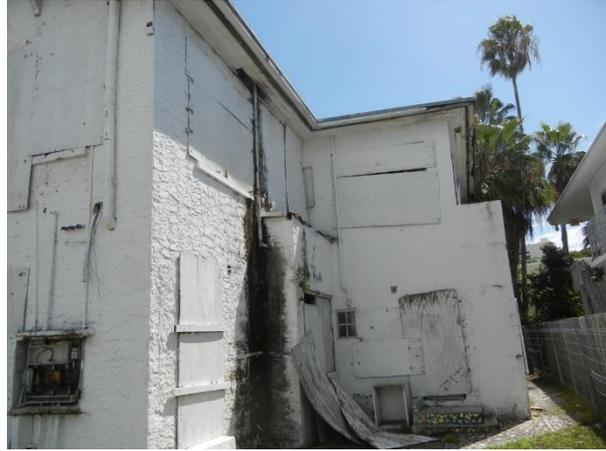
- The perimeter masonry bearing wall present several areas of patching or repairs. Is visible masonry cracks, opening masonry in-fills

At the time of the inspection the CMU block walls were safely standing in place. We did not note settlement of the structure based upon cursory observation of the soil/structure interface and corners of the structure. However, existing condition of floor framing in the first and second floor is clear indication that the structure is not in serviceable condition for human occupancy. The floor framings shall be replaced and repaired where acceptable. New floor sheathing shall be installed. The floor framing shall be connected to the masonry bearing wall. The existing bearing walls do not have concrete tie beam; appropriate shoring shall be designed and provided to allow implementation and construction of new concrete tie beam. The concrete tie beam shall be placed

In many areas of the perimeter masonry walls we consider that the piers between openings are unreinforced. Those piers shall be fastened to a substrate structure to accept out of plane forces induced by wind pressures. Consequently, the masonry piers shall be considered as cladding elements that would require special analysis and condition for proper structural attachment.

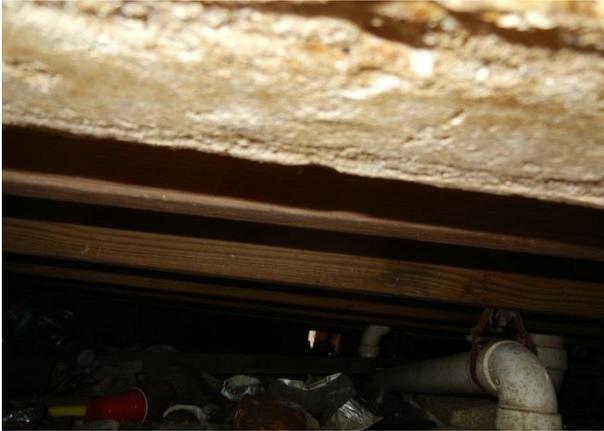
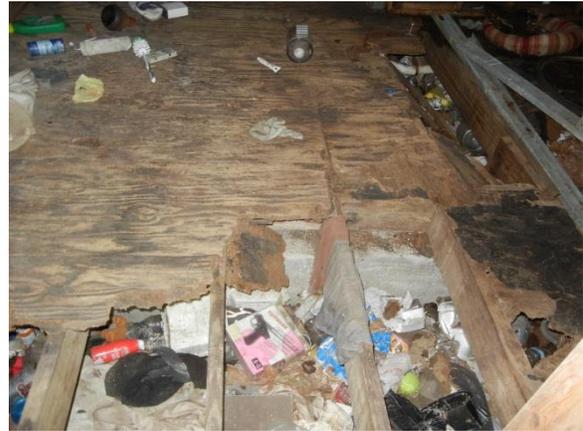
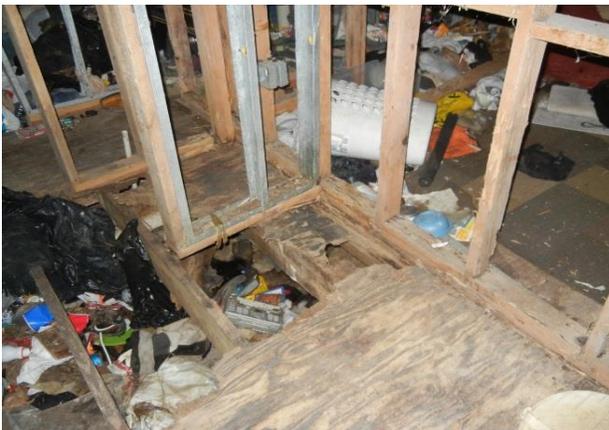
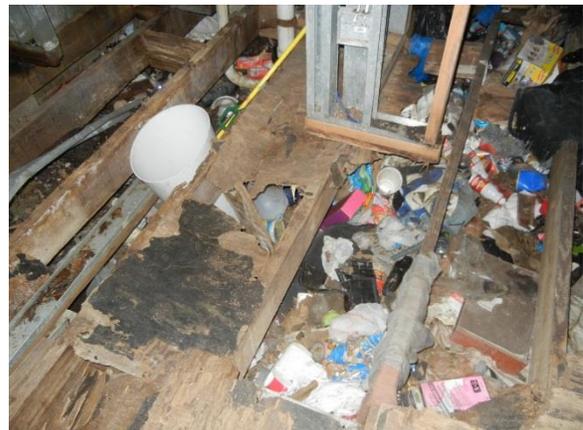
- Floor joists and floor sheathing are deteriorated by termites and humidity. The floor framing is placed raised over a crawl space which does not have proper ventilation.

- Roof sheathing and roofing; these items shall be replaced according to FBC 2010, section 606.3.2
- Second floor framing replacement or retrofitted accordingly and floor sheathing replacement, first floor framing and sheathing shall be replaced; these item shall be constructed or implemented in compliance with existing structures FBC 2010, section 707.4
- Wall openings shall be addressed and filled with impact resisting windows. In addition, the openings shall be reinforced and retrofitted structurally to transfer wind pressure loads to floor and roof diaphragms. These items shall be implemented in compliance with existing structures FBC 2010, section 606.4
- Concrete tie beams at floor and roof diaphragm line. Rational analysis shall be performed by a registered professional engineer

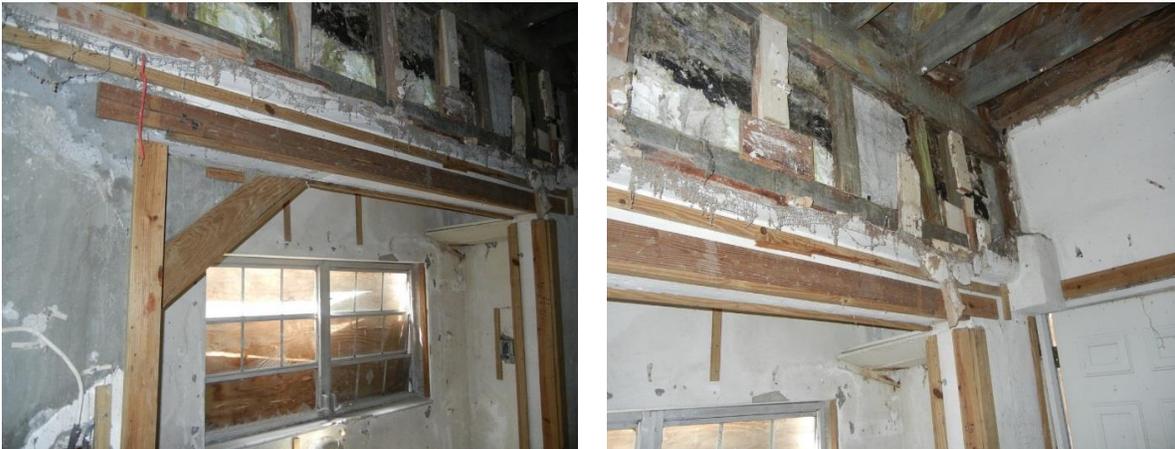
- Some openings in the masonry wall show unstable condition caused by lack of reinforcement. No proper or adequate retrofit procedure were provided at the time the openings were created. Interior CMU walls depict an original structural layout which in some degree were altered on its role as part of the building envelope. Besides, the portion of the building structure located at the east and south of the structure that we considered was an addition at certain time of the life of the structure, uses the area under the stairs that access to the second floor. To extend the area of the addition a portion of the perimeter bearing wall was demolished and reached the exterior face of the stair wall. That opening shows no reinforcement or retrofit to count for gravity loads from second and roof levels.

The building openings will require new impact windows. The existing openings do not present adequate construction condition to accept new window frames and transmit forces to the building diaphragms. The existing masonry openings shall be reinforced and retrofitted accordingly. The new reinforcement of the opening jambs shall frame to a new concrete tie beam.

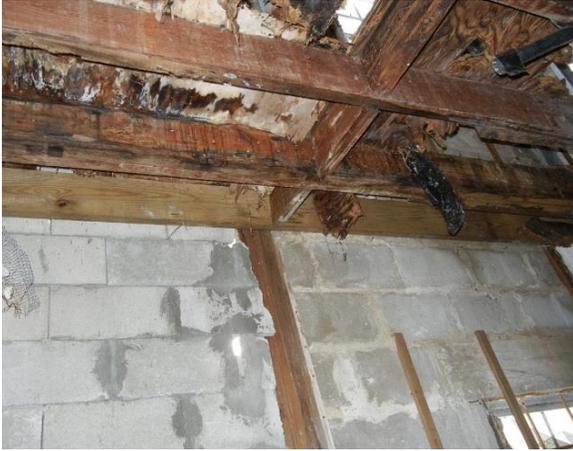
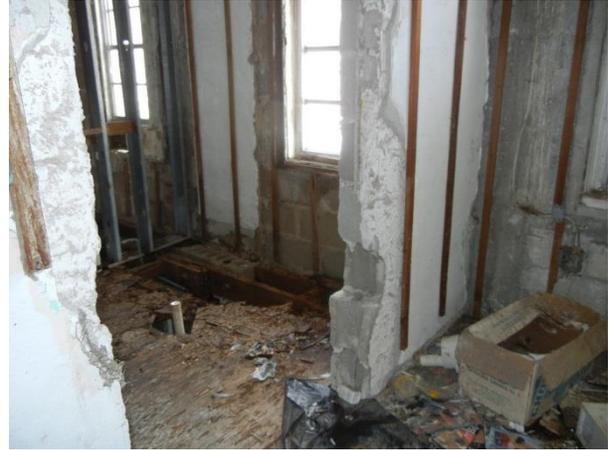
- A substantial number of floor joists in the second floor present sign of deterioration caused by termites and humidity. Also the floor sheathing is severely damaged or deteriorated by the same source of joist damage.

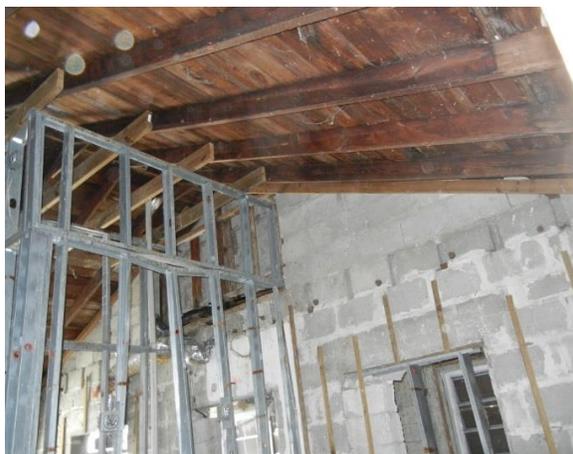
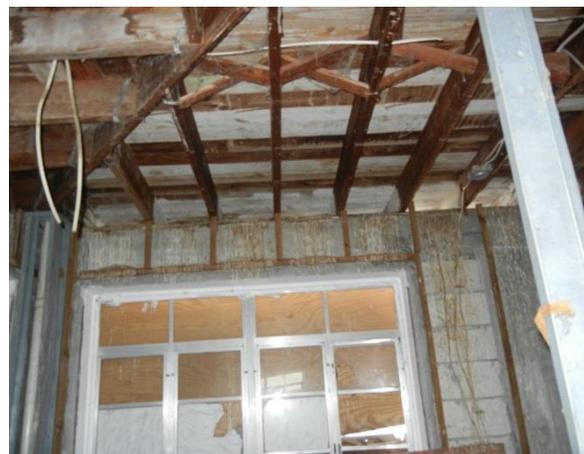
- The roof rafters are in fair condition for the most part. However, the roof sheathing evidence progressive deterioration.

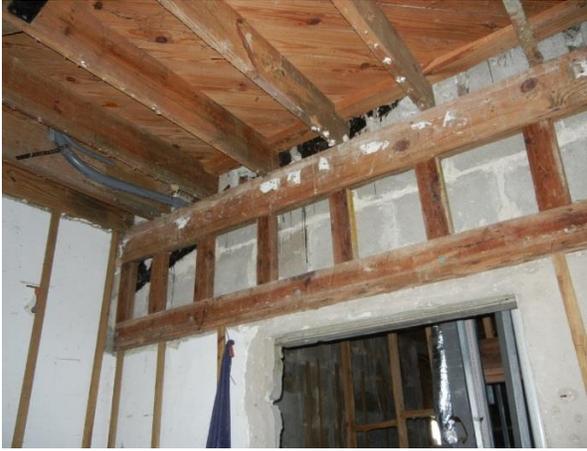
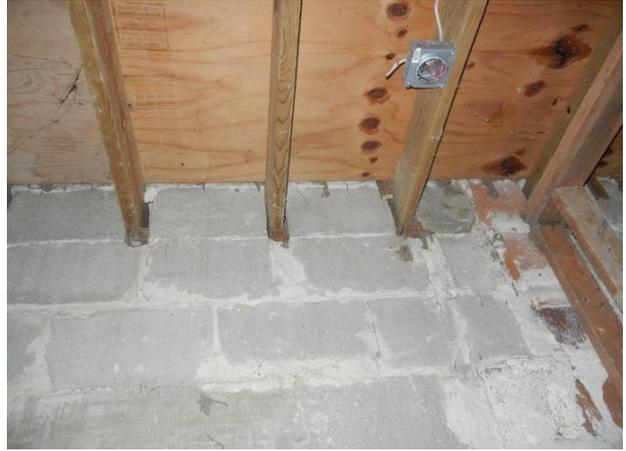
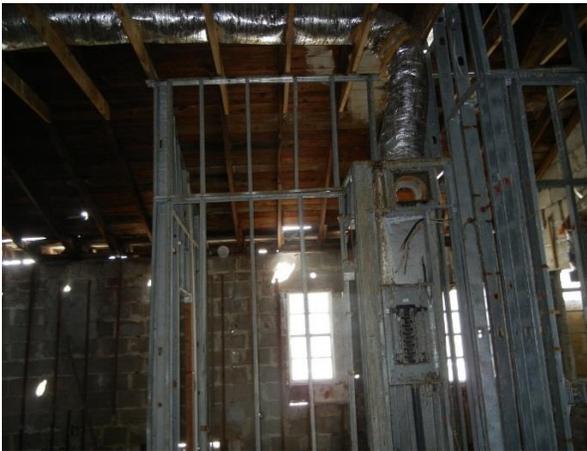
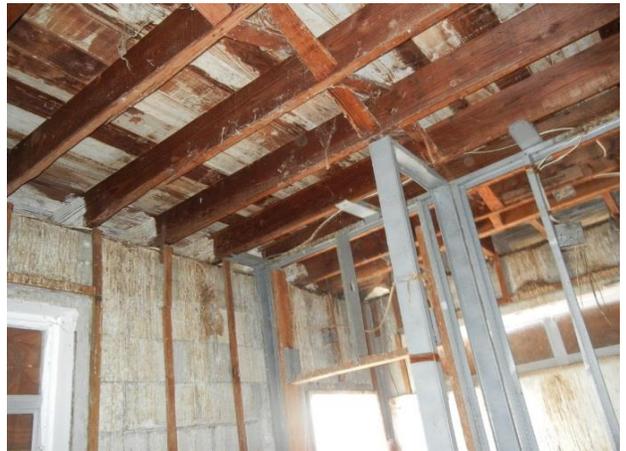
- The masonry walls throughout the structure layout do not have concrete tie beams. The floor joists have been placed in pockets created into the masonry built-up. The roof rafters have been placed on top of the masonry wall final grout.

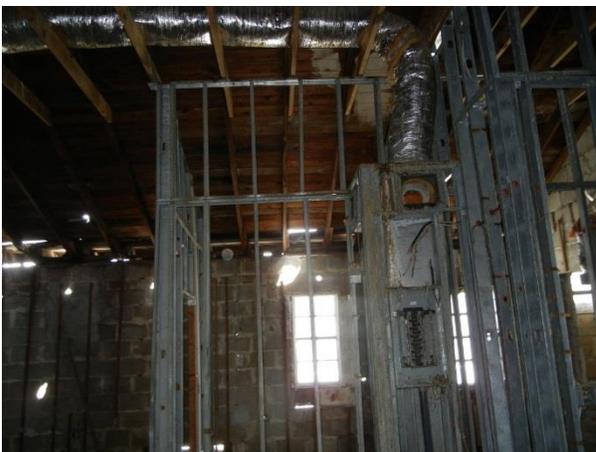
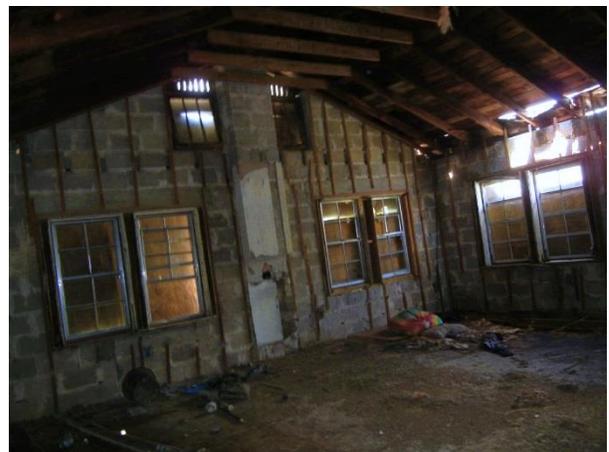
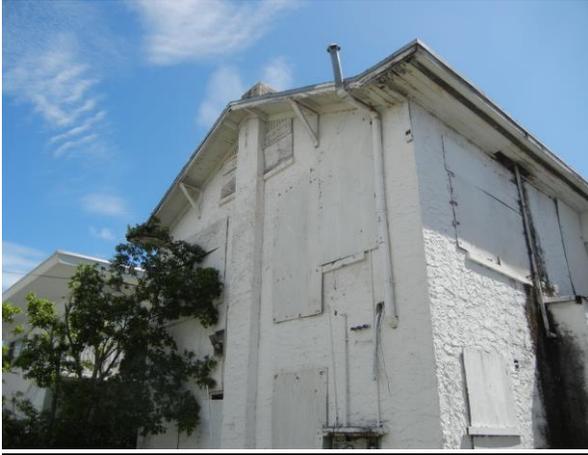
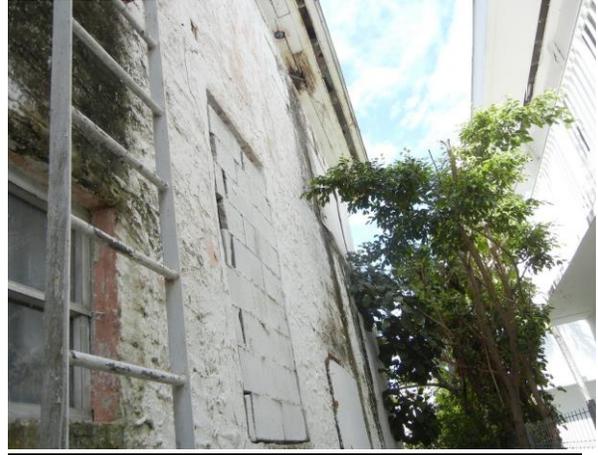
- Second floor walls at the west and north side walls are considered high walls. We assumed those walls are unreinforced. Cracks are evident in the exterior side of the wall.
