HISTORICAL PRESERVATION BOARD STRUCTURAL REPORT
947 Lincoln Road
Miami Beach, Florida, 33139

Prepared for
Beilinson Gomez Architects

August 14, 2024

STRUCTURAL CONDITION ASSESSMENT for
947 Lincoln Road
Miami Beach, Florida, 33139

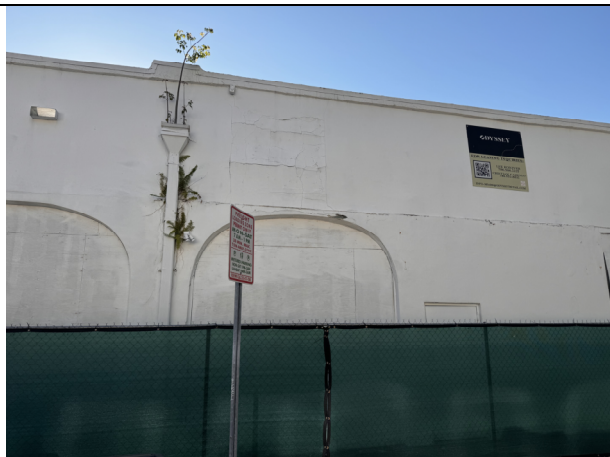
The parapet walls should also be repaired, they have signs of deterioration, the wood has rotted and the exterior finishes damaged.

Photo 4 – Cracks on the parapet wall

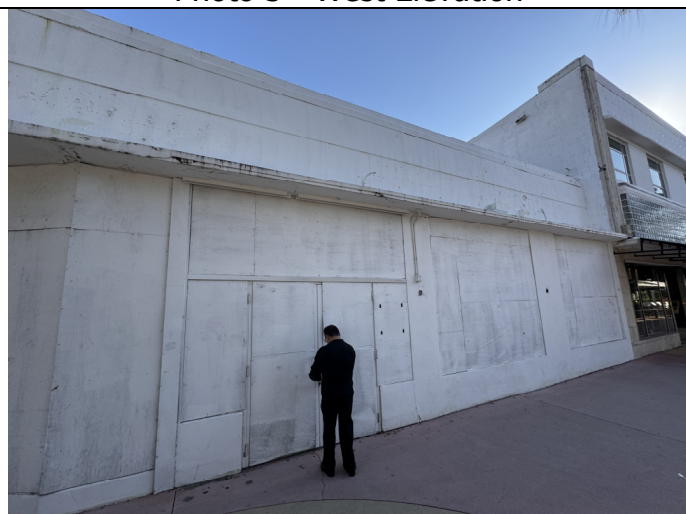
The concrete cantilever slab at the exterior walls exhibits concrete spalling, cracking, and deterioration.

Photo 5- Cantilever slab with concrete spalling and cracks.

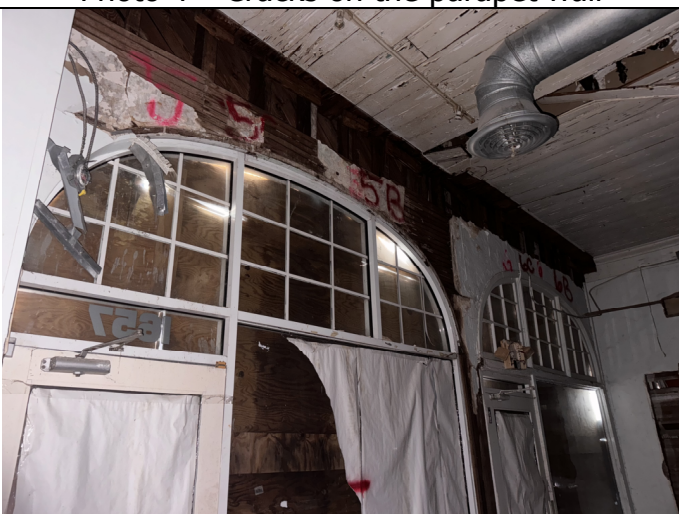
The windows, doors, and ceiling of the building are in poor condition.

Photo 6 – Windows, door, and ceiling in bad condition.

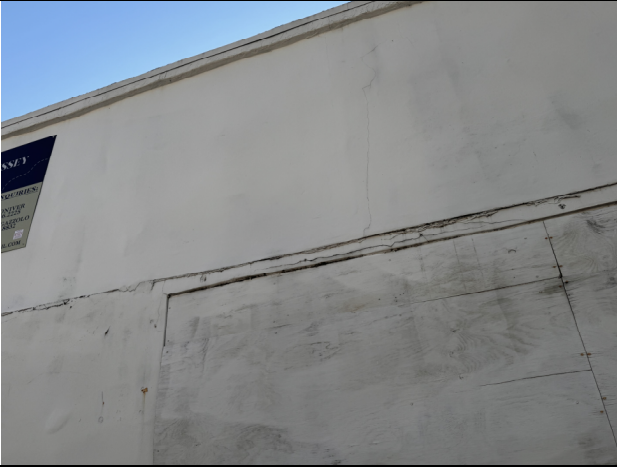
Photo 7 – Exterior stucco with cracks

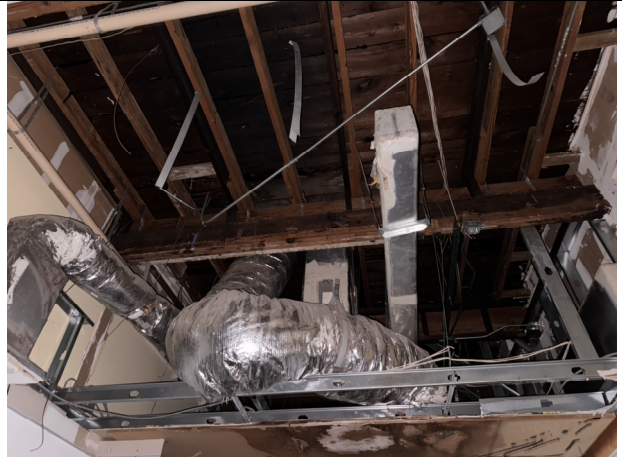
The interior partitions and ceiling are in bad condition with the presence of humidity, rotting, and damage.

Photo 8 – Interior partitions in poor conditions, presence of humidity due to lack of waterproofing in the roof.
