Arborist Report

94 Palm Avenue

Miami Beach

11/14/2022

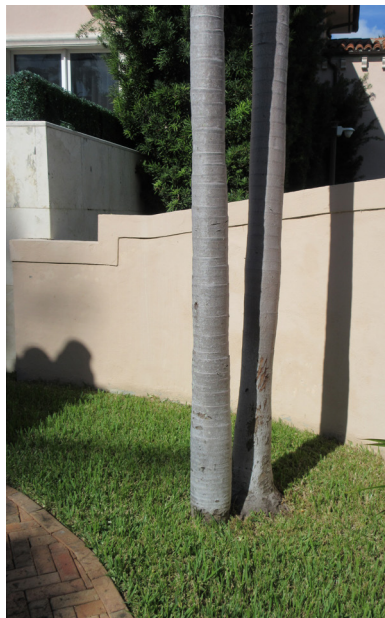
Tree #2 is a double Christmas Palm located at the front of the house. It is in good condition with one lower dead frond.

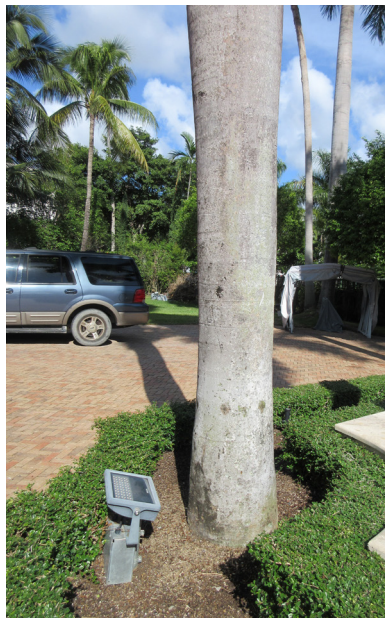
Tree #4 is a Royal Palm located next to the front fountain. It is in fair condition with a pencilling trunk.

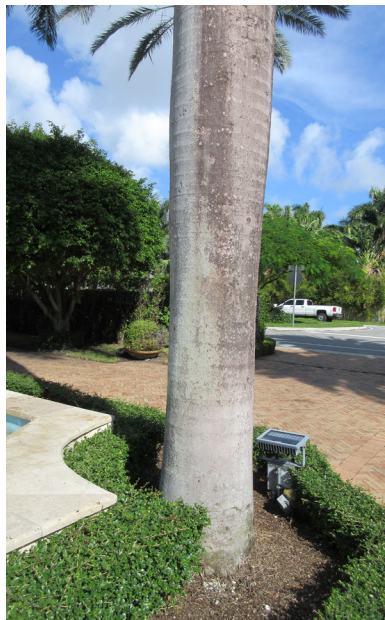
Tree #6 is a Royal Palm located next to the front fountain. It is in fair condition with a pencilling trunk.

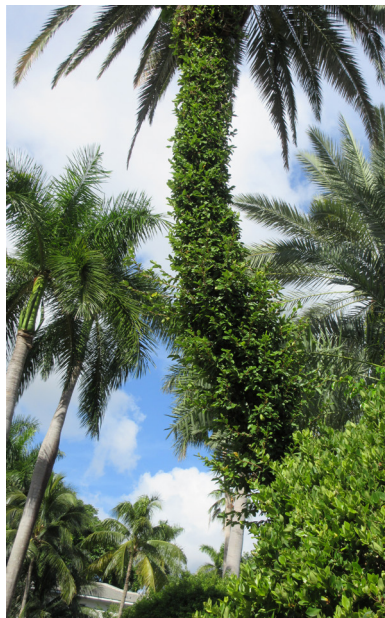
Tree #8 is a Canary Island Date Palm located at the front of the property. It is in good condition. Vines are growing on the trunk.

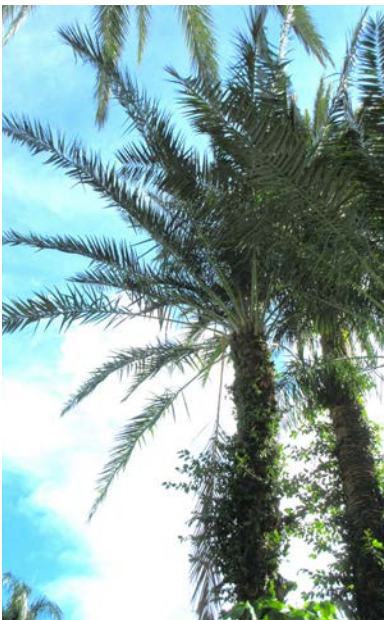
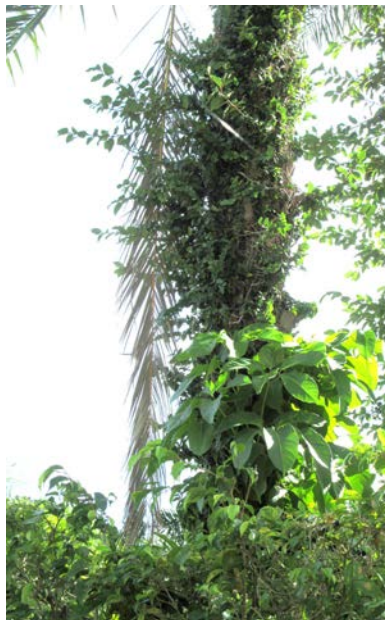
Tree #10 is a Date Palm located at the front of the property. It is in fair condition and is competing with the nearby trees. Vines are on the trunk.

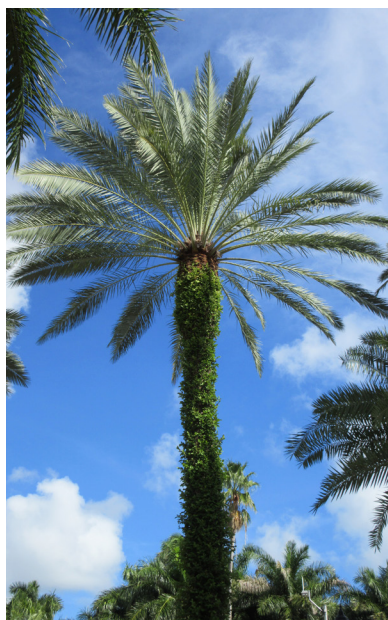
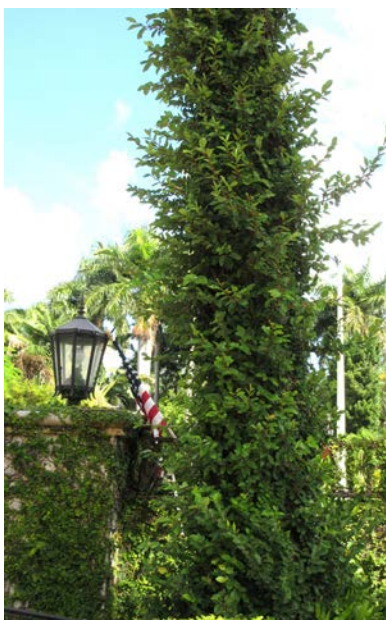
Tree #11 is a Date Palm located at the front entrance. It is in good condition. Vines are on the trunk.

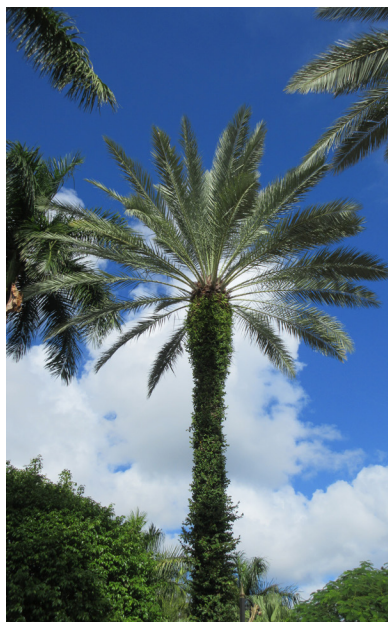
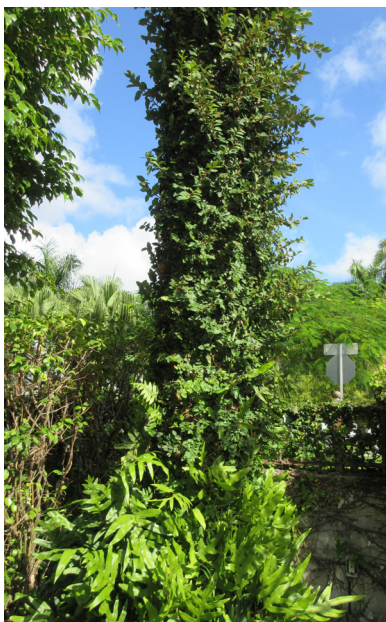
Tree #12 is a Date Palm located at the front entrance. It is in good condition. Vines are on the trunk.

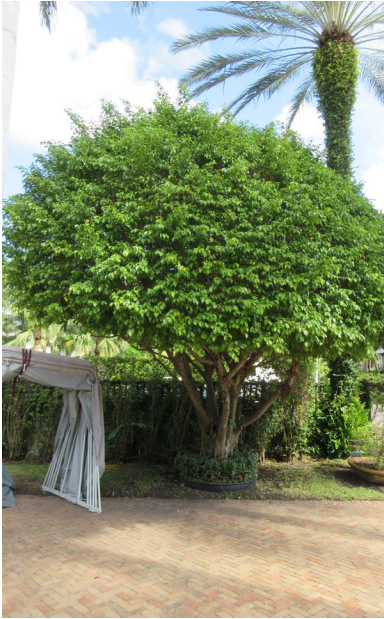
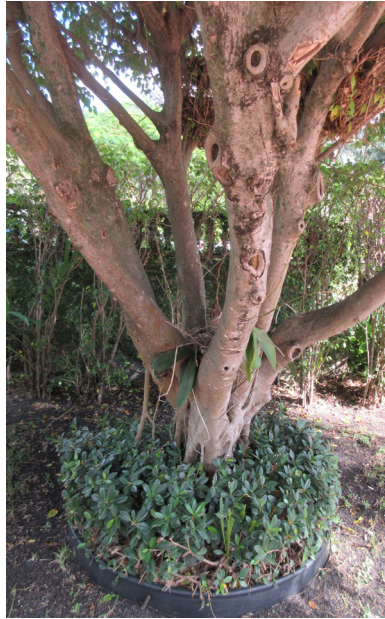
Tree #13 is a Weeping Fig located at the front of the property. It is multi-trunked and in good condition. The canopy has been shaped. There is thrips damage to the foliage.

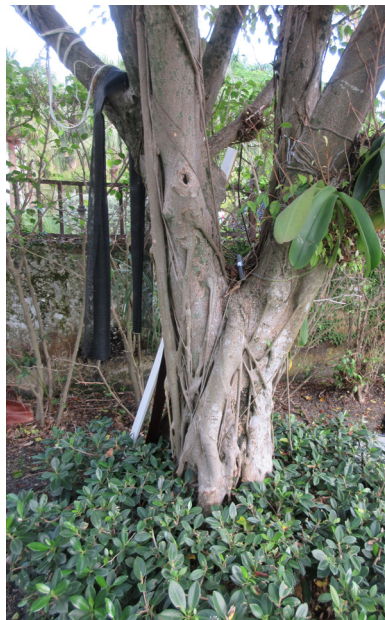
Tree #16 is a Weeping Fig located towards the northwest corner of the property. It is in fair condition. The canopy has been shaped and there is thrips damage to the foliage.

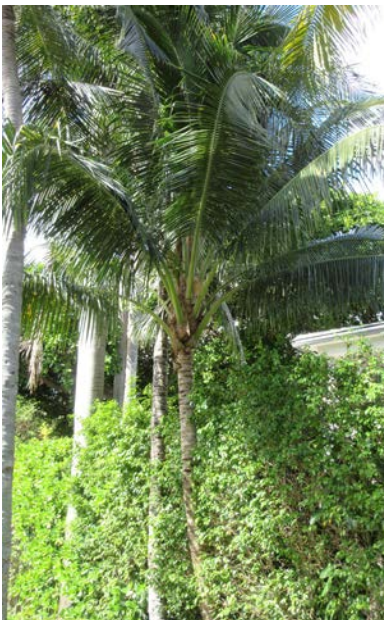
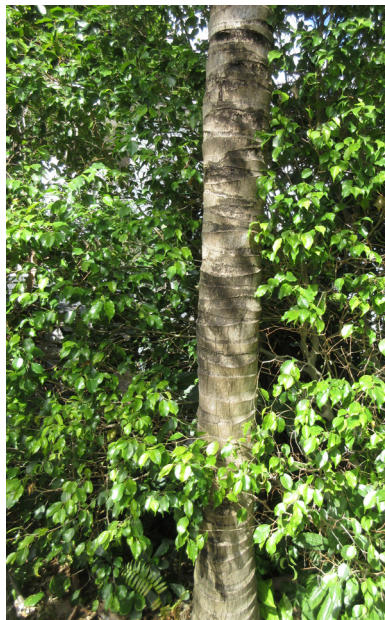
Tree #18 is a Coconut Palm located towards the northwest corner of the property. It is in fair condition with yellow spotting on the fronds.

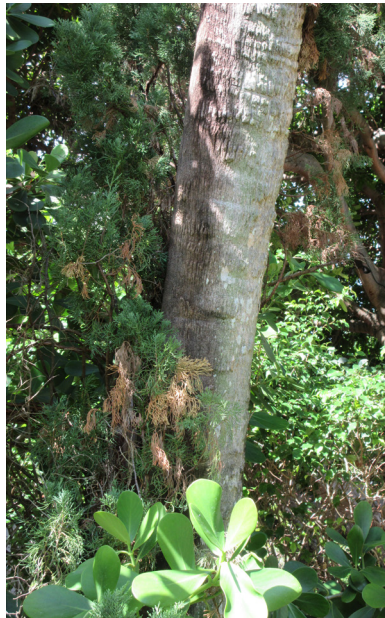
Tree #22 is a Chinese Fan Palm located on the west side of the property. It is in fair condition with a kinked trunk.

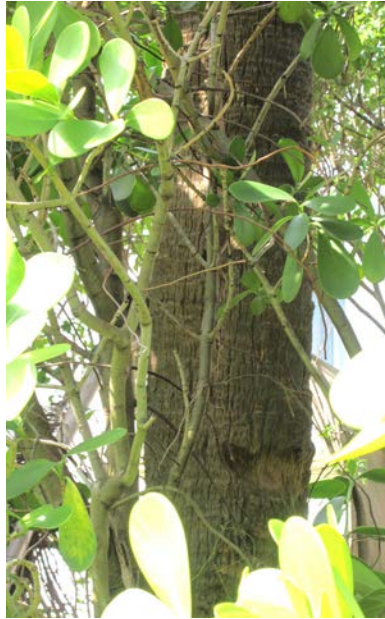
Tree #23 is a Sabal Palm located on the west side of the property. It is in poor condition with a sharply pencilling trunk. Little canopy remains.

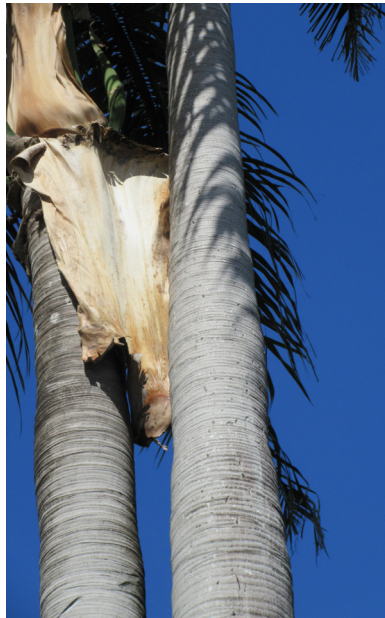
Tree #24 is a Royal Palm located on the west side of the property. It is in fair condition with a pencilling trunk and frizzled foliage.

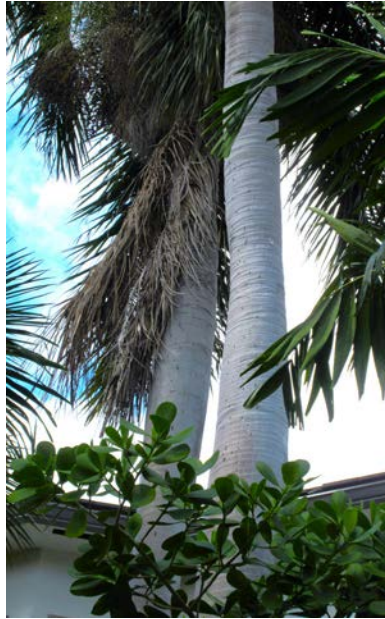
Tree #31 is a Royal Palm located on the west side of the property. It is in fair condition with a trunk that is narrowing.

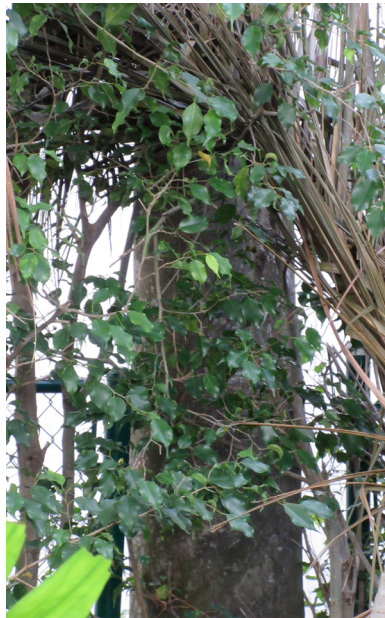
Tree #32 is a Royal Palm located on the border of the western neighbor's property. The propertyline chainlink fence is separated due to the tree. It is in fair condition.

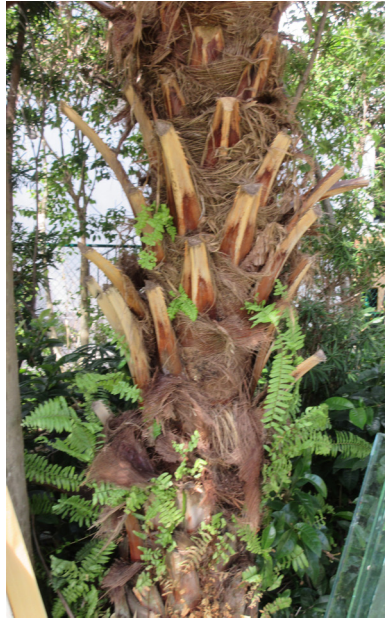
Tree #35 is a Chinese Fan Palm located on the western side of the property. It is in fair condition with off-color fronds.

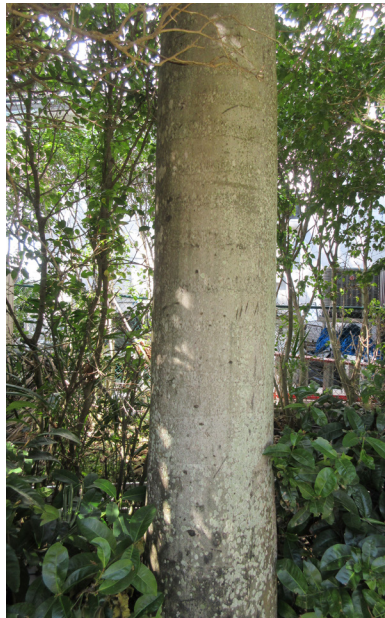
Tree #38 is a Royal Palm located on the western side of the property. It is in good condition. The lower fronds have been overpruned.

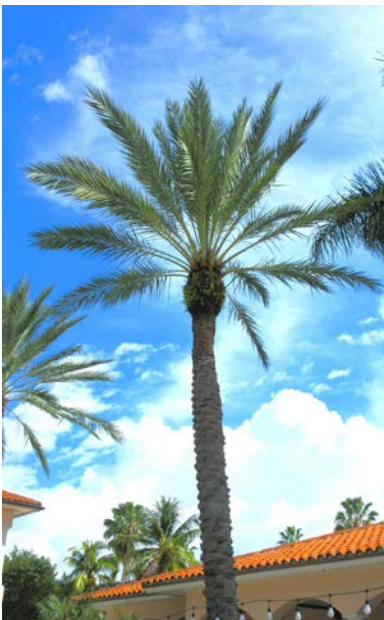
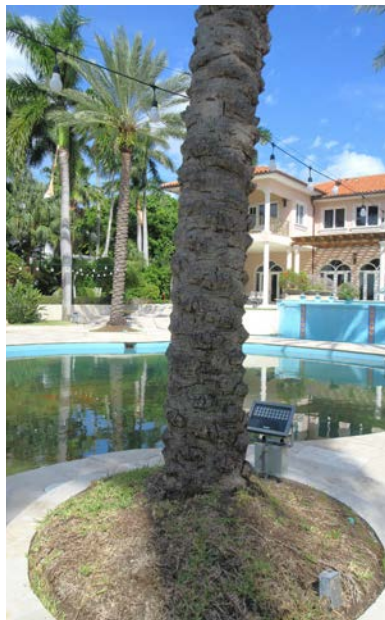
Tree #48 is a Date Palm located next to the pool. It is growing in a raised planter with limited rooting space. The tree is fair condition with a pencilling trunk.

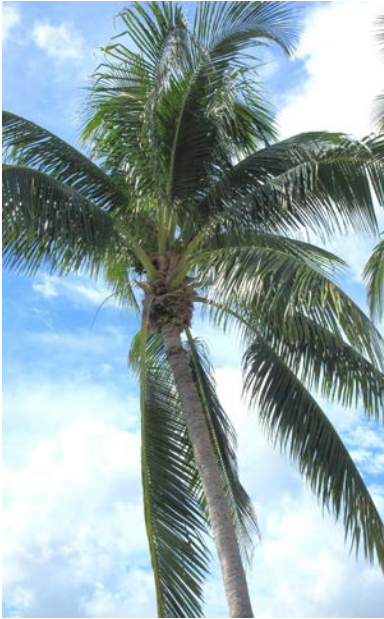
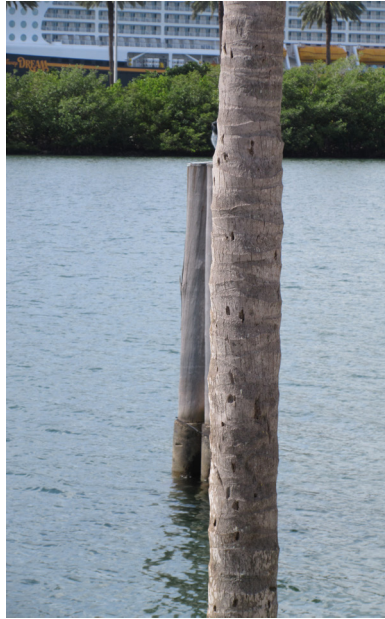
Tree #51 is a Coconut Palm located in the southeast corner of the property. It is in good condition with some trunk irregularities.

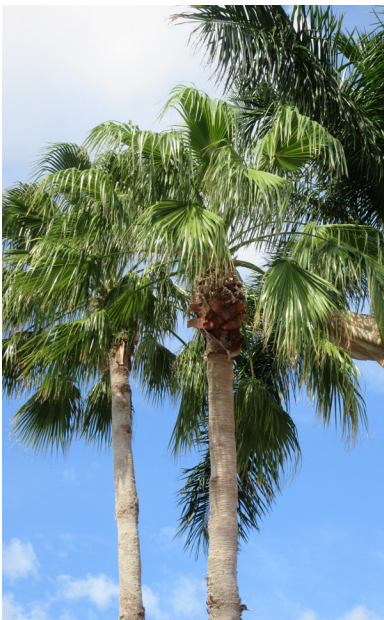
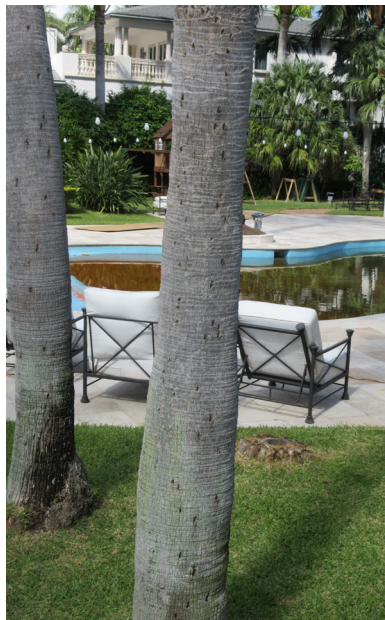
Tree #52 is a Washingtonia Palm located towards the southeast corner of the property. It is in good condition. There are climbing spike injuries to the trunk.

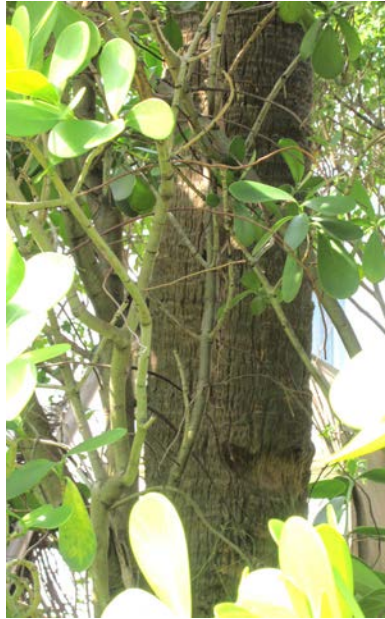
Tree #59 is a Sabal Palm located on the western side of the property. It is in fair condition with a thin, off-color canopy.

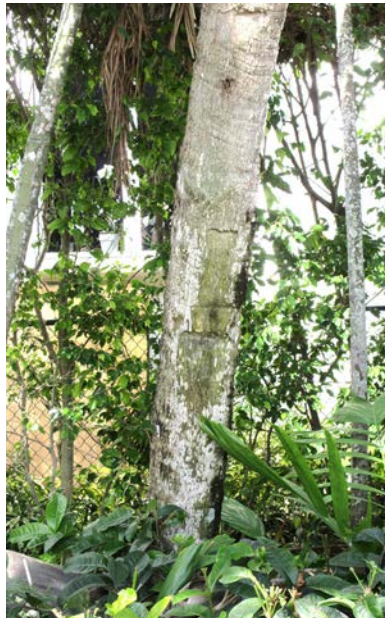
Tree #60 is a Washingtonia Palm located on the western side of the property. It is in poor condition with a thin canopy. The trunk narrows and curves. The tree is competing with the nearby vegetation.

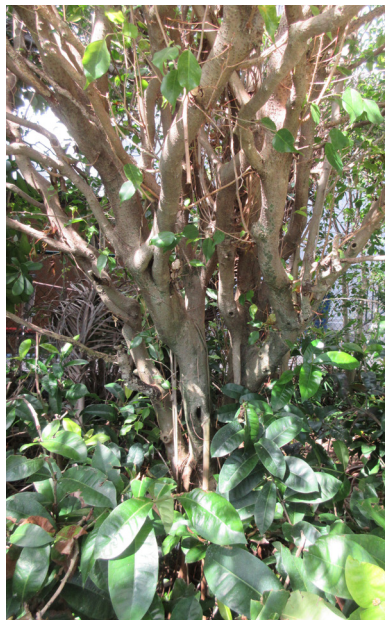
Tree #62 is a Weeping Fig located on the western side of the property. It is multi-trunked and in fair condition. The canopy has been shaped and there is thrips damage to the foliage.

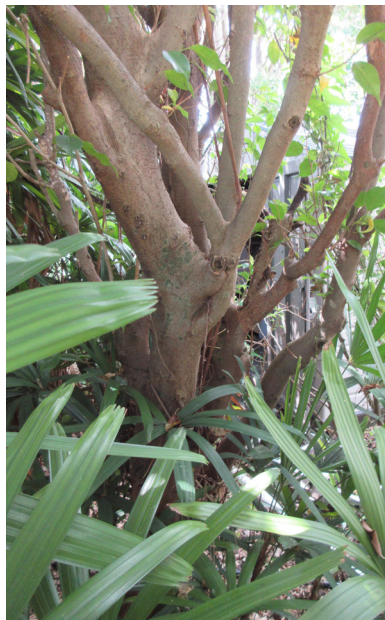
Tree #64 is a Weeping Fig located on the western side of the property. It is multi-trunked and in good condition. The canopy has been shaped and there is thrips damage to the foliage.

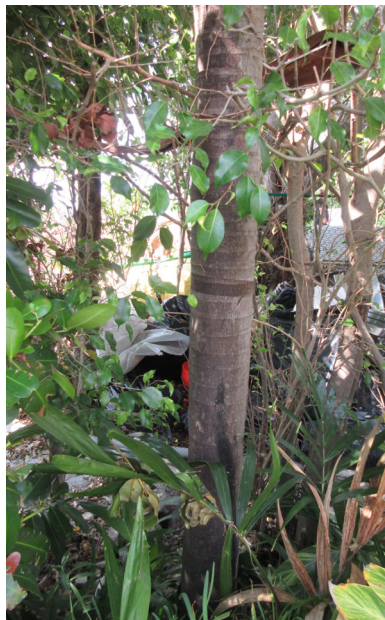
Tree #66 is a Christmas Palm located in the southwestern corner of the property. It is in good condition with some yellow spotting on the fronds.

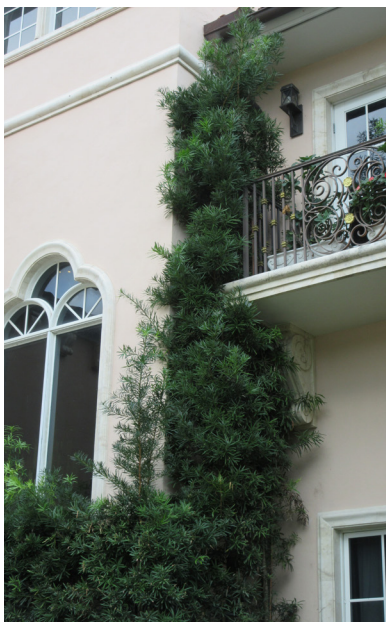
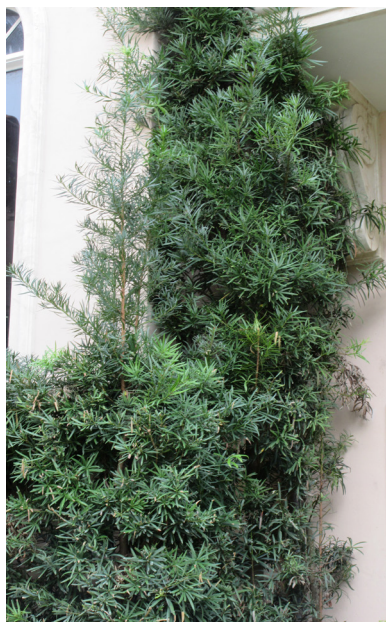
Tree #72 is a Podocarpus located at the front of the house. It is in fair condition and has limited growing space.

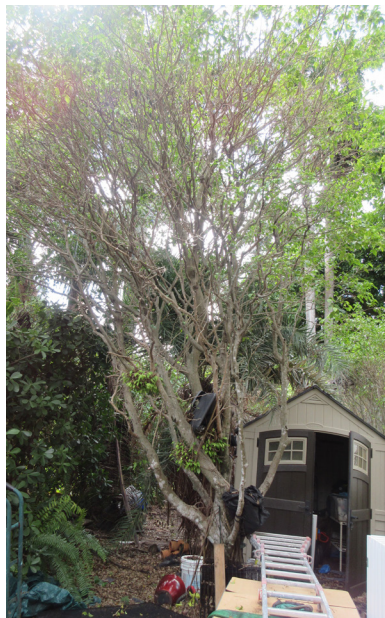
Tree #76 is a Weeping Fig located on the western side of the property. It is multi-trunked and in fair condition. The canopy is thin and there is thrips damage to the foliage.
