RE: **Request for After-the-Fact Certificate of Appropriateness for Demolition** - Letter of Intent for After-the-fact Certificate of Appropriateness for Demolition regarding 1525 Lenox Avenue, Miami Beach

1525 Lenox Avenue

STRUCTURAL CONDITION ASSESSMENT
1525 Lenox Ave
Miami Beach, Florida

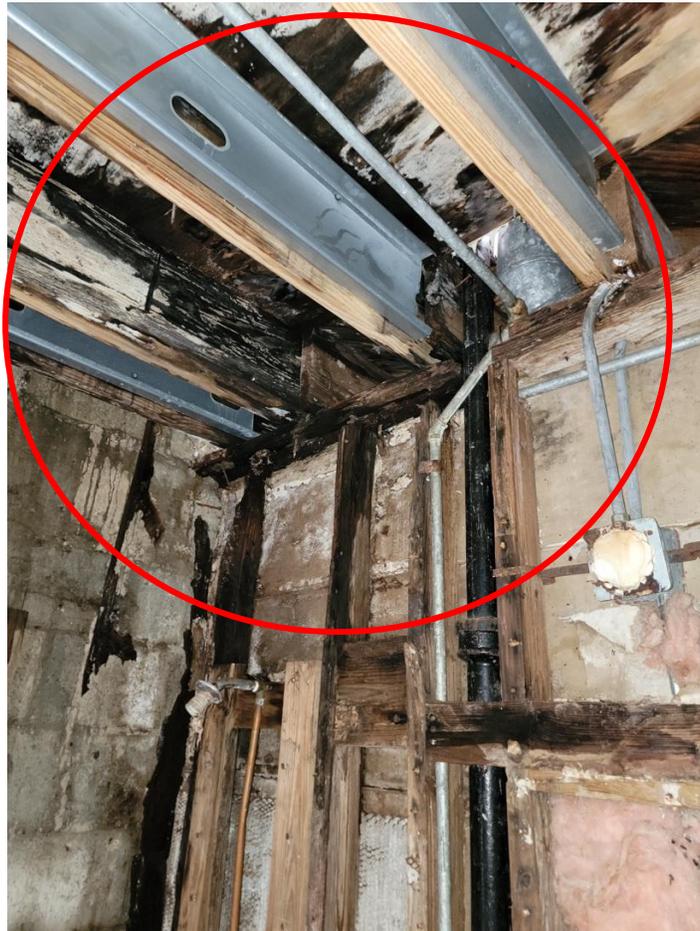
The wood decking and the roof joists are water damaged and deteriorated in several loactions.

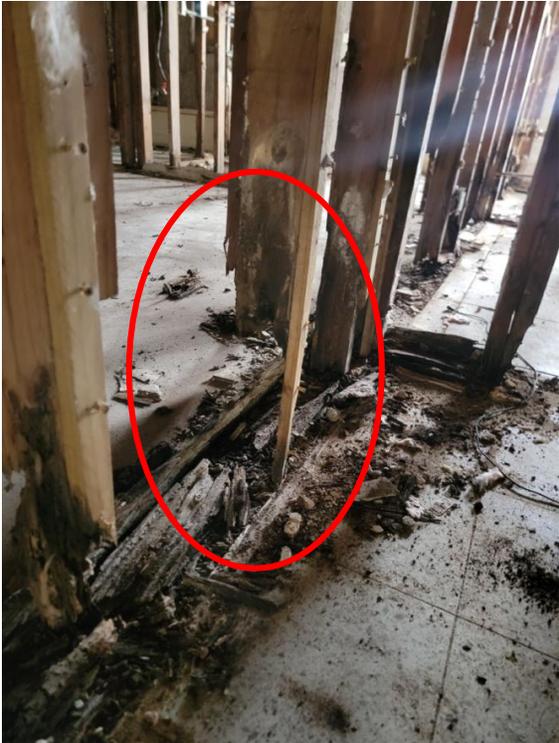
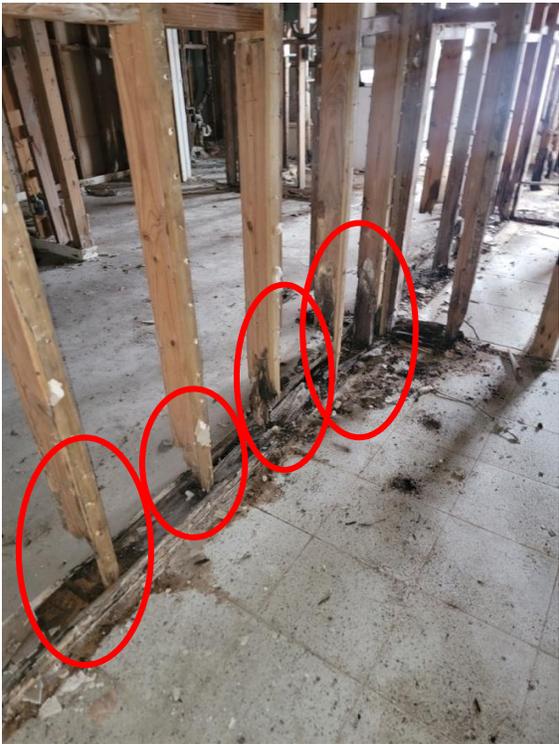
80% of the load bearing wood stud walls have failed 100% with completely deteriorated bottom and lost 100% of its capacity.

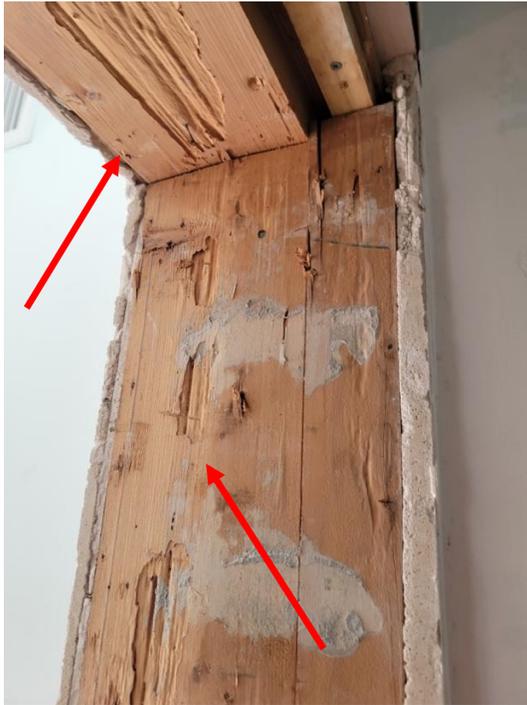
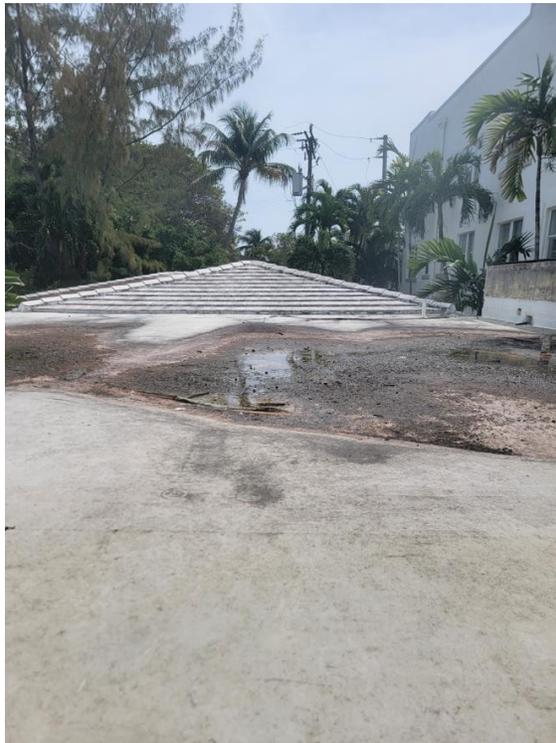
Termite damage is also evident throughout the building, see below

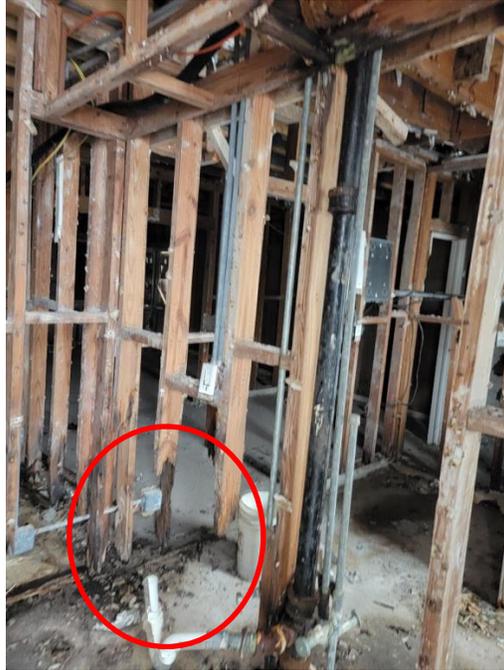
Throughout the building, there is loadbearing wall, stud deterioration, and loss of capacity up to 100%

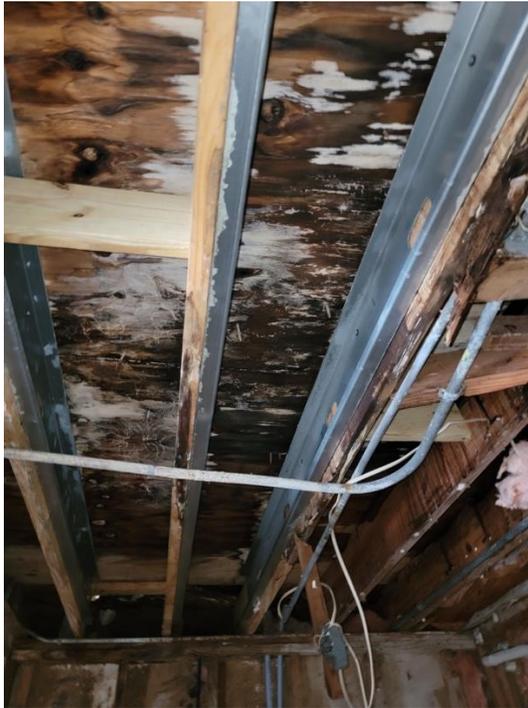
Throughout the building, there is loadbearing wall, stud deterioration, and loss of capacity up to 100%

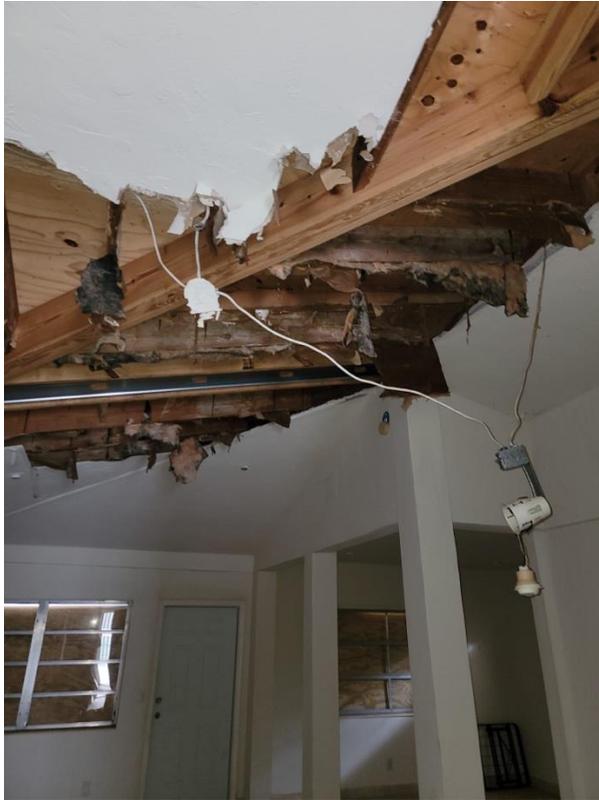
Water intrusion from the roof lead to damage of roof decking, and roof joists

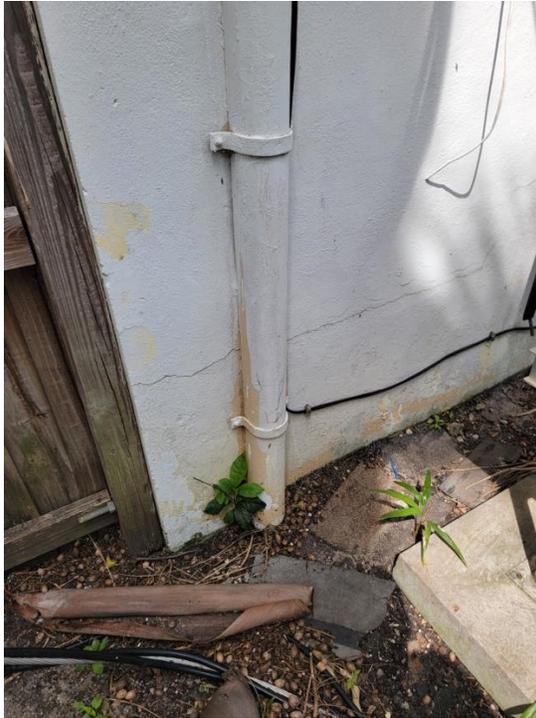
Stucco cracking and spalling

Stucco cracking on spalling

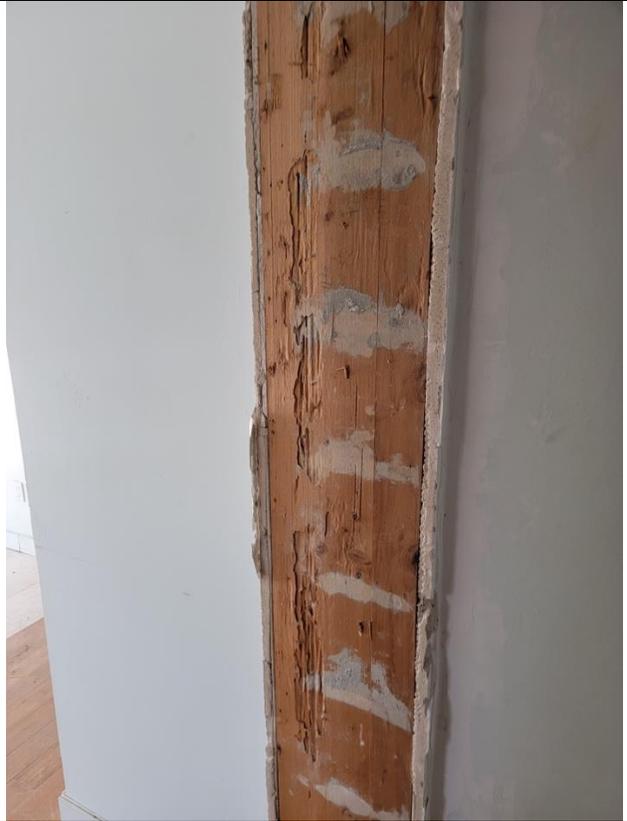
Termite Damage

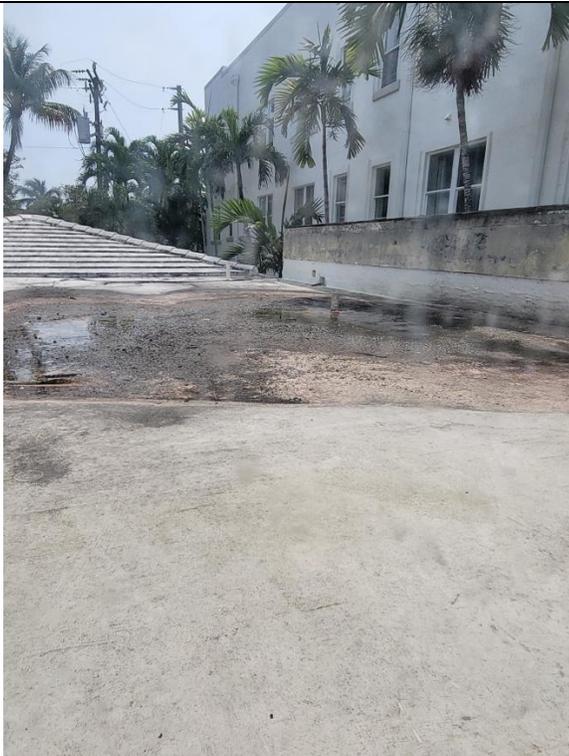
Waterproofing membrane failure

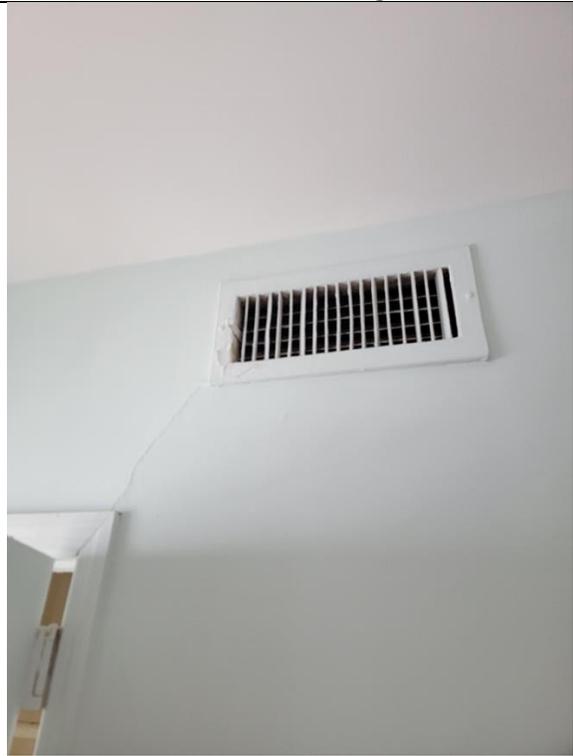
Settlement cracking

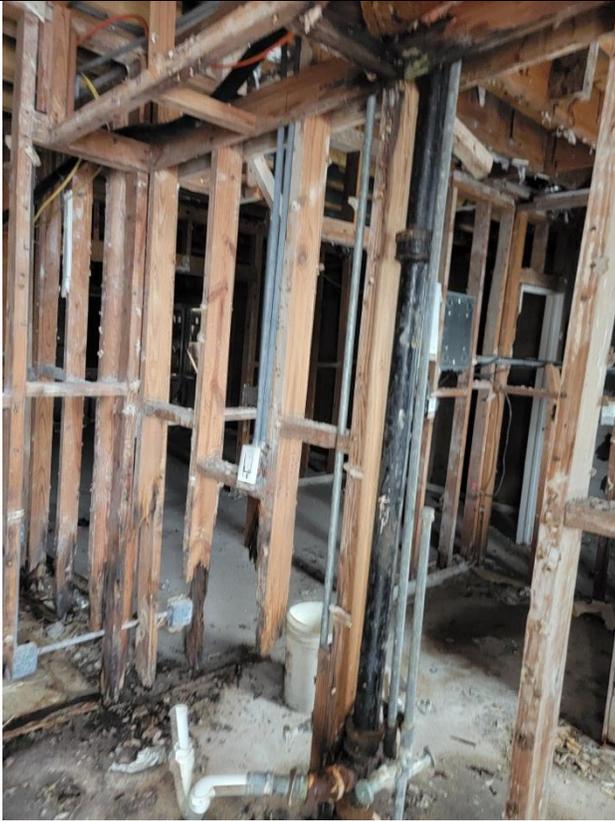
Load bearing stud walls 100% failure

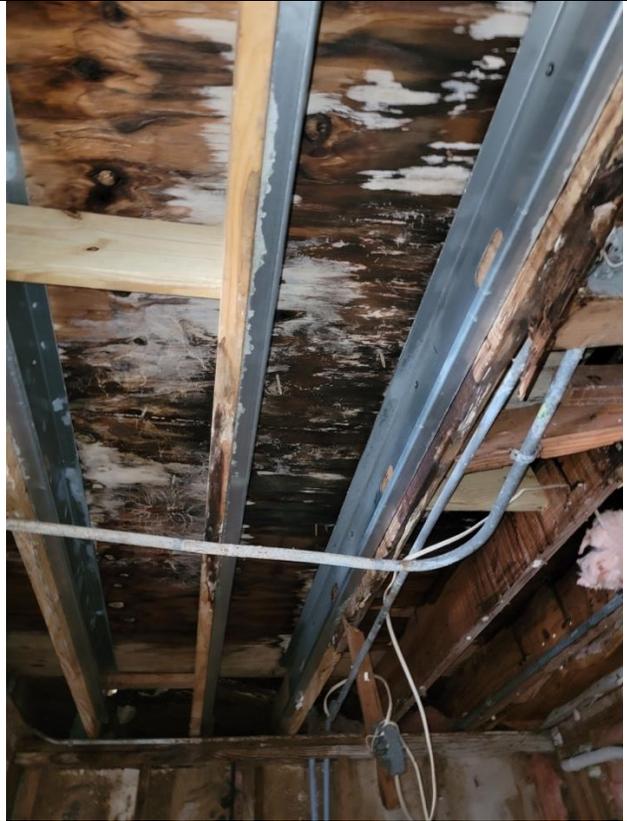
Moisture intrusion damage

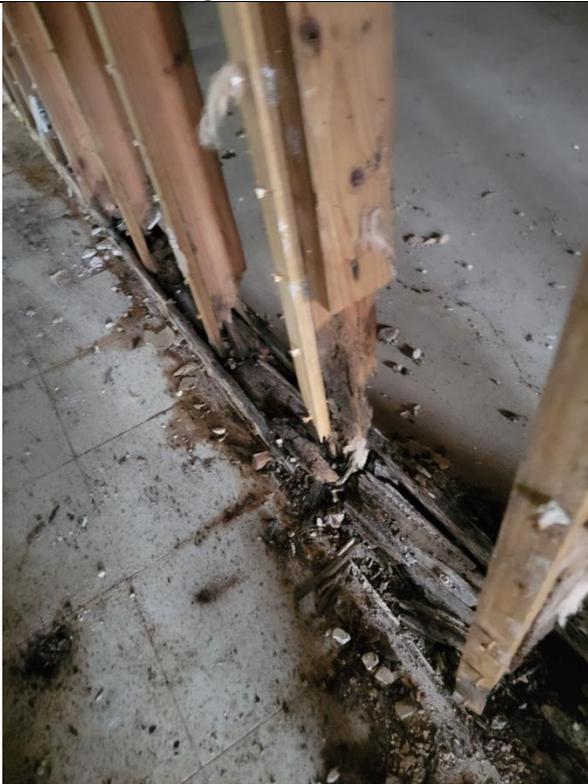
Load bearing stud walls 100% failure

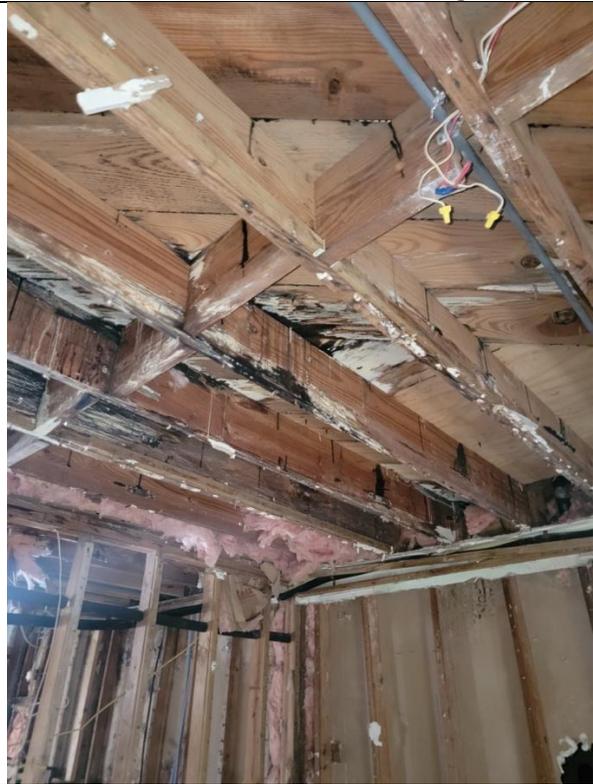
Moisture intrusion damage

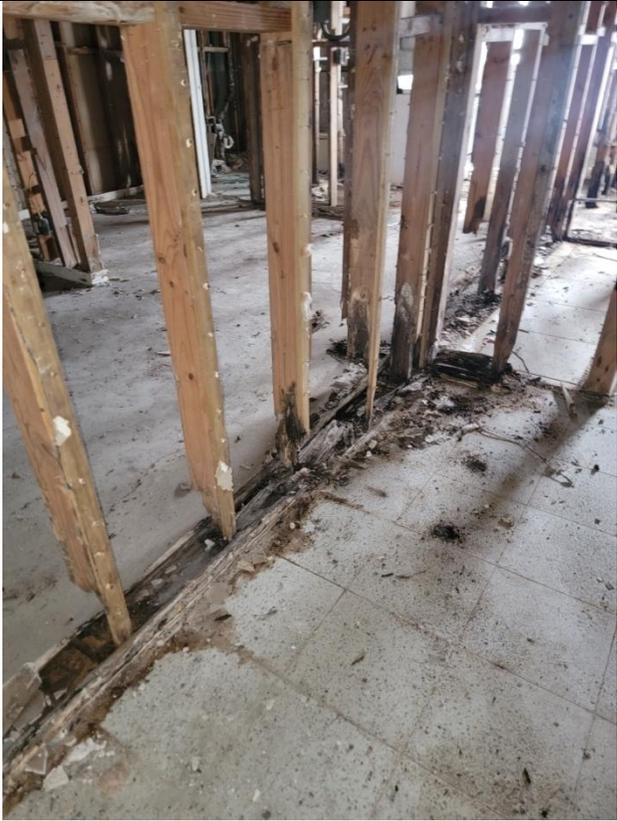
Load bearing stud walls 100% failure

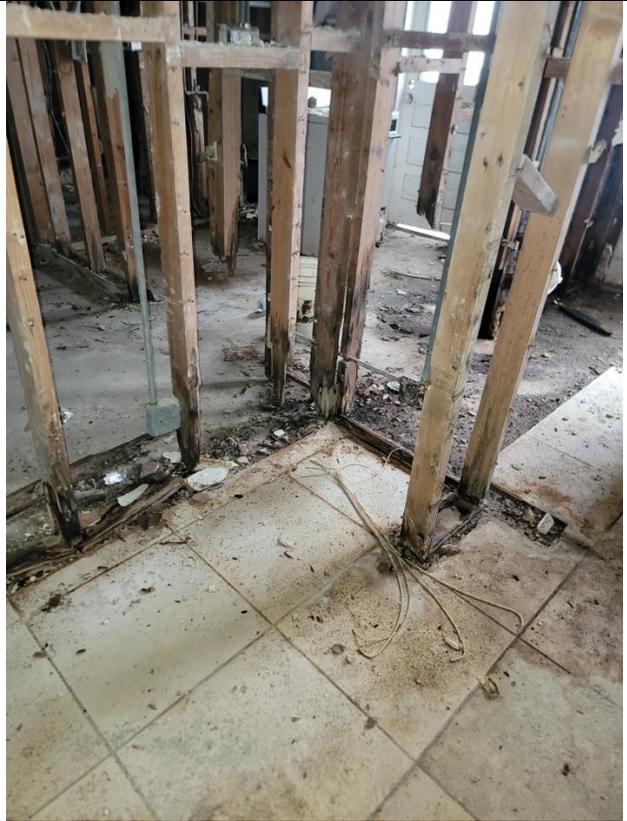
Load bearing stud walls 100% failure

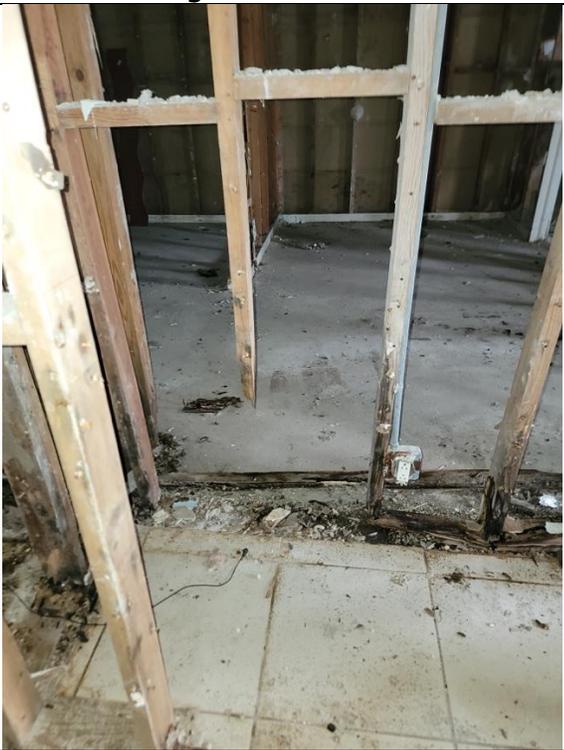
Load bearing stud walls 100% failure

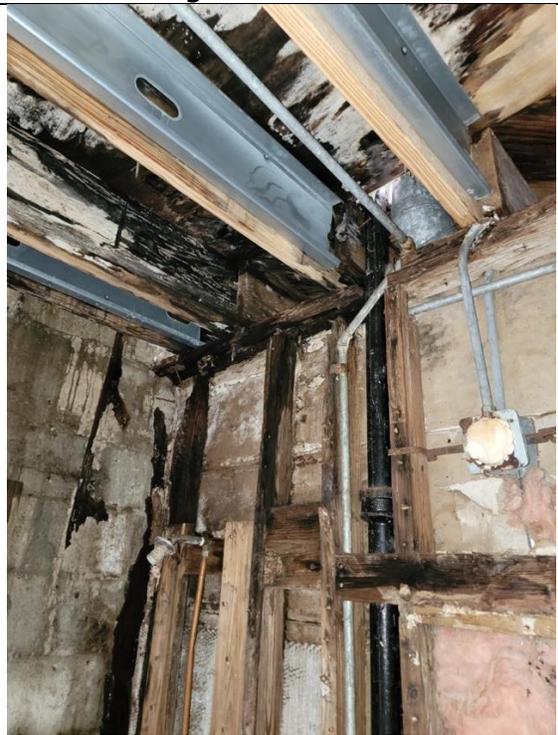
Moisture intrusion damage
