STRUCTURAL CONDITION ASSESSMENT
1818 Michigan Ave
Miami Beach, Florida

February 22, 2024

Youssef Hachem Consulting Engineering

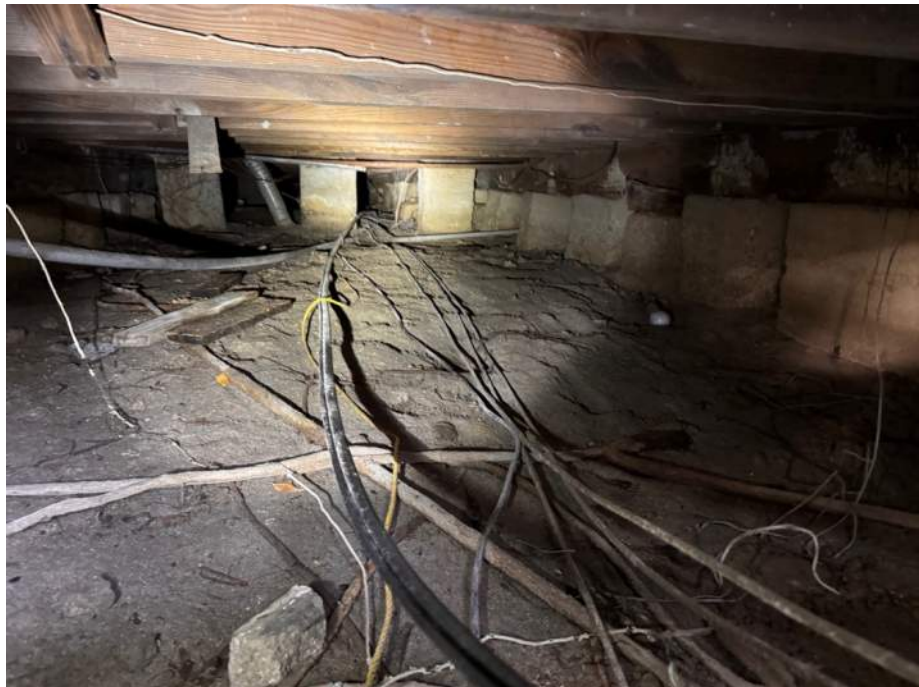
The foundations have failed due to the seawall having damages and allowing water to intrude under the building. Water is noted under the crawlspace access panels (see attached pictures), the crawlspace is very damp and concrete foundations supporting the first floor wood joists have shifted, making the floor unstable and uneven.

The foundations for the house are just concrete piers that are under designed and inappropriately designed and installed. in our opinion 100% of the foundations are compromised.

Damaged foundations

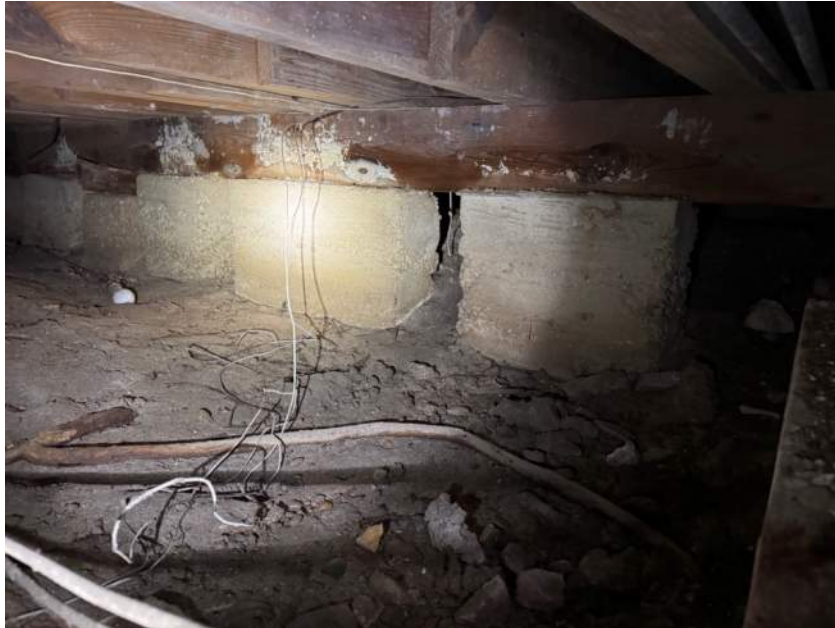
**The wood floors are water damaged, water clogged, please see below.
90% of the wood beams are damaged.**

Damaged first floor joists and beams

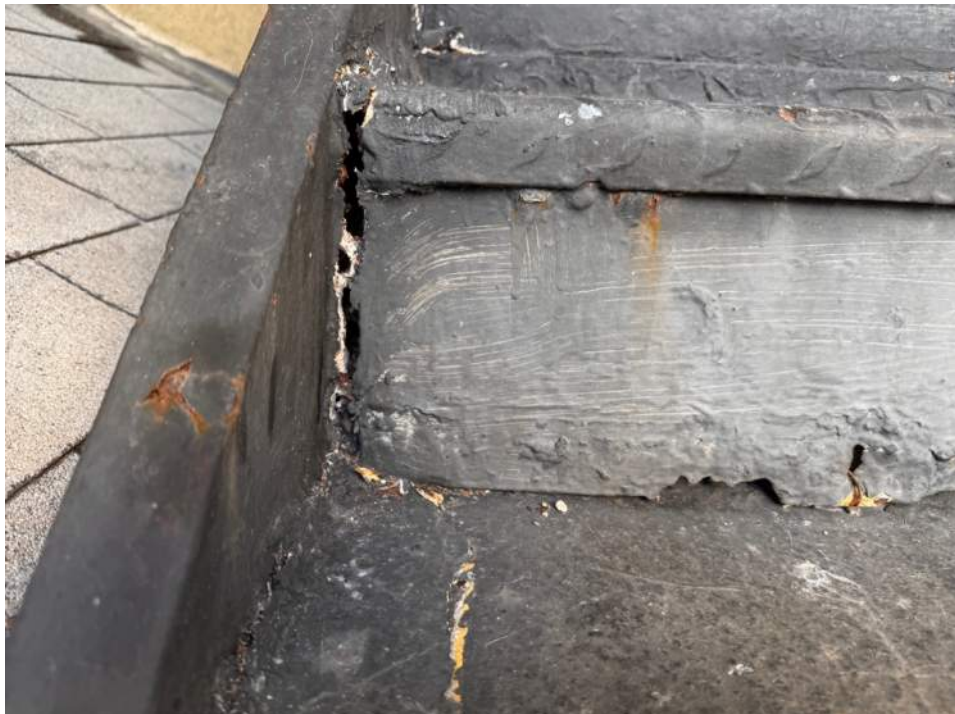
The metal staircase leading to unit 6 on the second floor is completely deteriorated and unstable to use, the stair case is 80% compromised and failed.

Steel staircase 80% failed

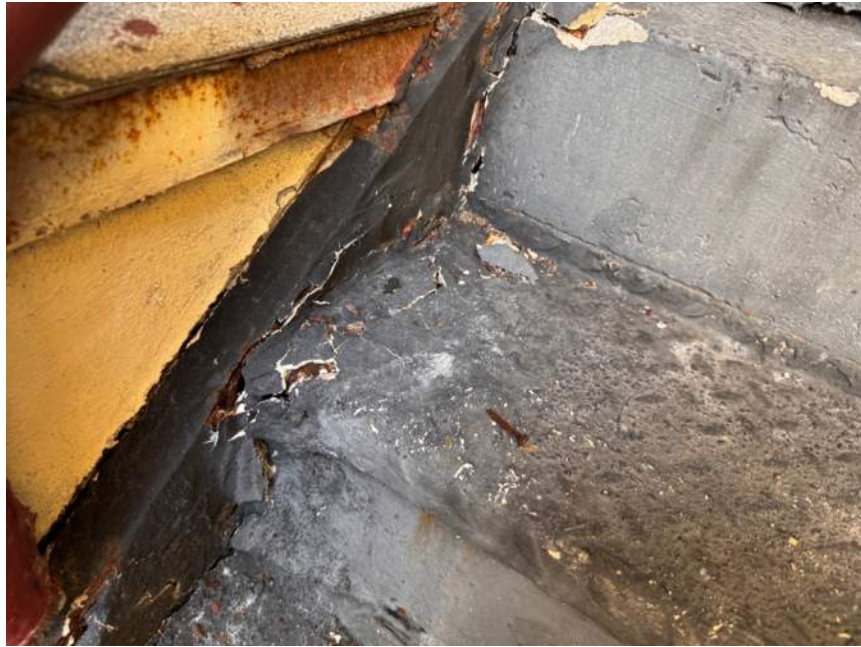
All connections have failed

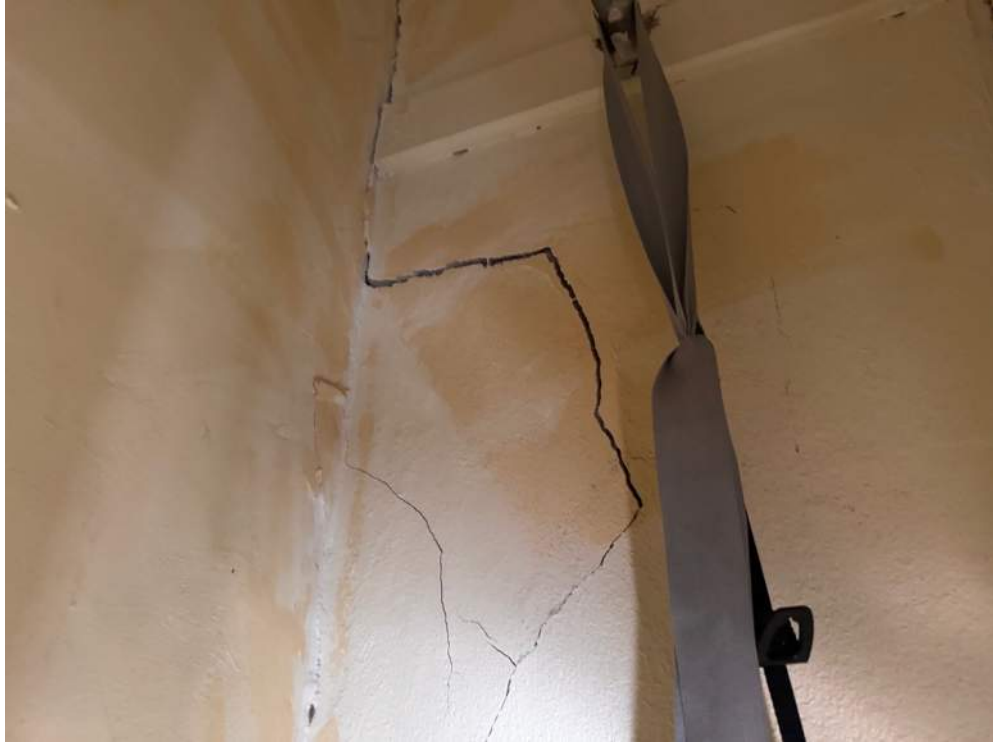
The whole portion of the house close to the seawall (units 5 and 6) have separated from the house and are slanted and leaning towards the canal. This is evident from the cracking in the walls and floors of the second floor.

Cracking in the 2nd floor walls

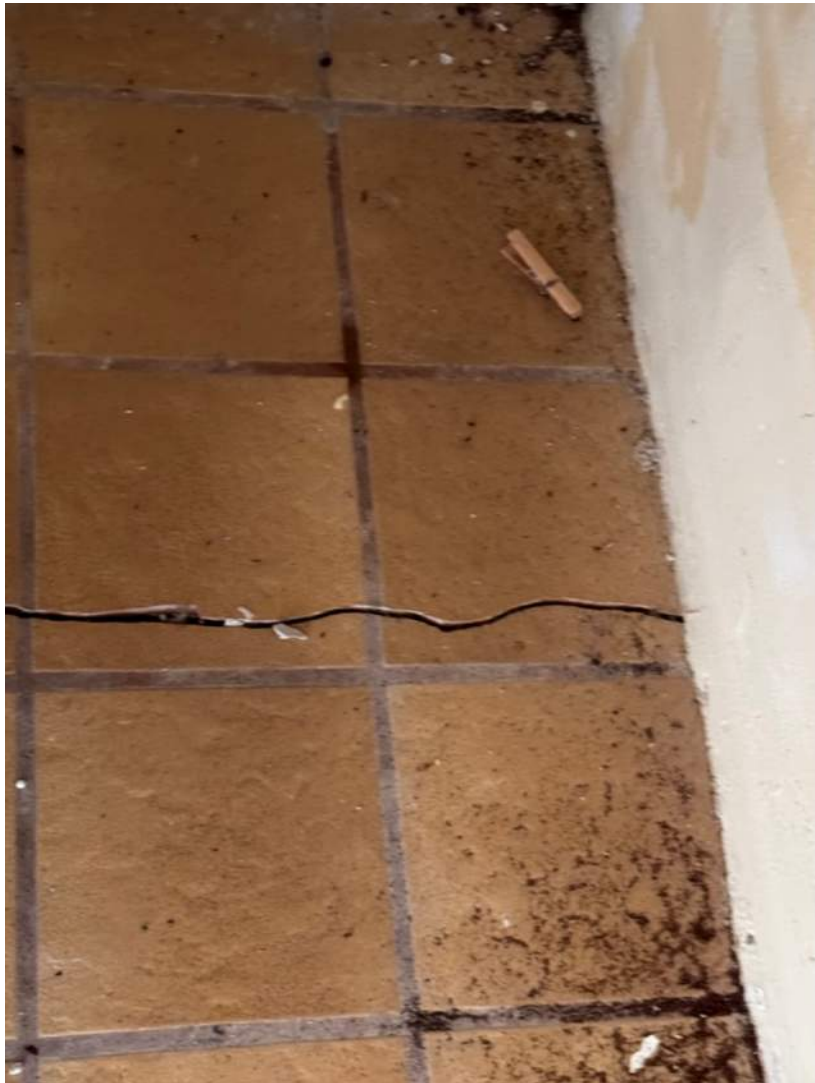
Cracking in the 2nd floor

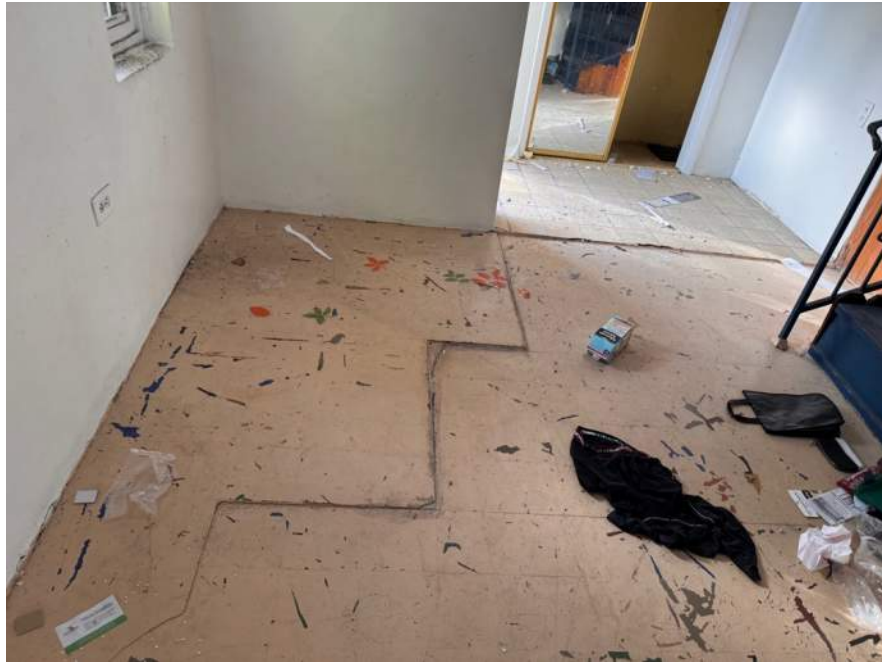
Unit 5 floor cracking

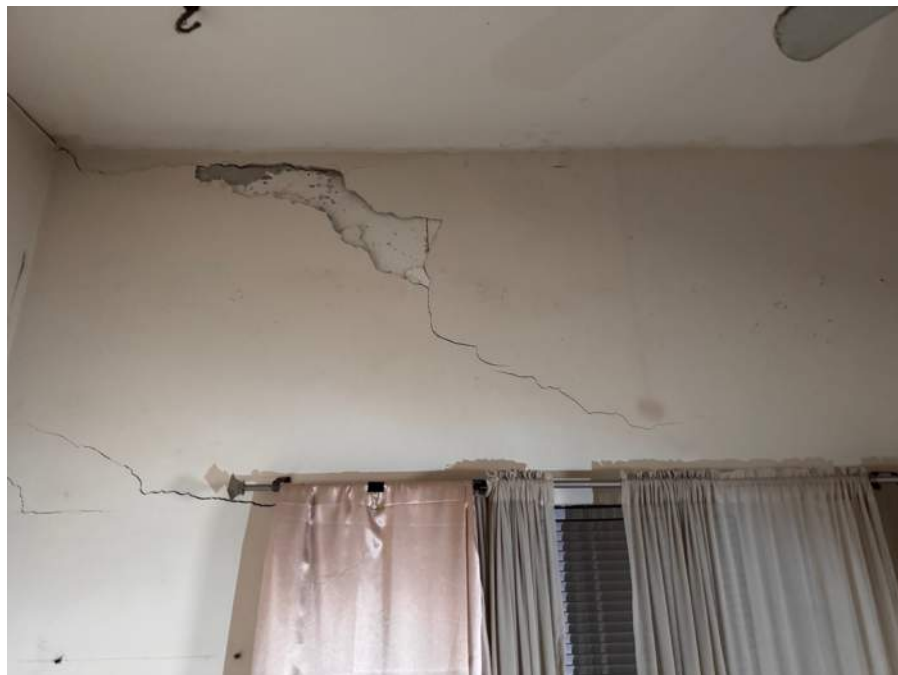
Units 6 walls cracking and evidence of settlement and leaning towards canal

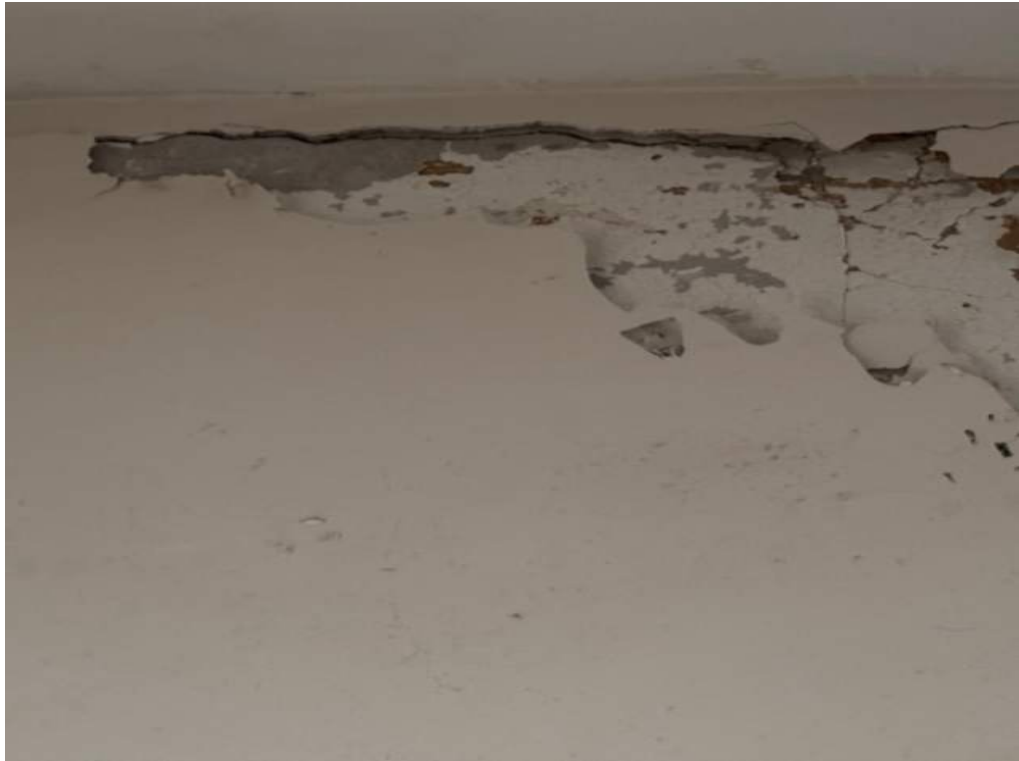
2nd floor walls cracking

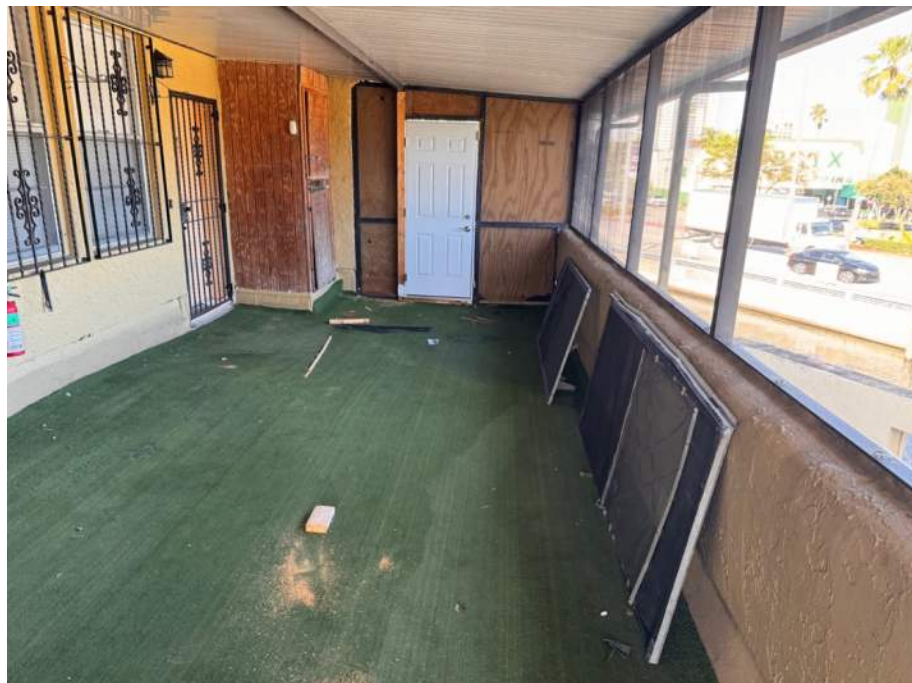
2nd floor deck unwalkable and leaning towards canal

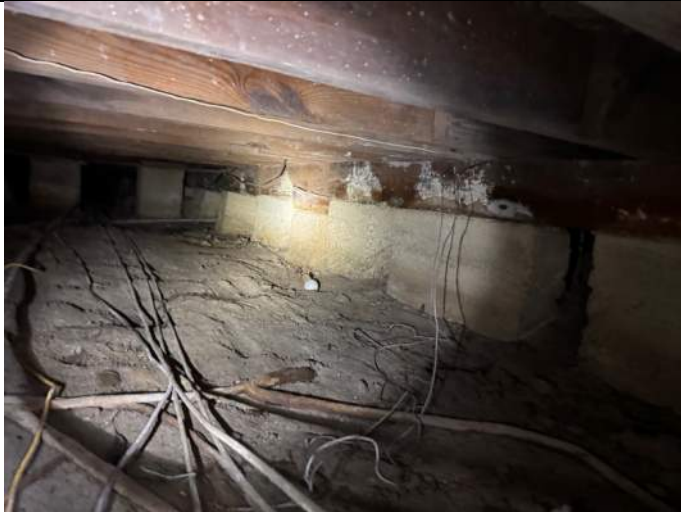
Foundation view showing damaged beams

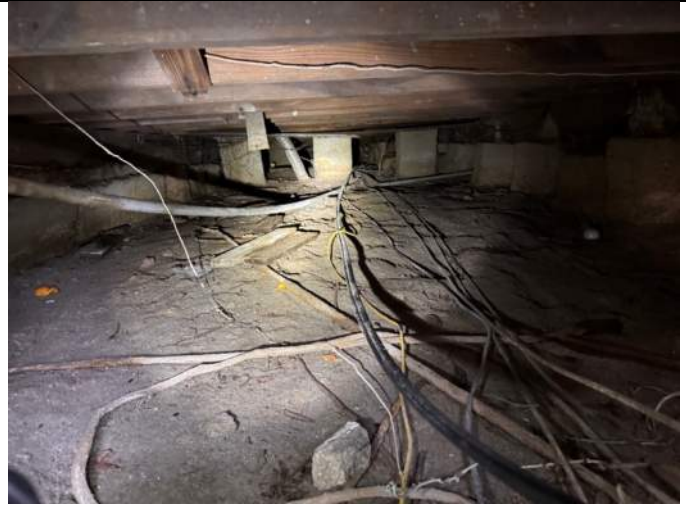
Failed foundations

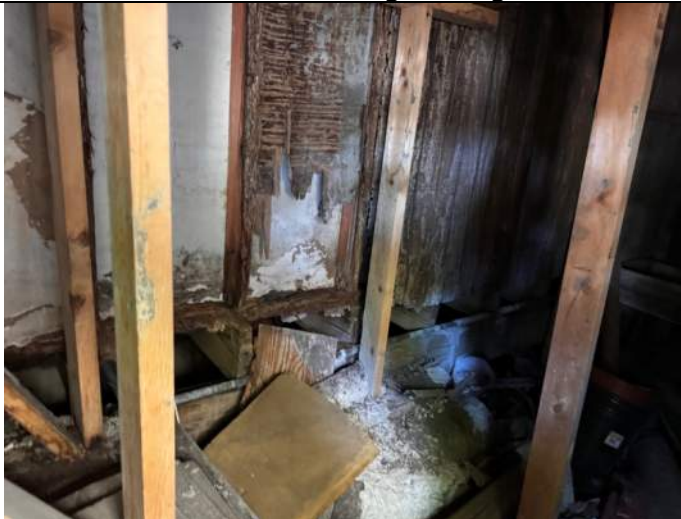
Damaged 1st floors walls

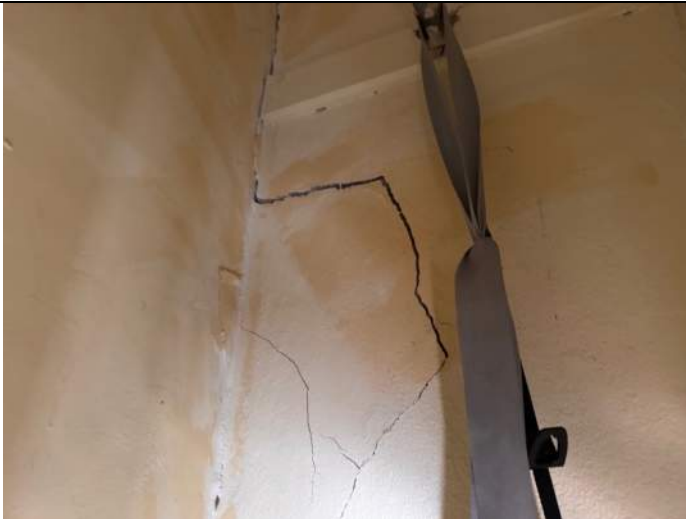
2nd floor cracking

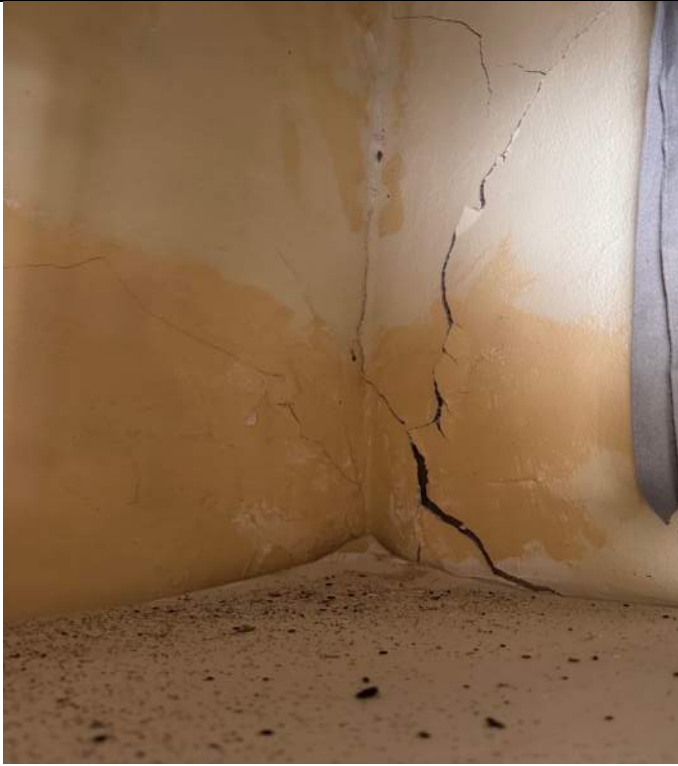
2nd floor wall cracking

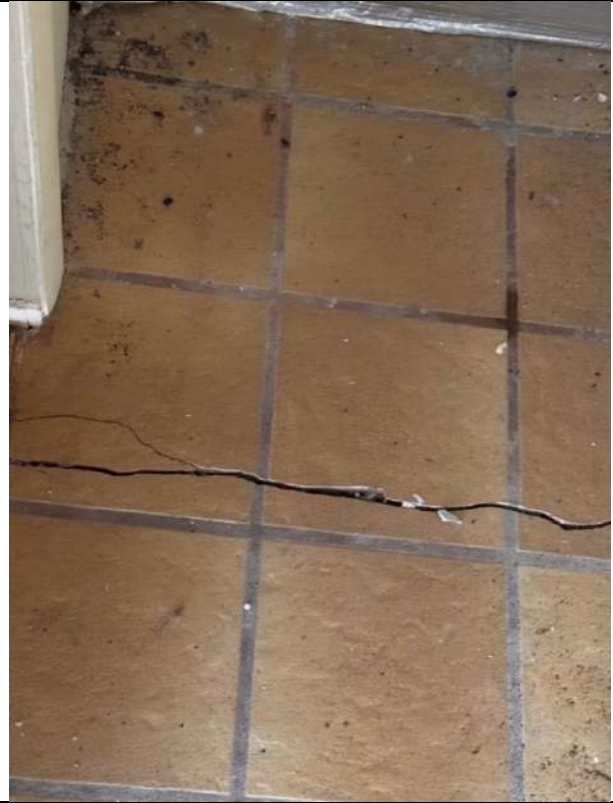
2nd floor cracking

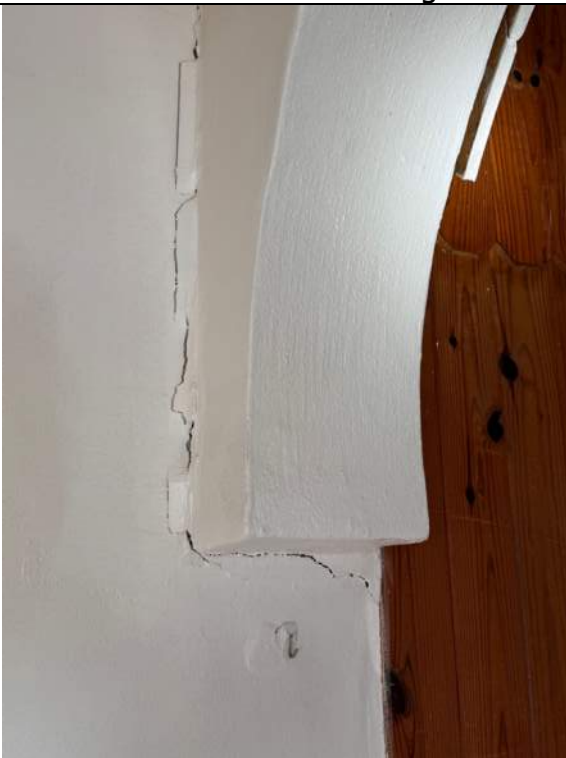
Beam cracking

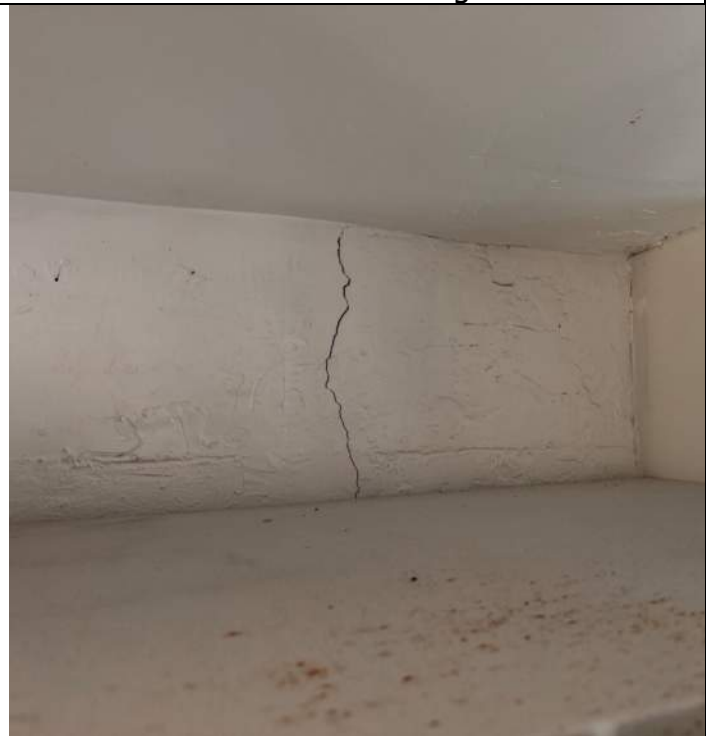
Beam cracking

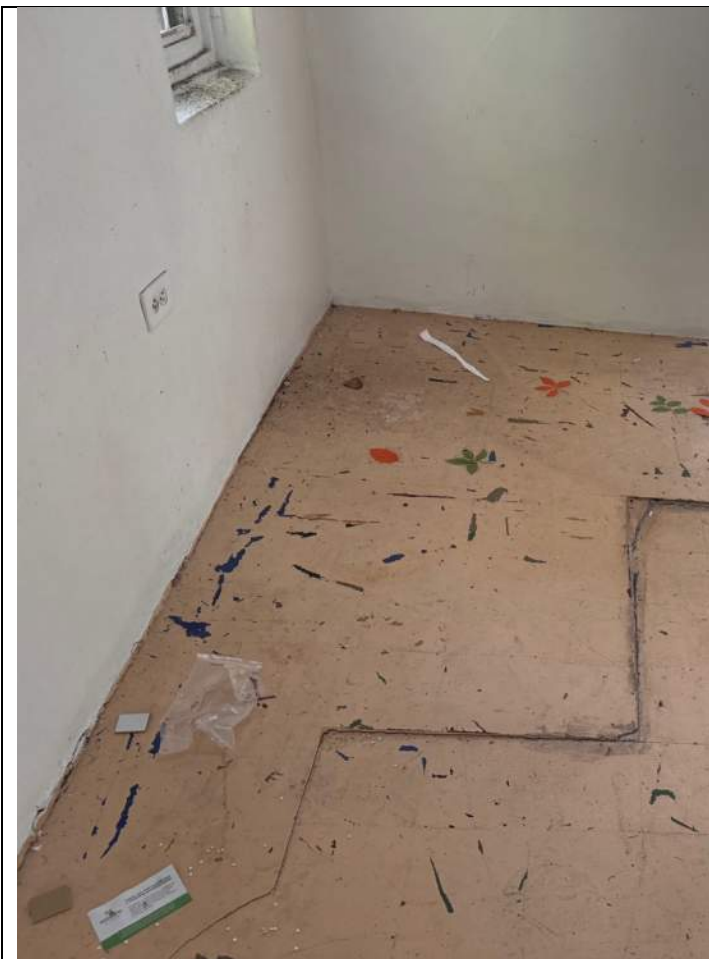
2nd floor cracking and settlement

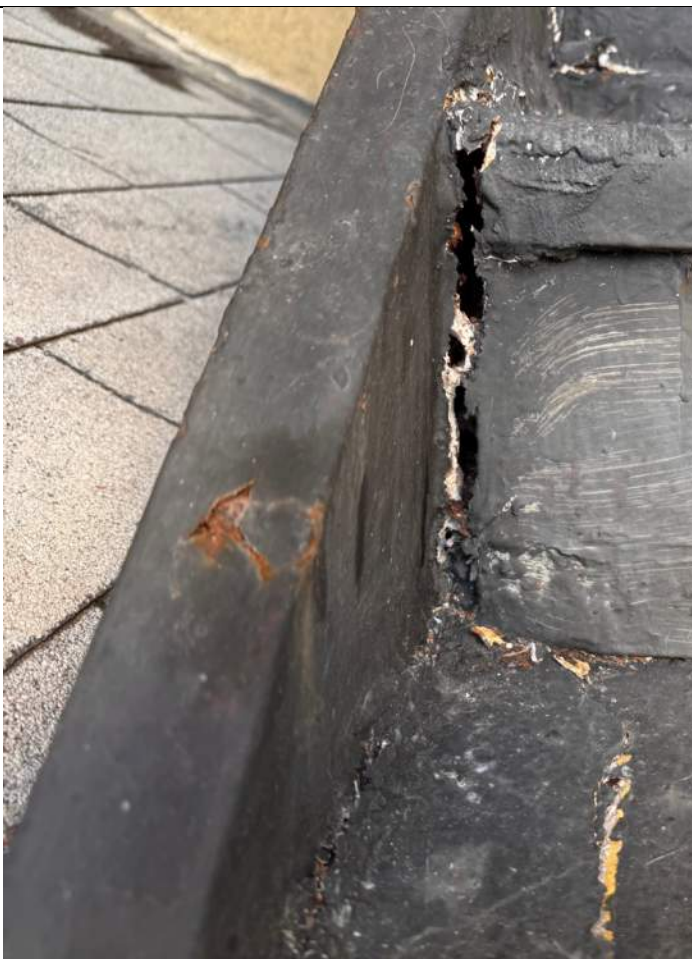
Steel stair connections failure

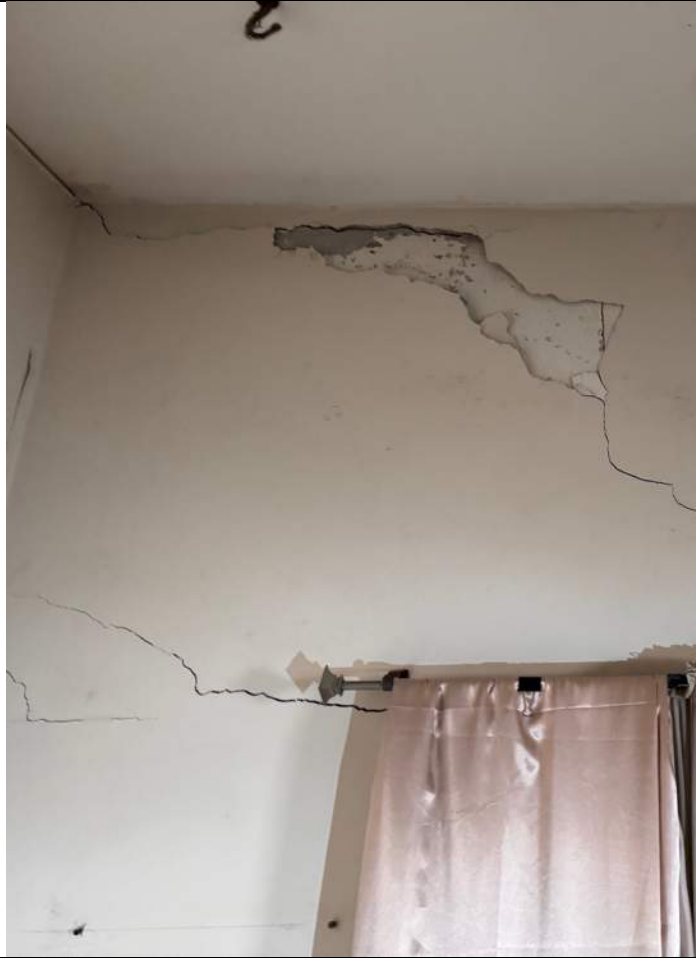
Wall cracking and settlement and leaning
towards canal

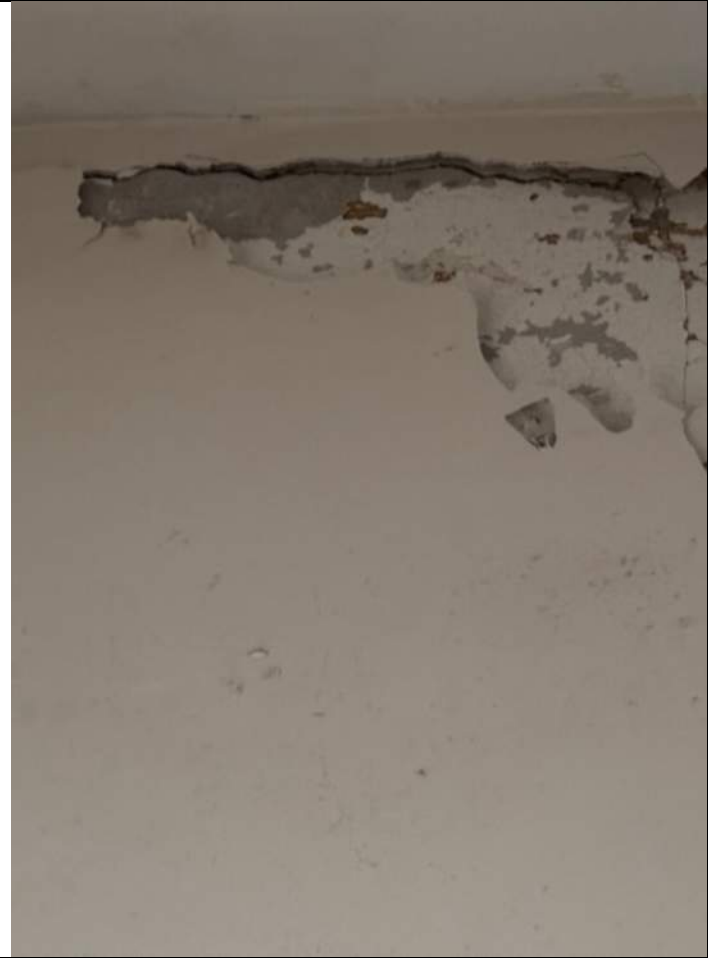
Wall cracking and seperation

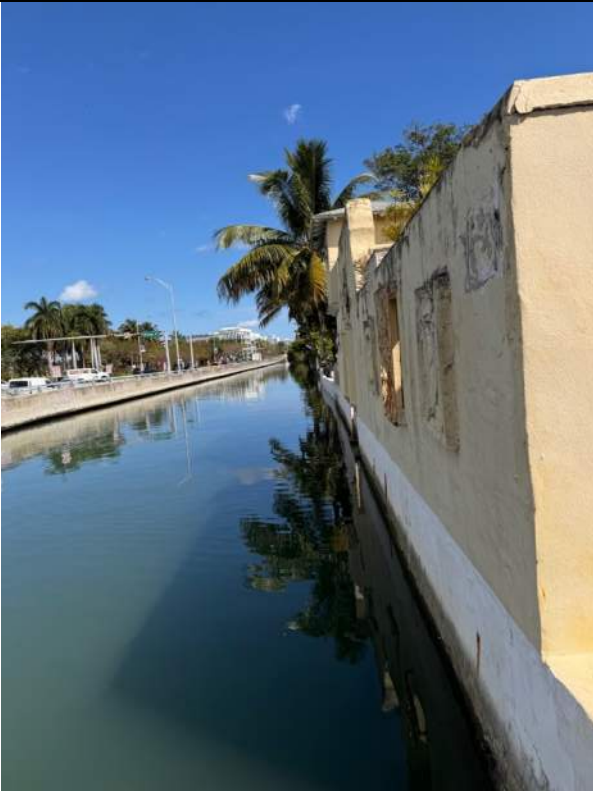
The seawall along the canal has deteriorated beyond repair, and has shifted leading to unstable ground conditions undermining the structure foundations.

Structure wall on the seawall

The structure cannot be repaired without the repair of the seawall, and the seawall cannot be repaired without the demolition of the structure over the seawall.

It is imperative to have a proper seawall installed to have adequate foundations for the house.

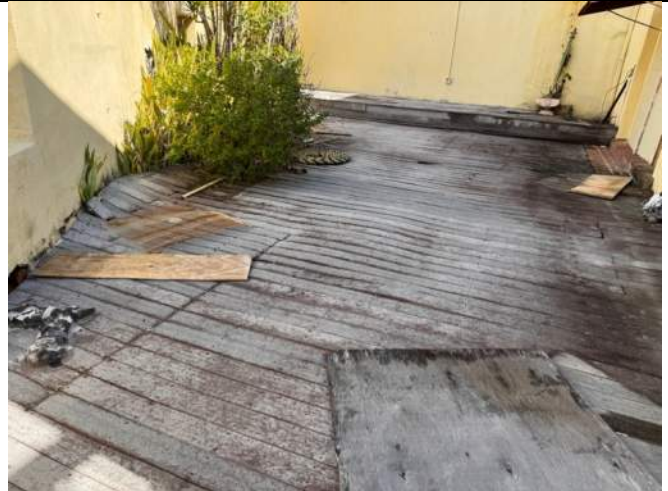
Uneven decking and subfloor failure

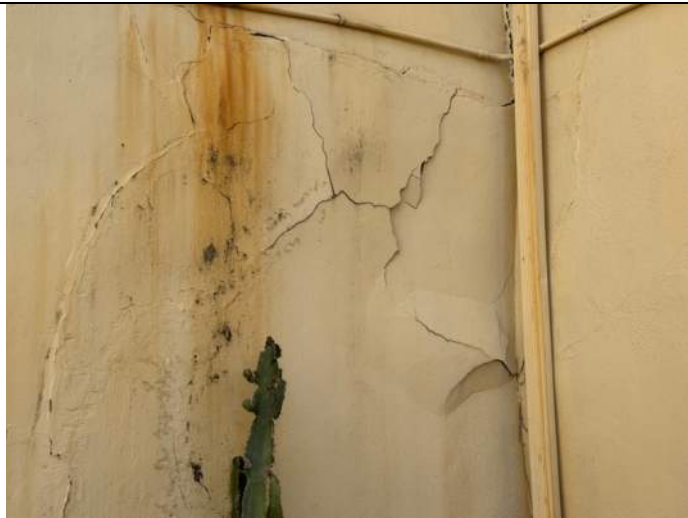
Wall cracking

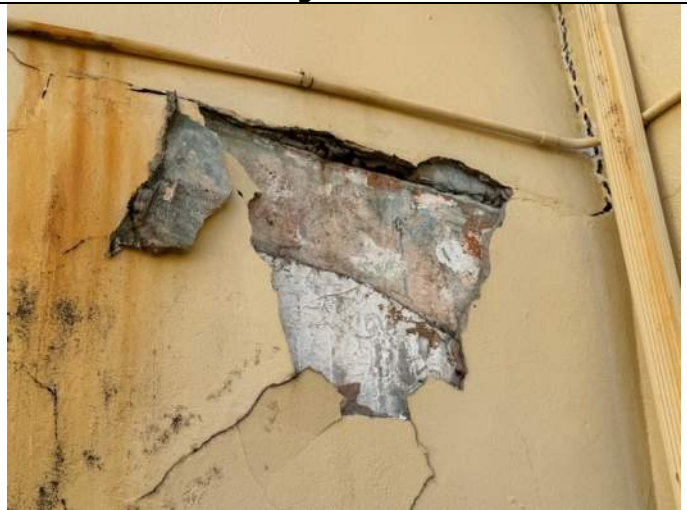
Inappropriate wall structure
