STRUCTURAL CONDITION ASSESSMENT
1810 Michigan Ave
Miami Beach, Florida

Prepared for
J. Luis Quintana

February 22, 2024

Youssef Hachem Consulting Engineering

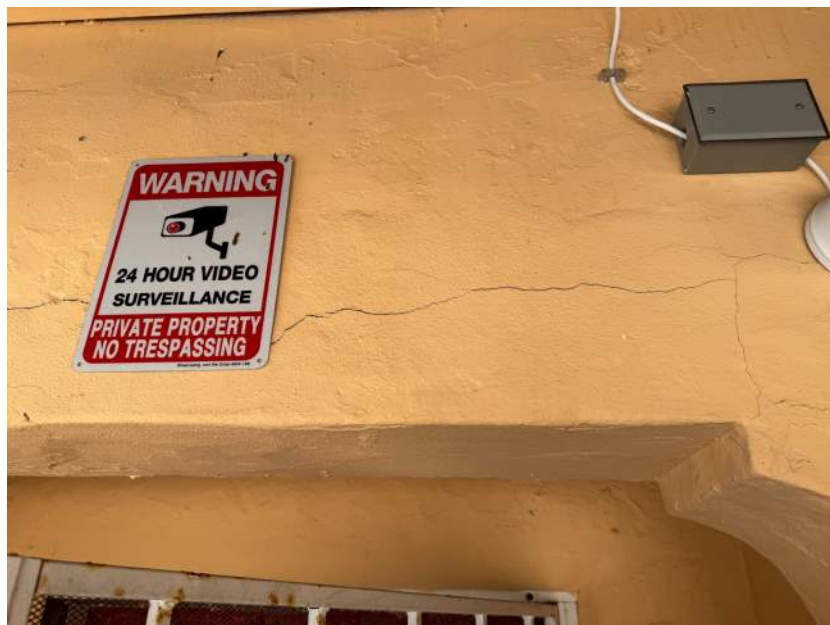
Concrete spalling and cracking is evident throughout the building, see below.
Concrete columns and beams exhibit concrete spalling that is estimated at 45% of the area. Stucco cracking is also evident throughout the building. Previous repairs are also present that exhibit failure and re-cracking.

Concrete Cracking at the entrance

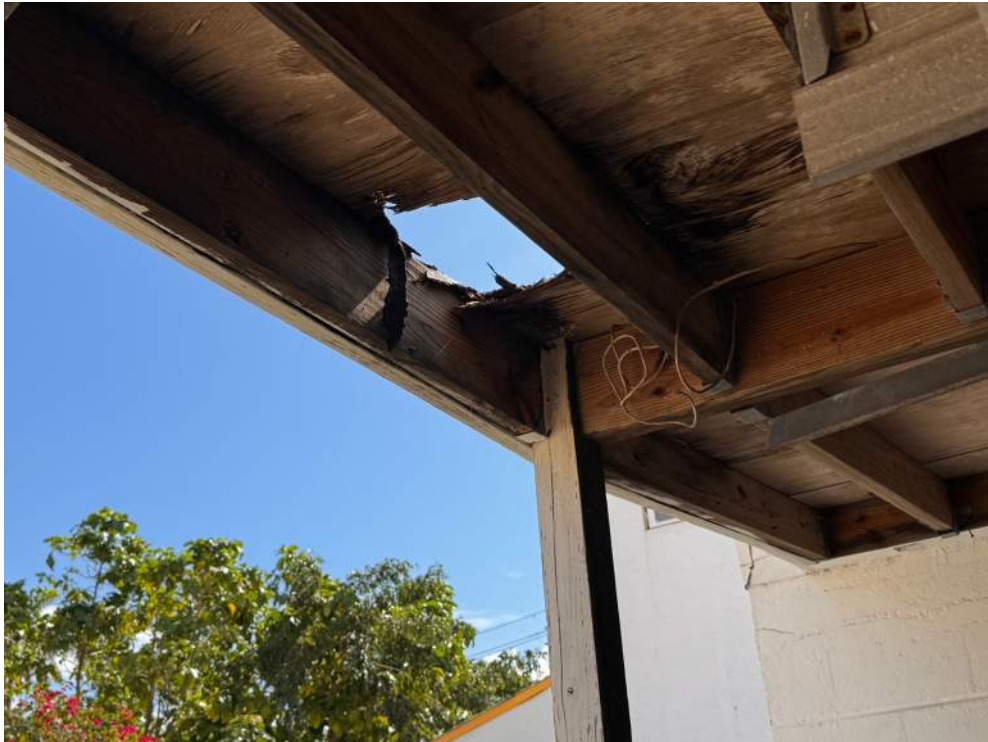
Covered side yard exhibiting failure

There are multiple wood canopies, all exhibit varying levels of failure. All the wood overhead covers seem to be built without permits as they do not comply to code based on member sizes and the fact that they share columns with the neighboring 1800 Avenue structure, see below

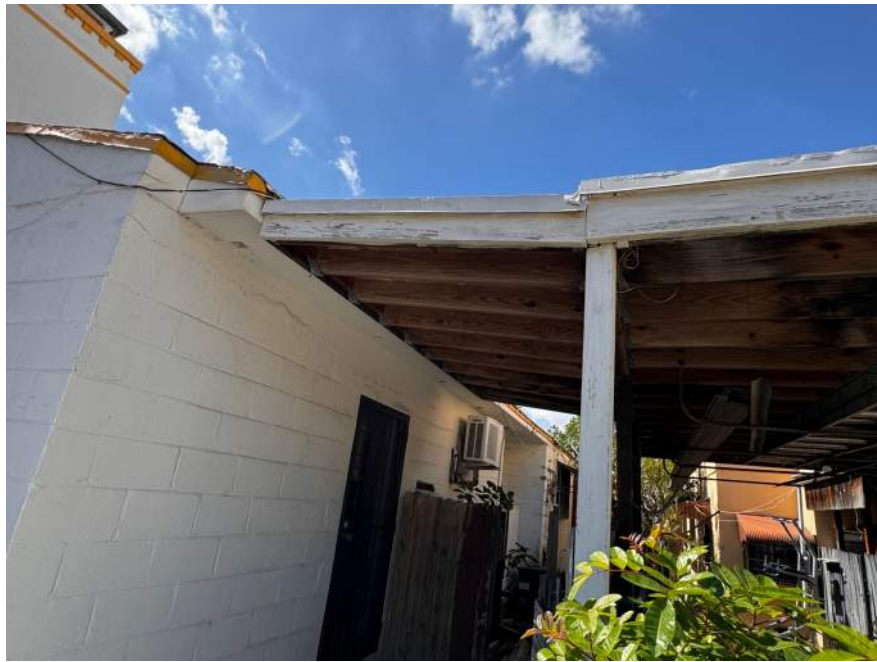
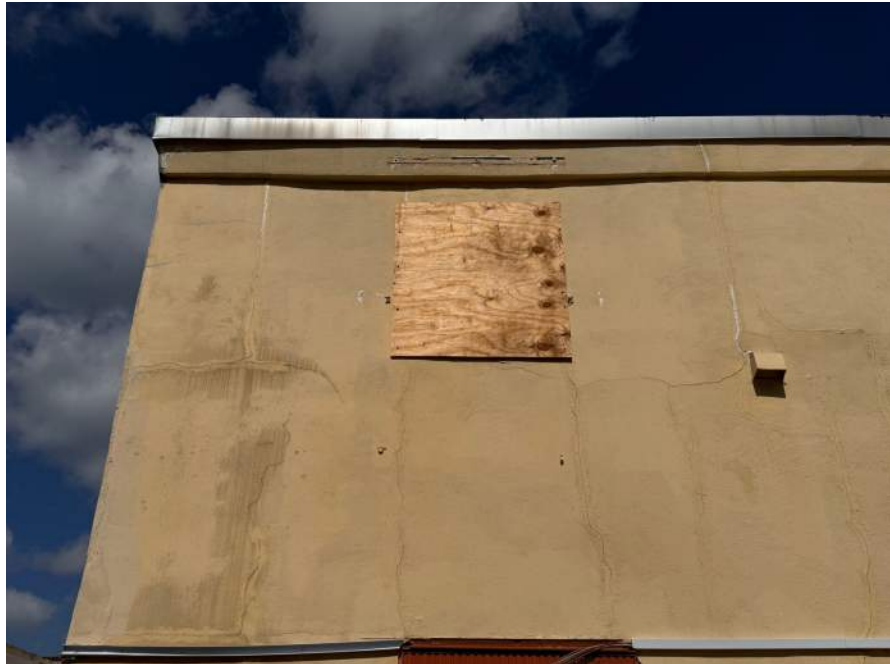
Stucco cracking throughout property

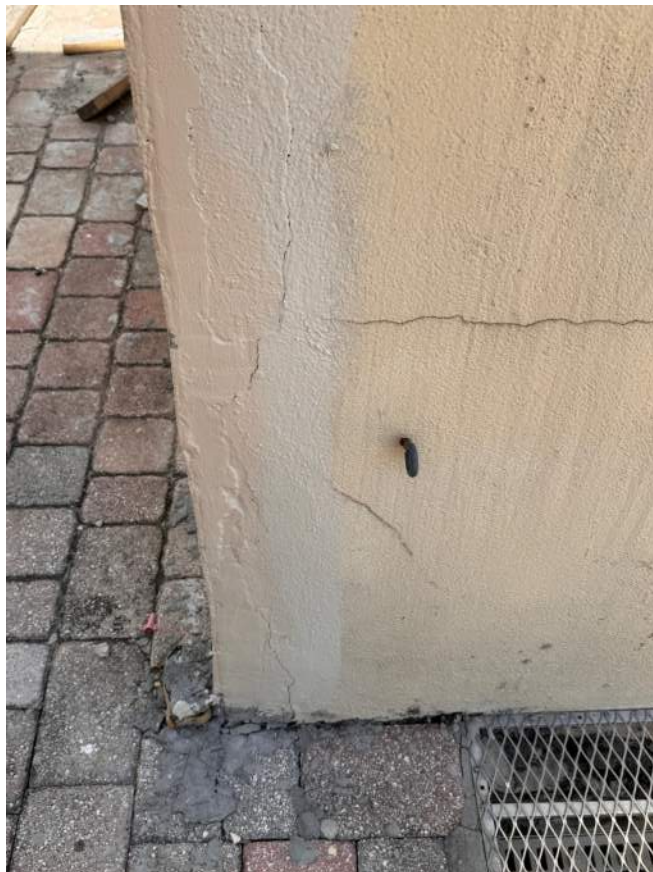
Stucco cracking throughout property

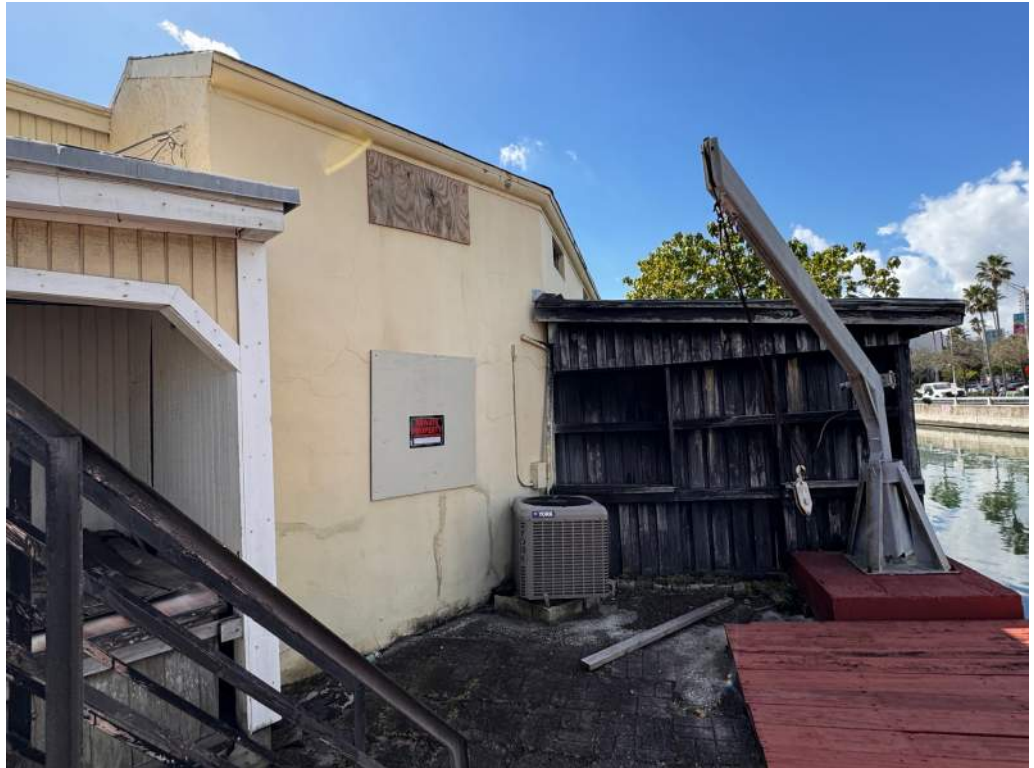
Stucco cracking, shed deterioration and dock failure

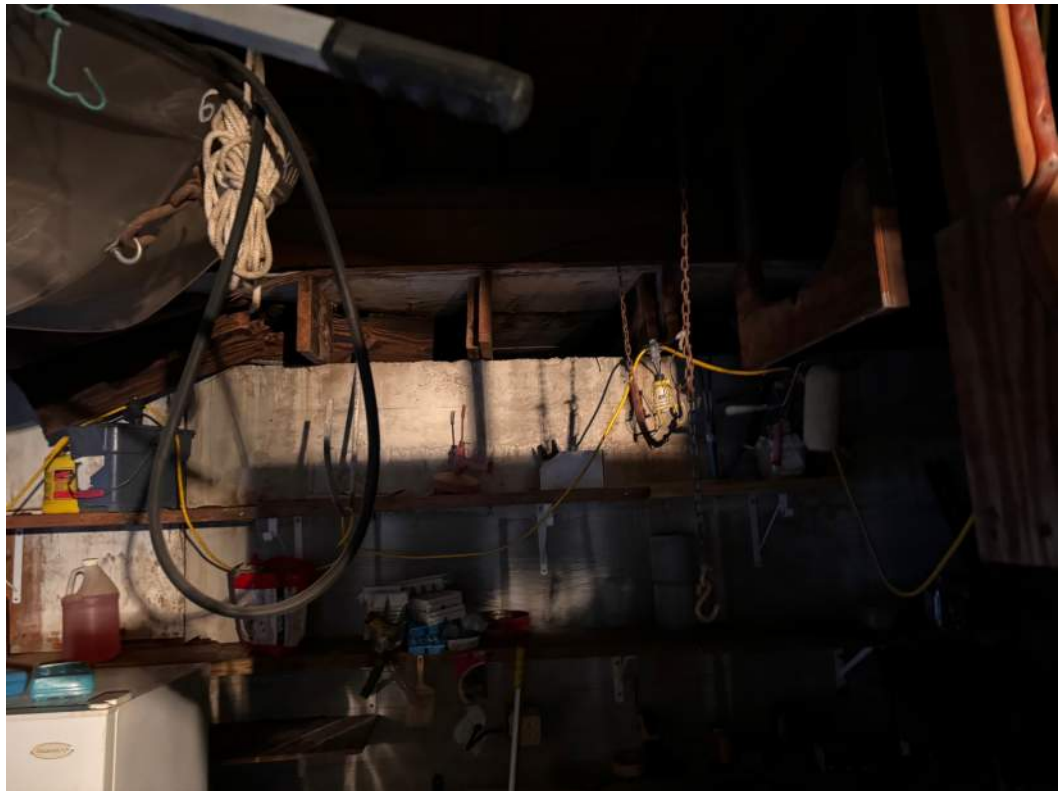
Unpermitted and non-compliant work, unstrapped and no connection

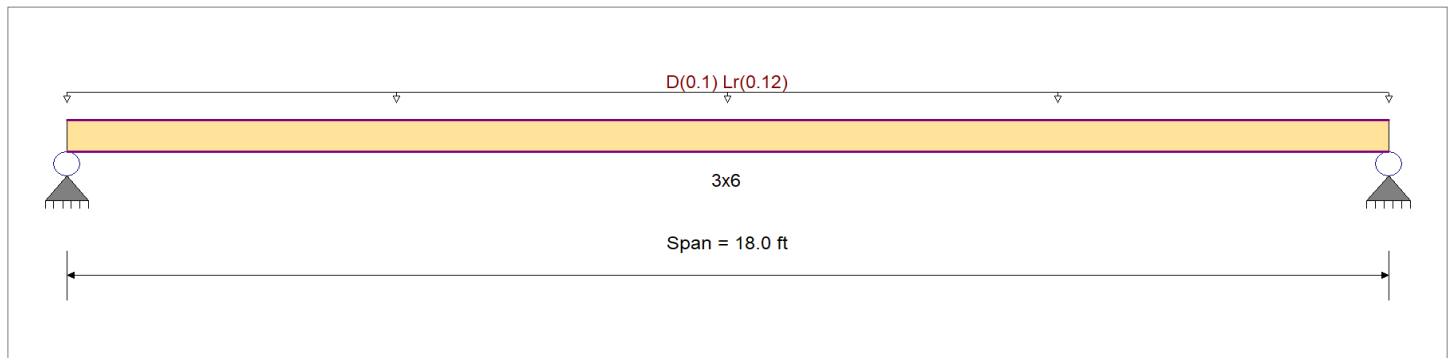
DESCRIPTION: 1810 Roof Joist, 3x6 18' span

Design N.G.

Maximum Bending Stress Ratio	=	5.027 : 1	Maximum Shear Stress Ratio	=	0.944 : 1
Section used for this span		3x6	Section used for this span		3x6
fb: Actual	=	8,482.91 psi	fv: Actual	=	206.54 psi
F'b	=	1,687.50 psi	F'v	=	218.75 psi
Load Combination		+D+Lr	Load Combination		+D+Lr
Location of maximum on span	=	9.000ft	Location of maximum on span	=	17.606 ft
Span # where maximum occurs	=	Span # 1	Span # where maximum occurs	=	Span # 1
Maximum Deflection					
Max Downward Transient Deflection	5.141 in	Ratio = 42 < 360	Span: 1 : Lr Only		
Max Upward Transient Deflection	0 in	Ratio = 0 < 360	n/a		
Max Downward Total Deflection	9.425 in	Ratio = 22 < 180	Span: 1 : +D+Lr		
Max Upward Total Deflection	0 in	Ratio = 0 < 180	n/a

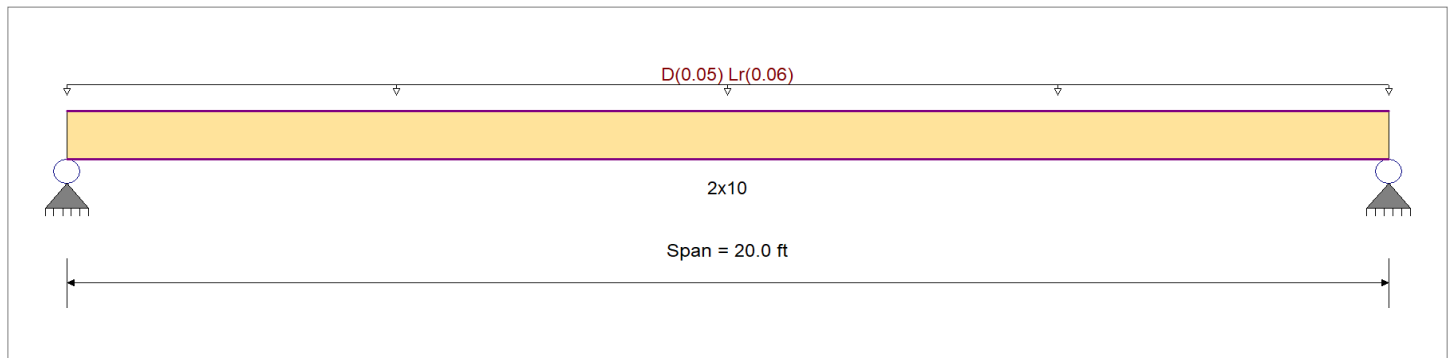
DESCRIPTION: 1810 2nd floor Joist, 2x10 20' span

Design N.G.

Maximum Bending Stress Ratio	=	2.598 1	Maximum Shear Stress Ratio	=	0.504 : 1
Section used for this span		2x10	Section used for this span		2x10
fb: Actual	=	3,085.46psi	fv: Actual	=	110.24 psi
F'b	=	1,187.50psi	F'v	=	218.75 psi
Load Combination		+D+Lr	Load Combination		+D+Lr
Location of maximum on span	=	10.000ft	Location of maximum on span	=	0.000ft
Span # where maximum occurs	=	Span # 1	Span # where maximum occurs	=	Span # 1
Maximum Deflection					
Max Downward Transient Deflection	1.569 in	Ratio = 153 <360	Span: 1 : Lr Only		
Max Upward Transient Deflection	0 in	Ratio = 0 <360	n/a		
Max Downward Total Deflection	2.876 in	Ratio = 83 <180	Span: 1 : +D+Lr		
Max Upward Total Deflection	0 in	Ratio = 0 <180	n/a
