HISTORIC RESOURCES REPORT

1810 Michigan Avenue, Miami Beach, FL 33139

PRELIMINARY REMARKS:

PHOTO SURVEY:

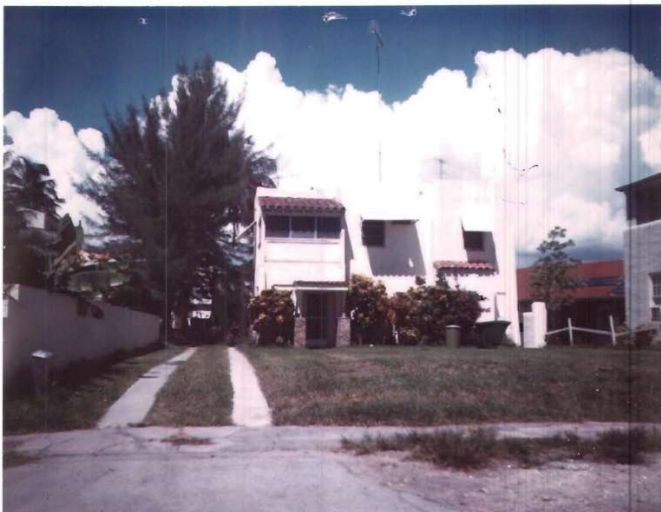
Despite extensive research extending to local agencies and libraries, available imagery of the existing structure is limited to a few photographs of the façade and a few aerial photographs depicting the numerous unpermitted additions carried out over the span of decades, which cross setbacks and even property lines.
