PROPERTY INSPECTION CHECKLIST

DATE: 03-05-2025

TENANT NAME: North Shore Library 7505 Collins Ave

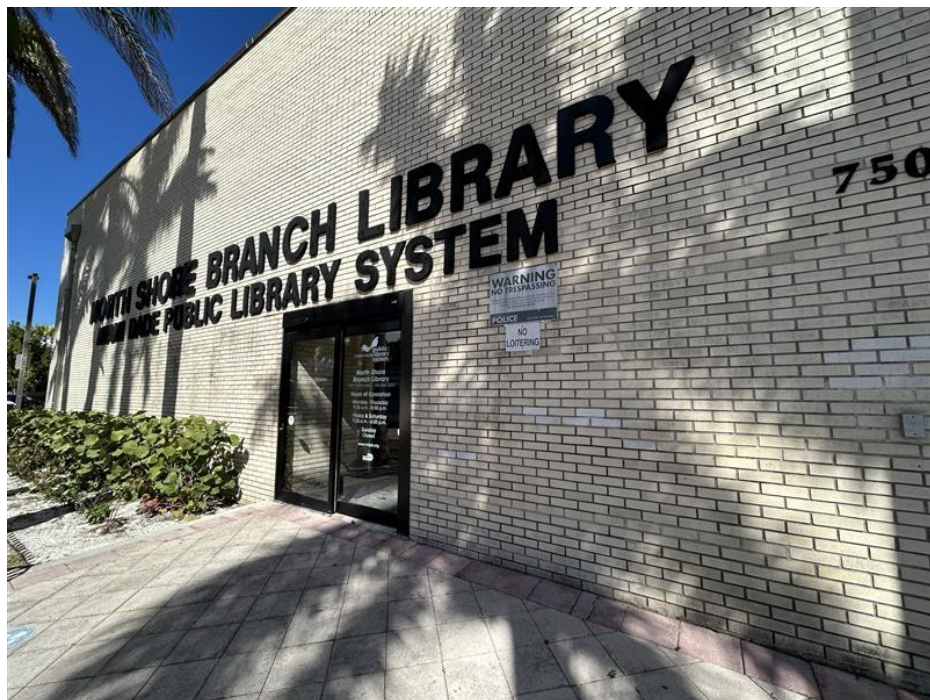
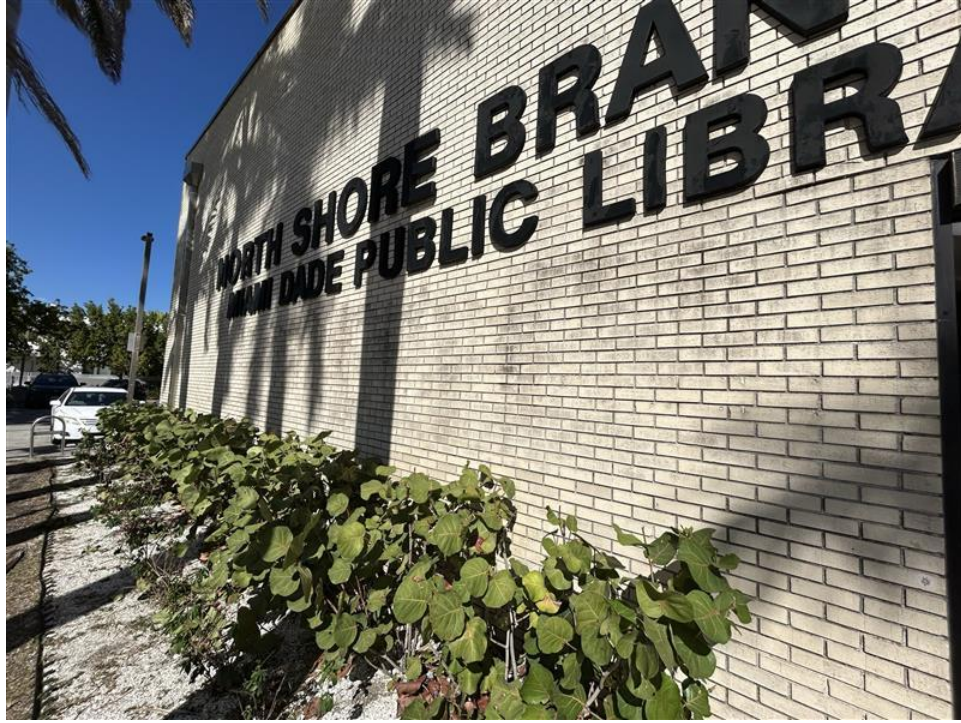
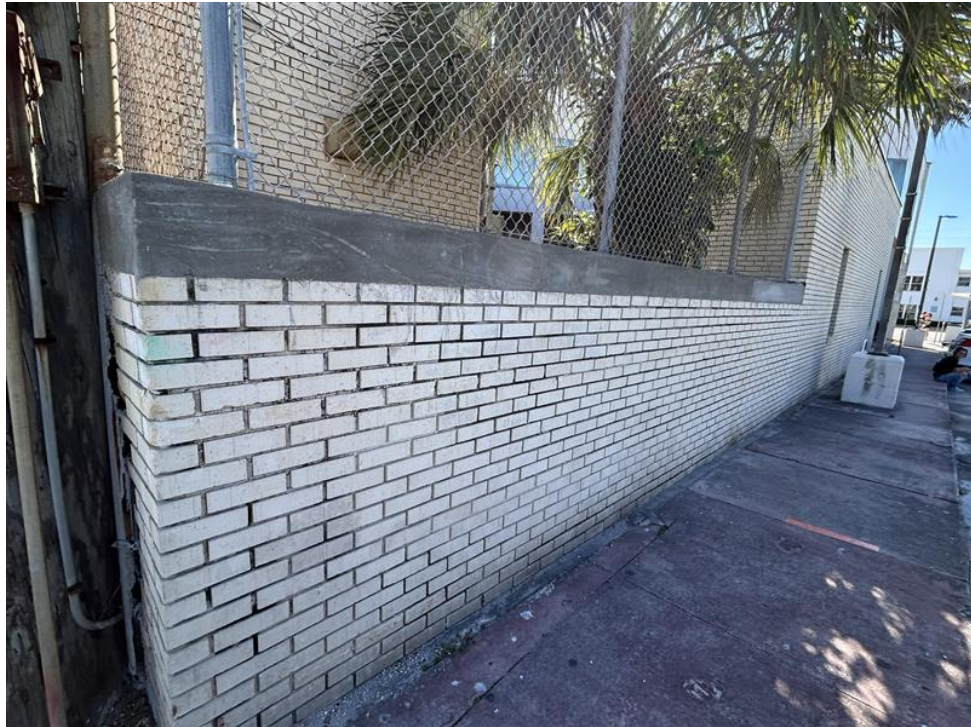
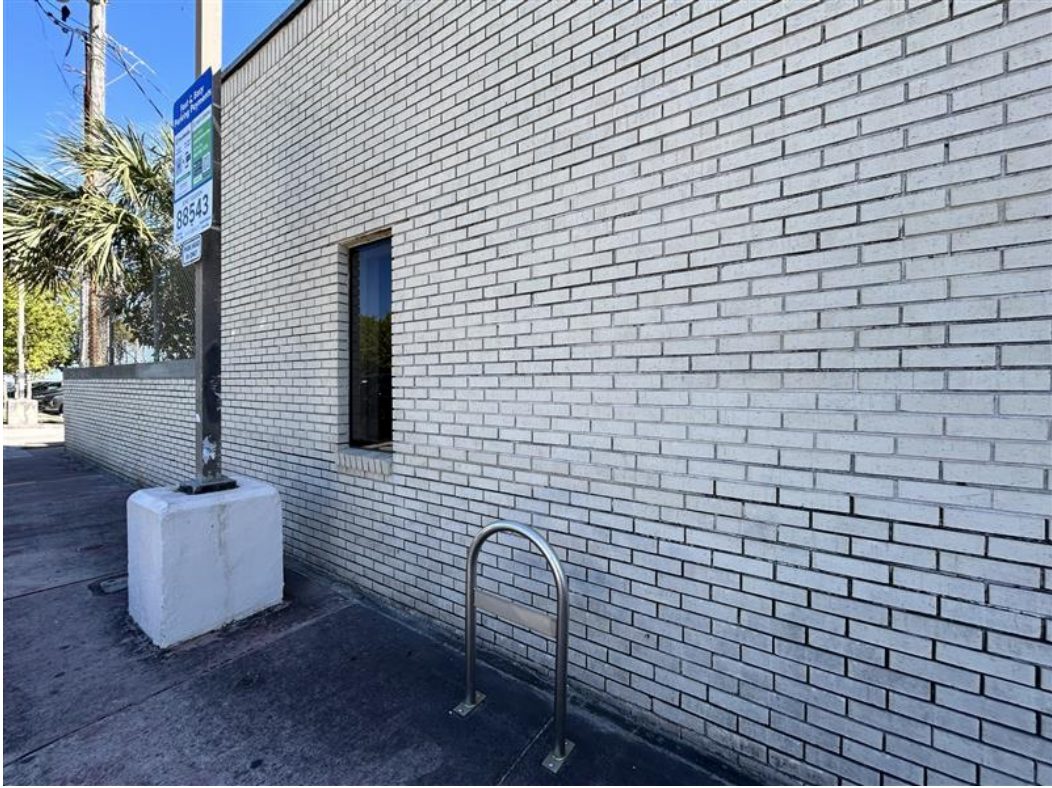
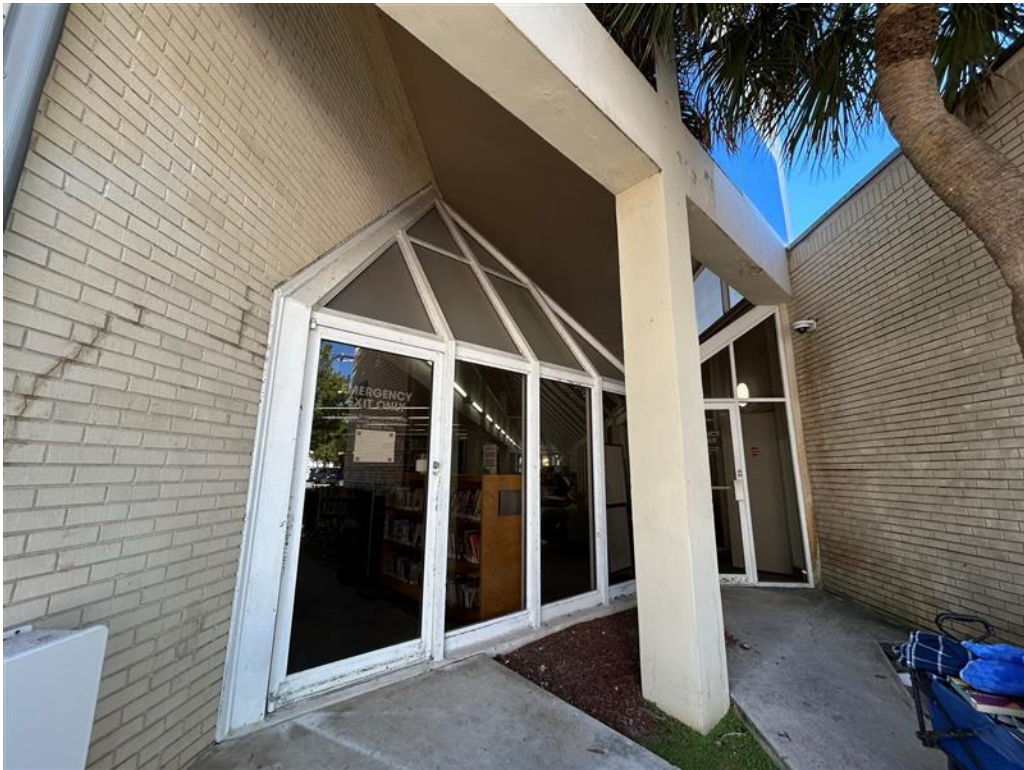
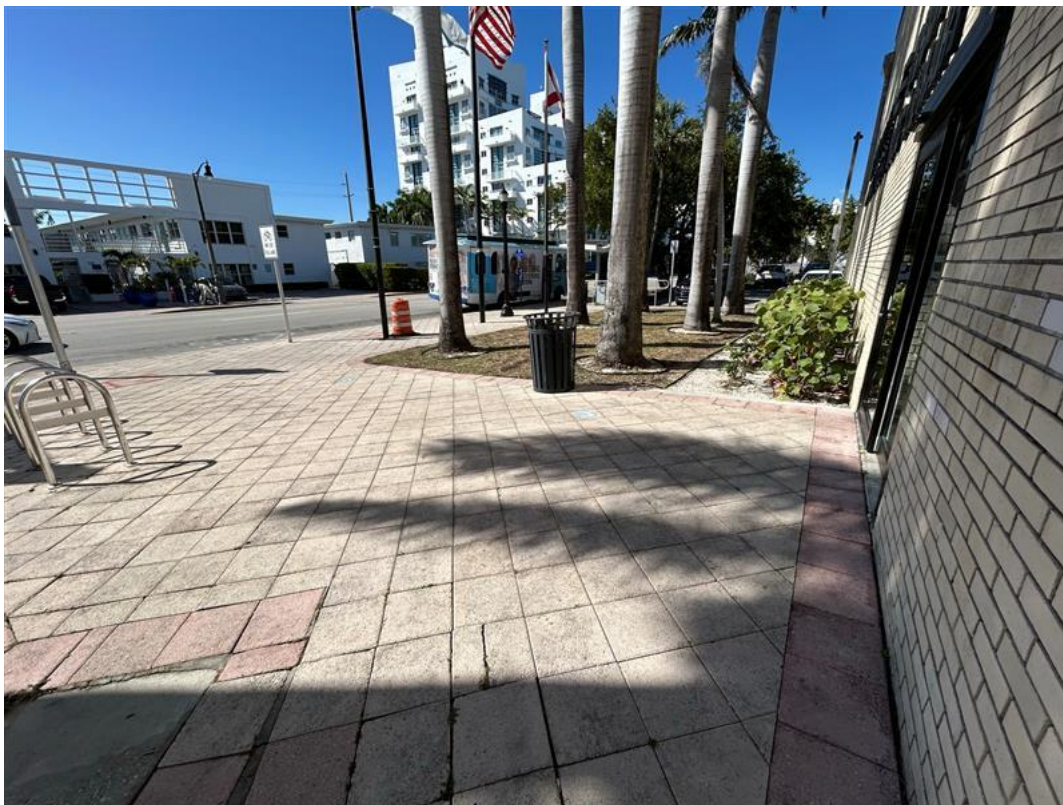
- The façade and sidewalks require thorough pressure cleaning

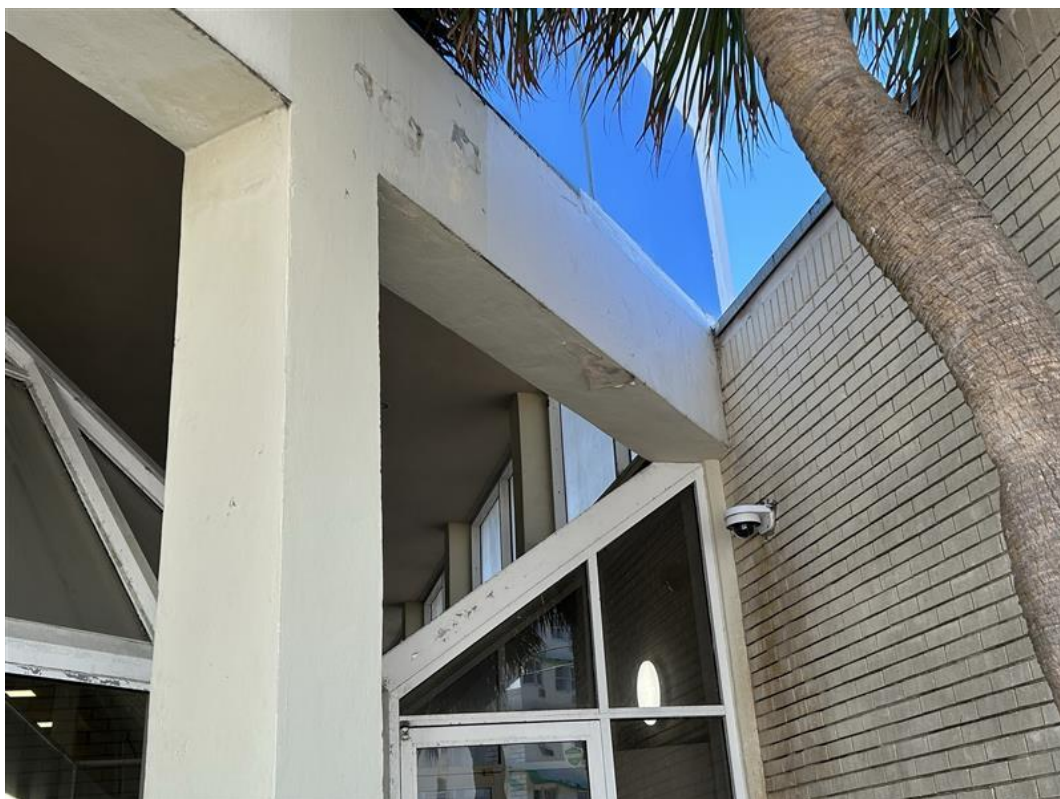
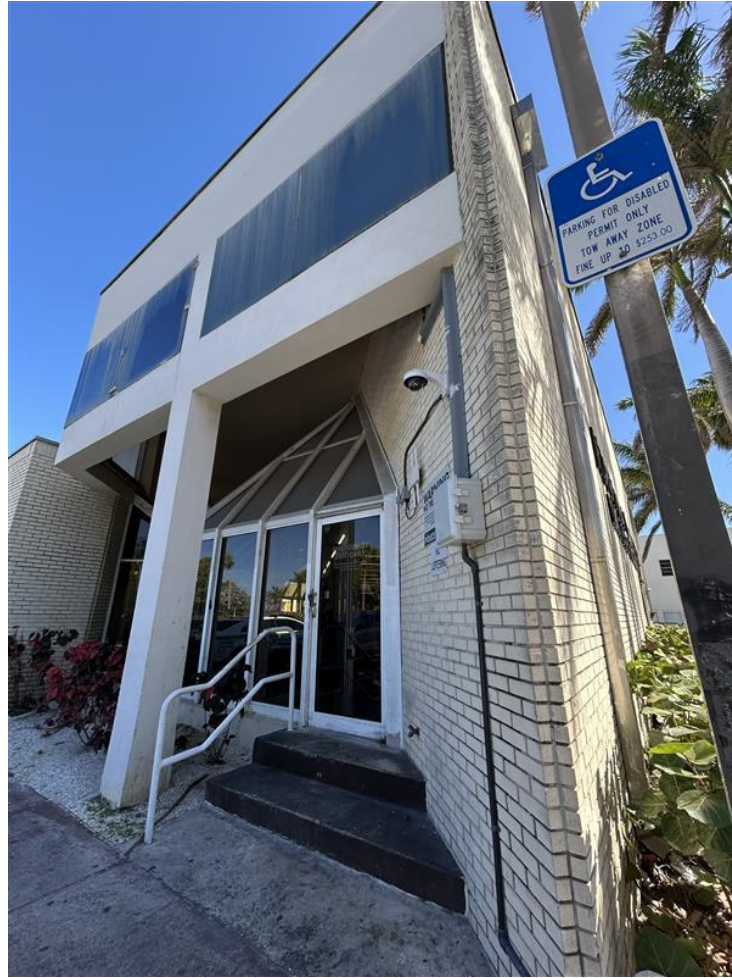
- The facade requires a fresh coat of paint

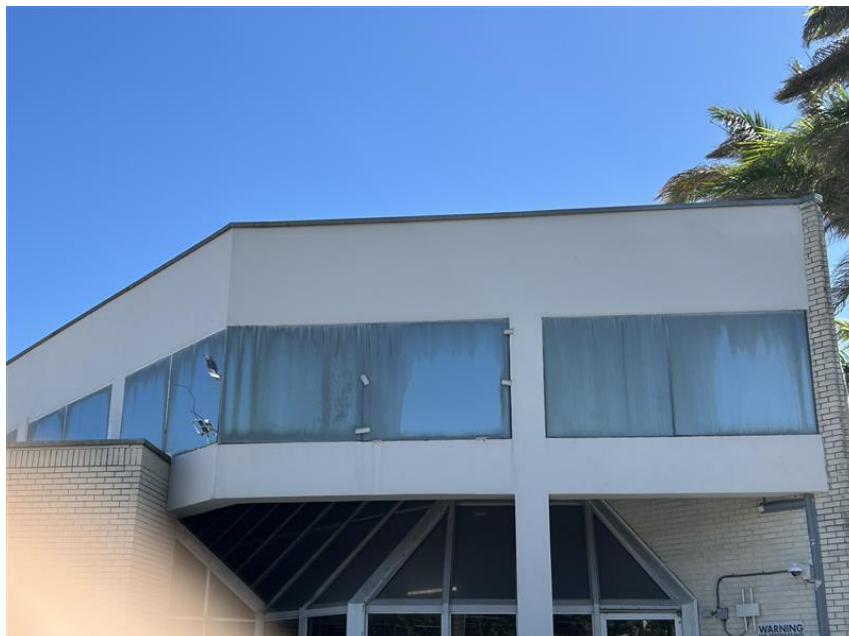
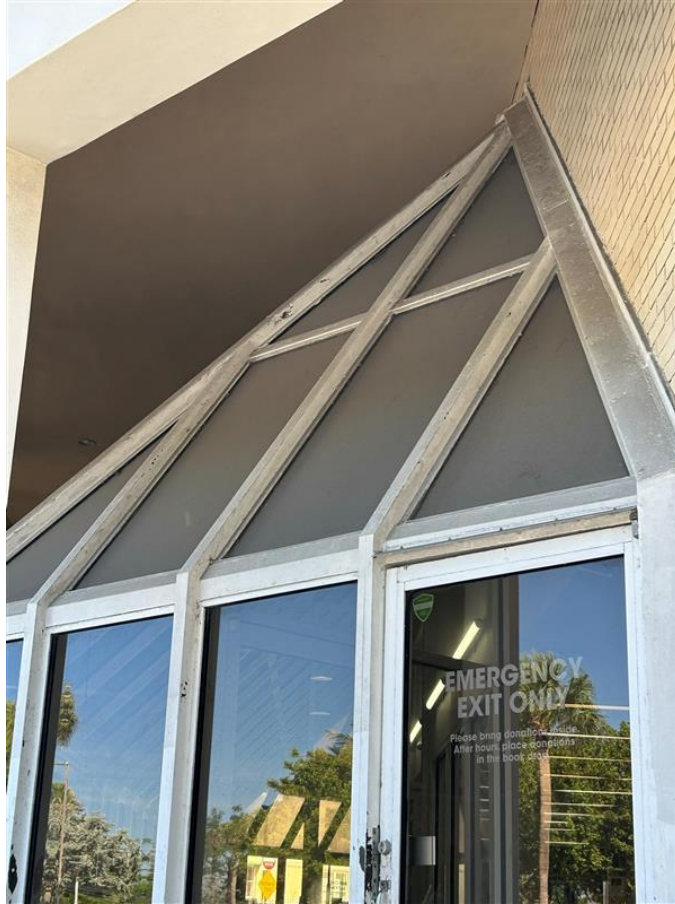
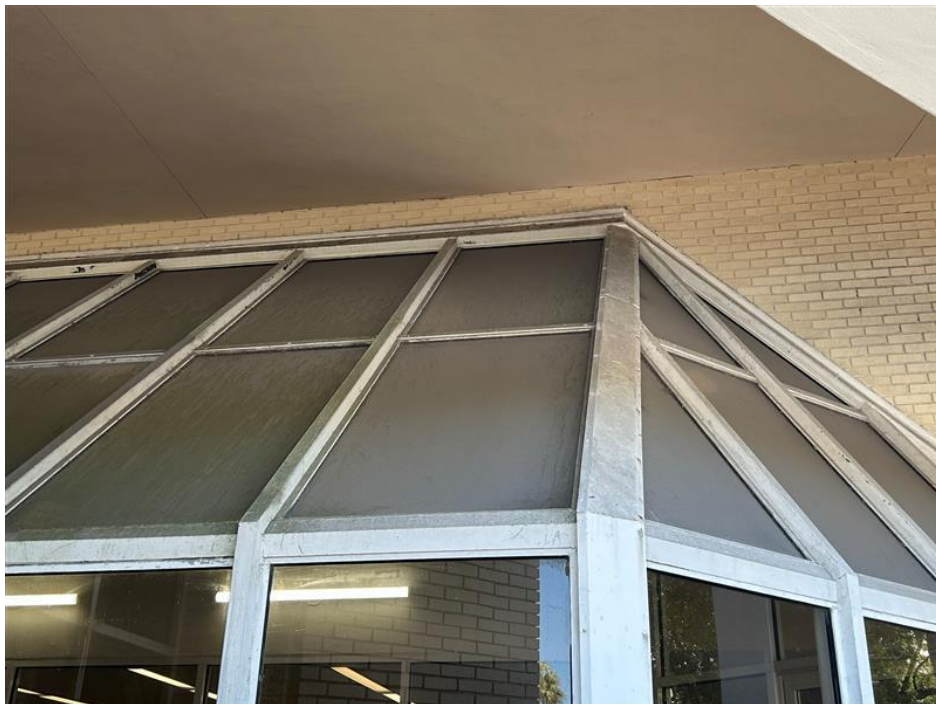
- The windows glass needs a thorough cleaning

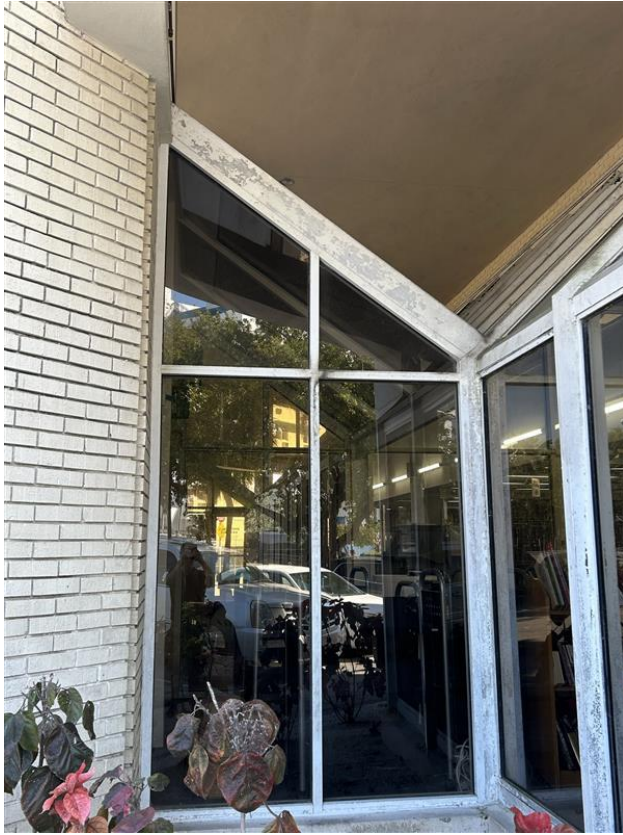
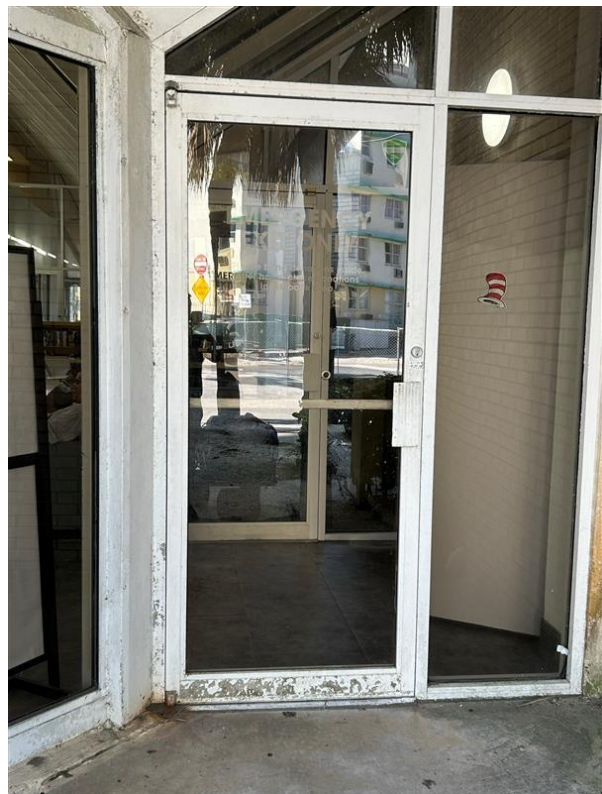
- The window and door frames are in poor condition

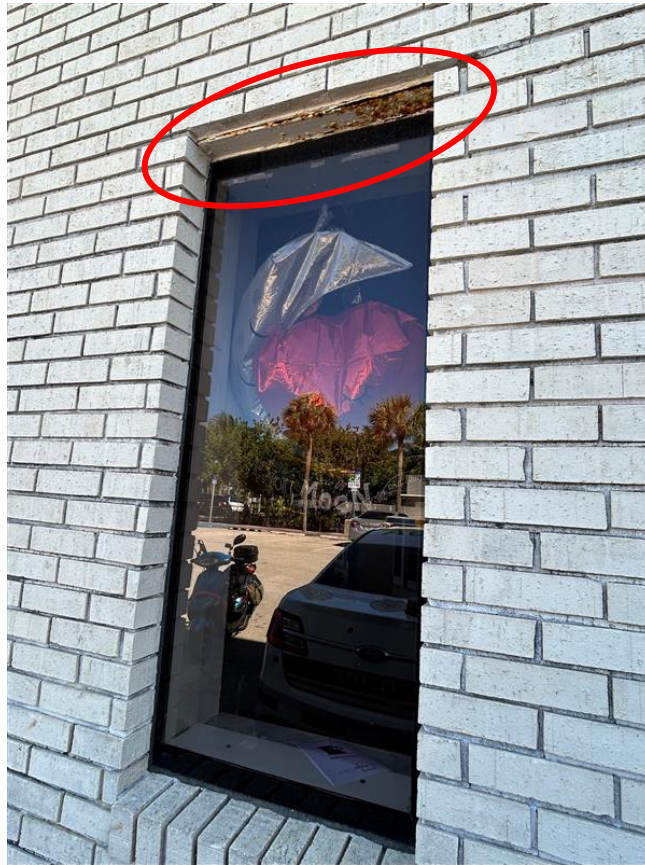
- Rust is present on the top of the window frame

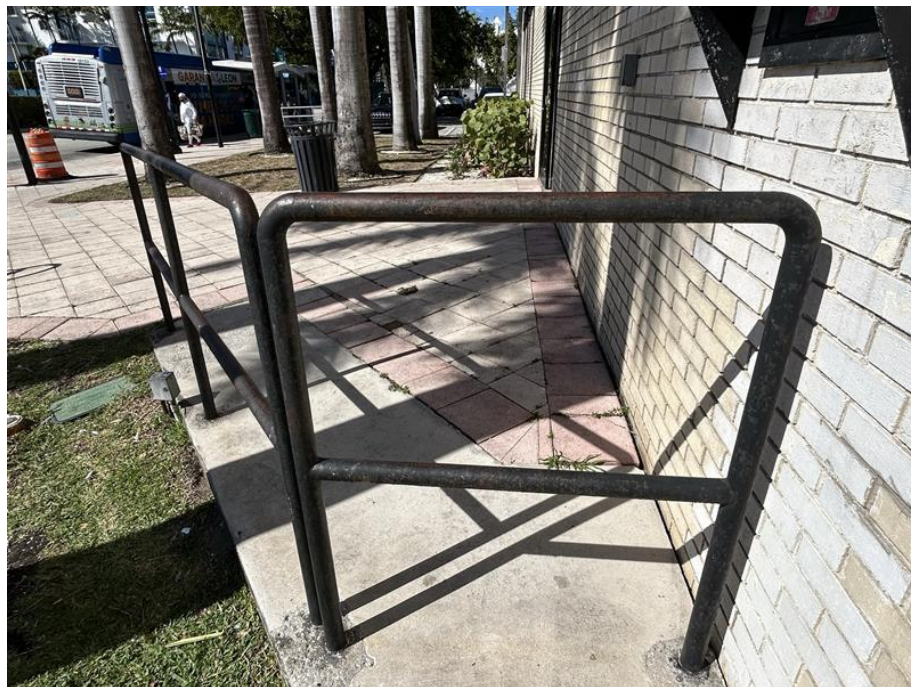
- The handrail requires a fresh coat of paint

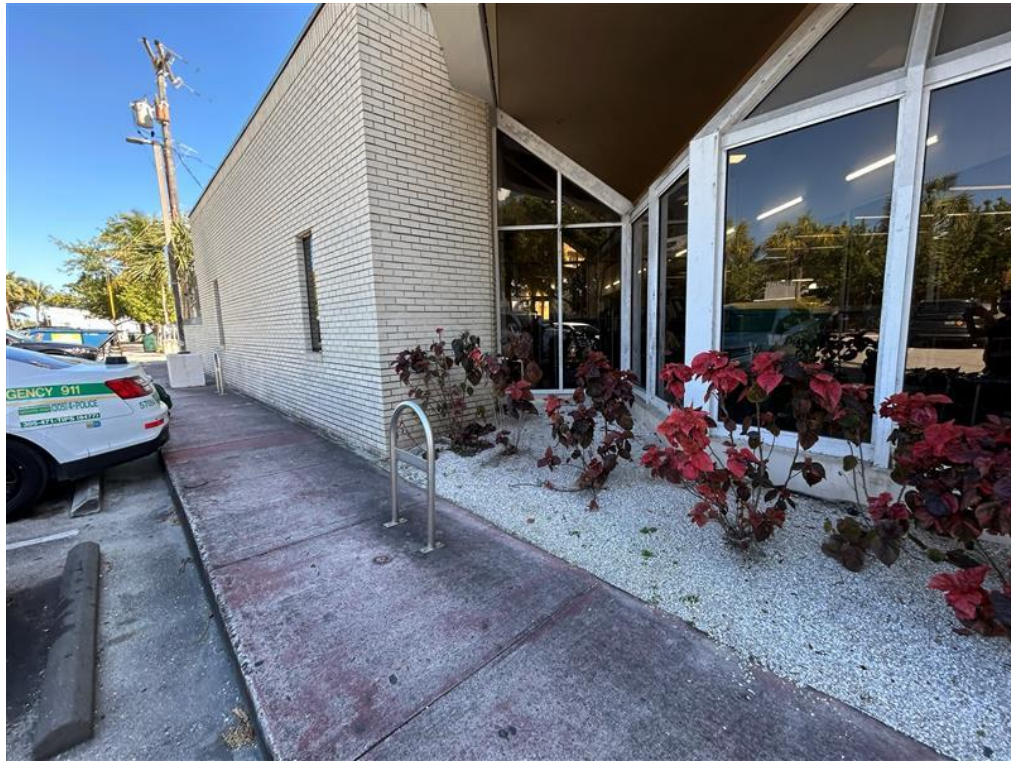
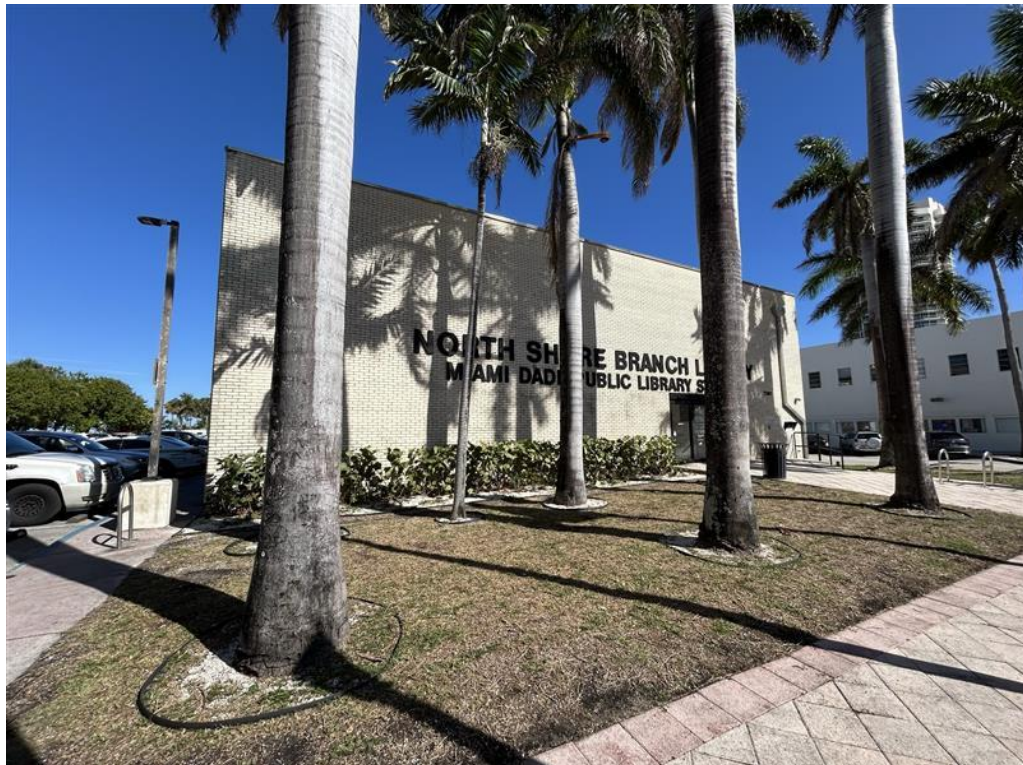
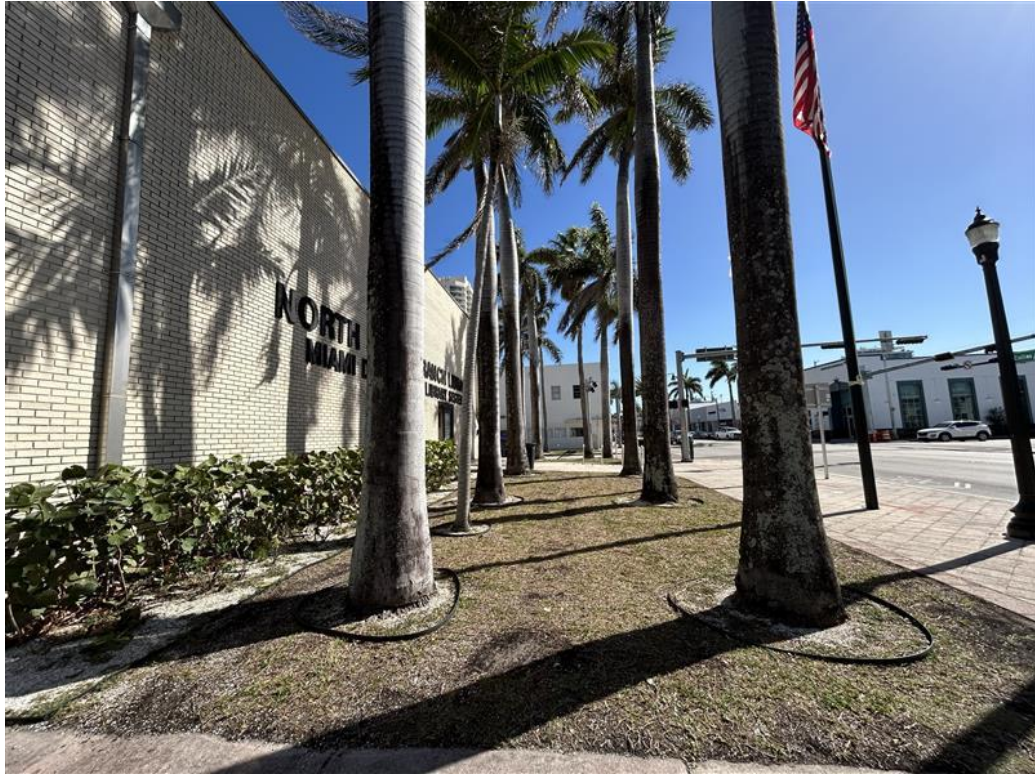
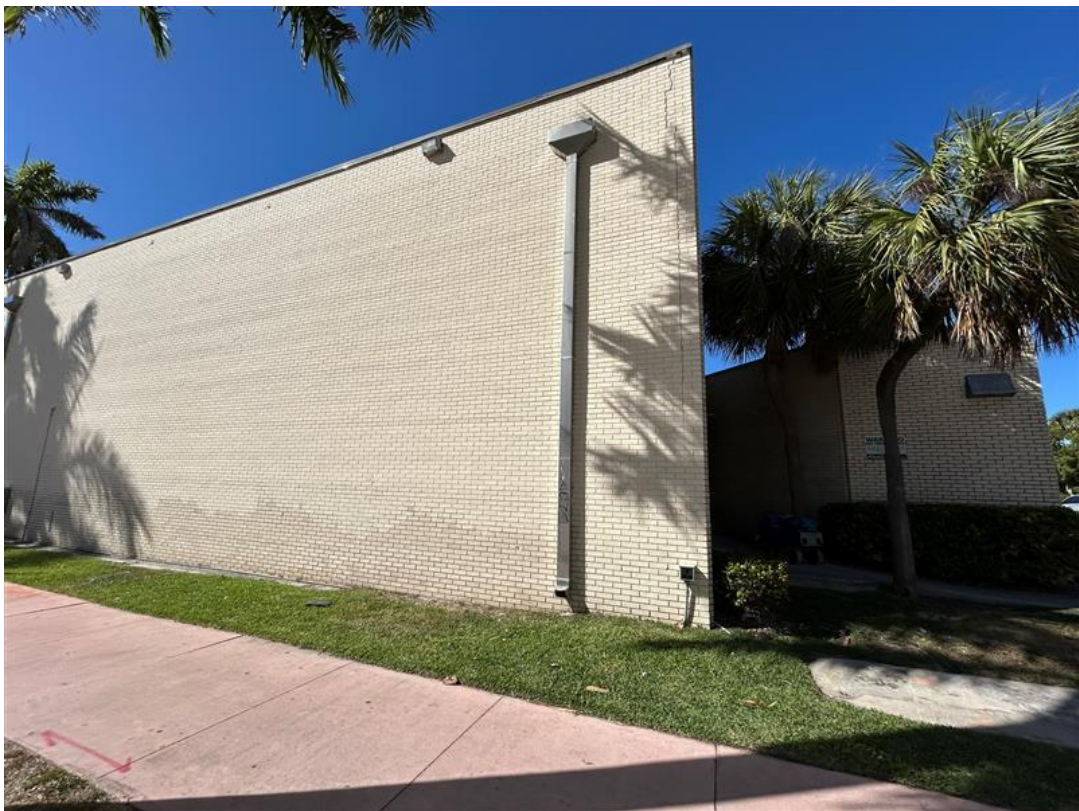
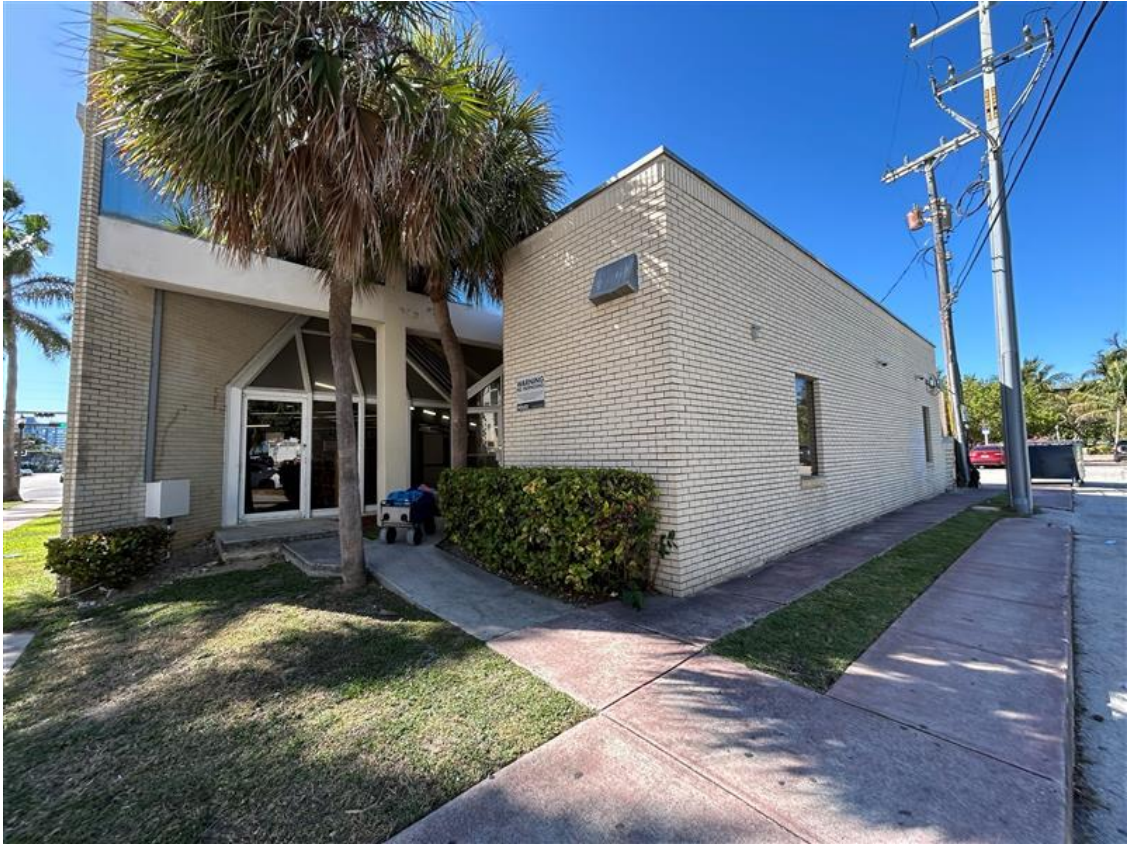
- The landscaping is in good condition; however, there is potential for further improvement
