STRUCTURAL CONDITION ASSESSMENT
1800 Michigan Ave
Miami Beach, Florida

February 14, 2025

Youssef Hachem Consulting Engineering

STRUCTURAL CONDITION ASSESSMENT for
1800 Michigan Ave
Miami Beach, Florida

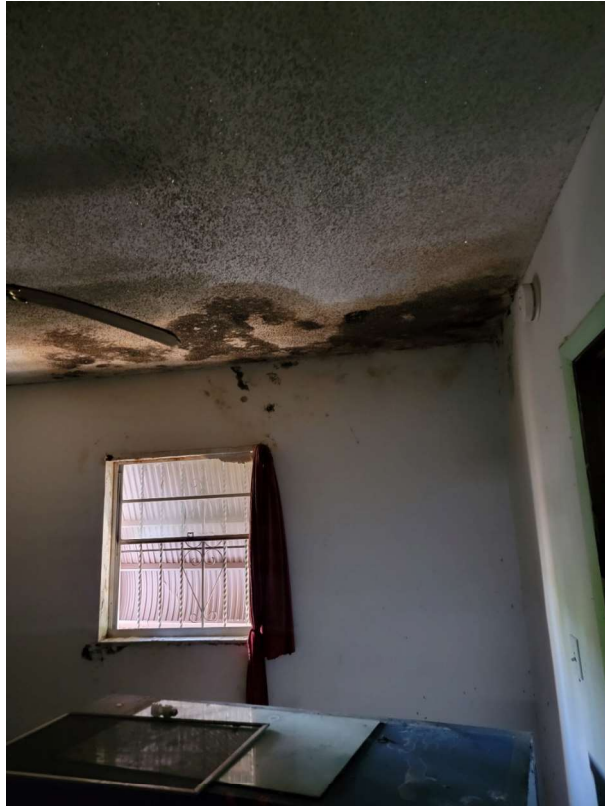
Mold is present on the interior finishes

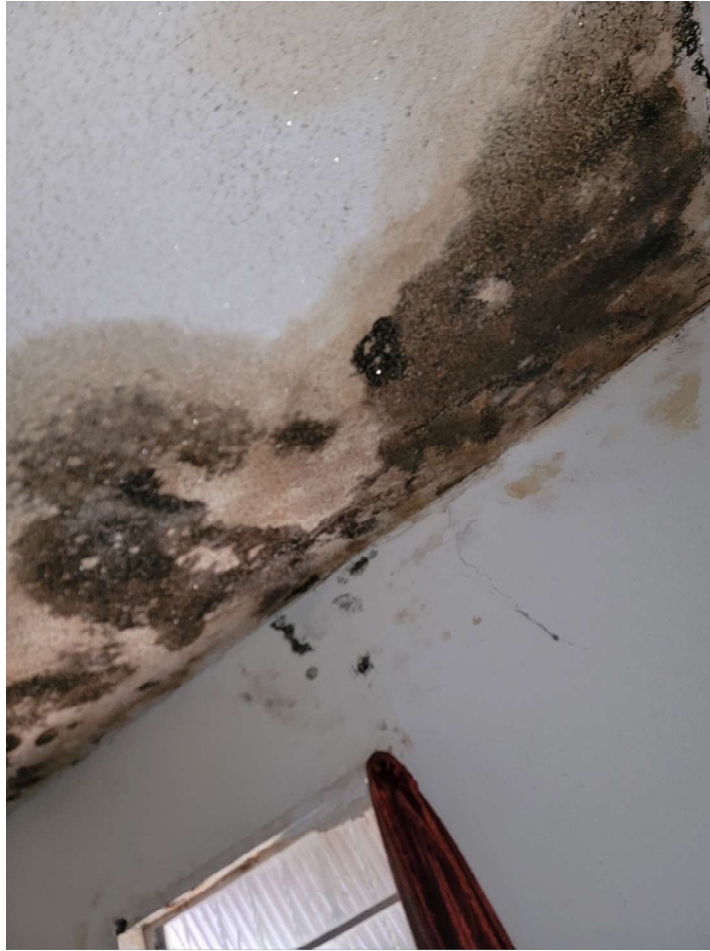
Mold and water intrusion is present

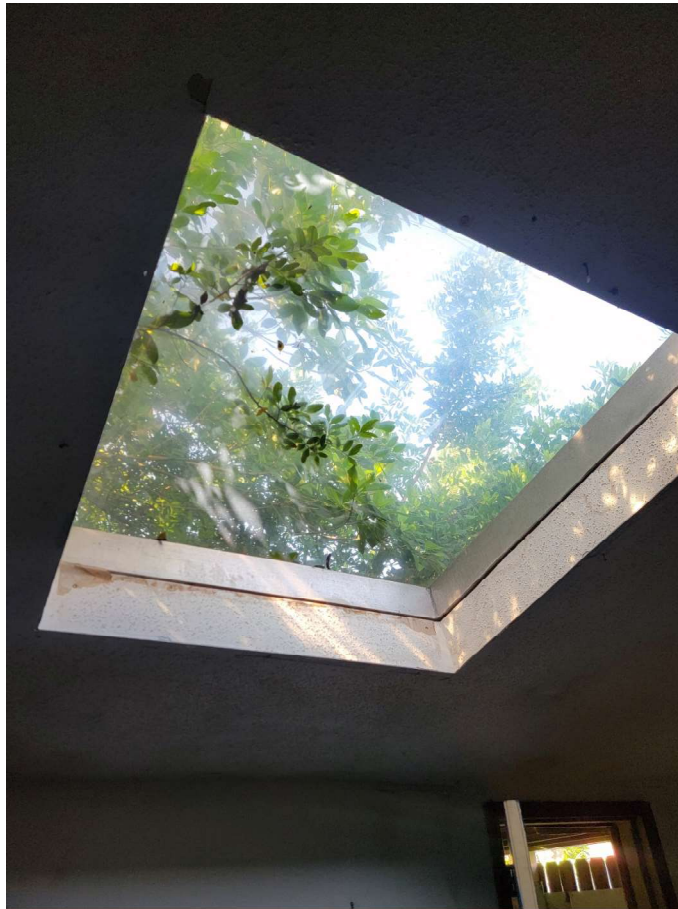
Skylights present show water intrusion.

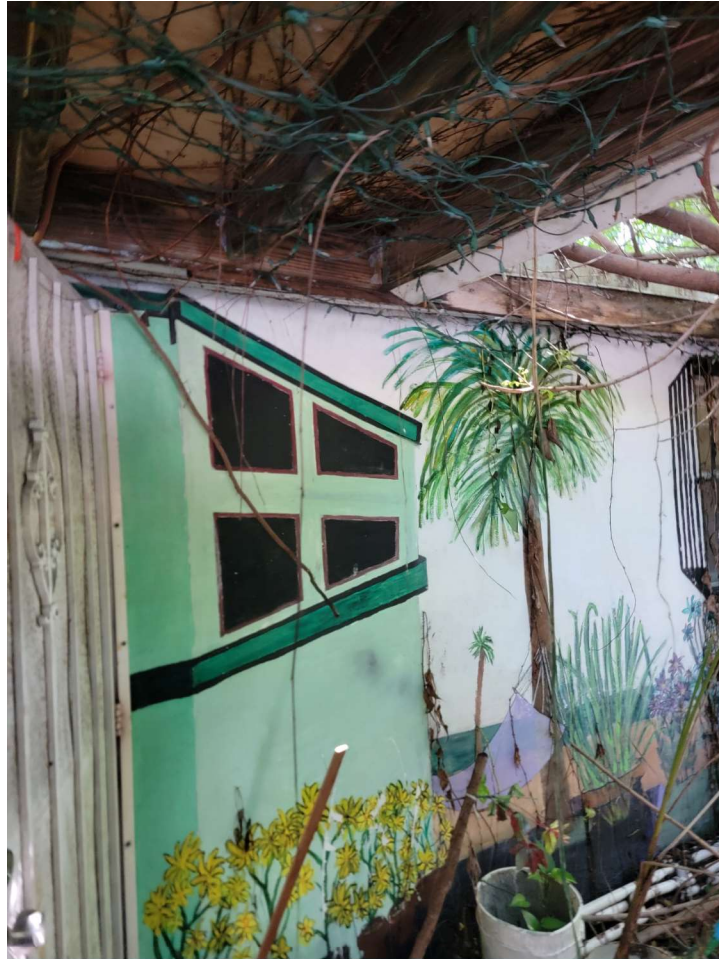
Failures noted in the exterior wood canopy

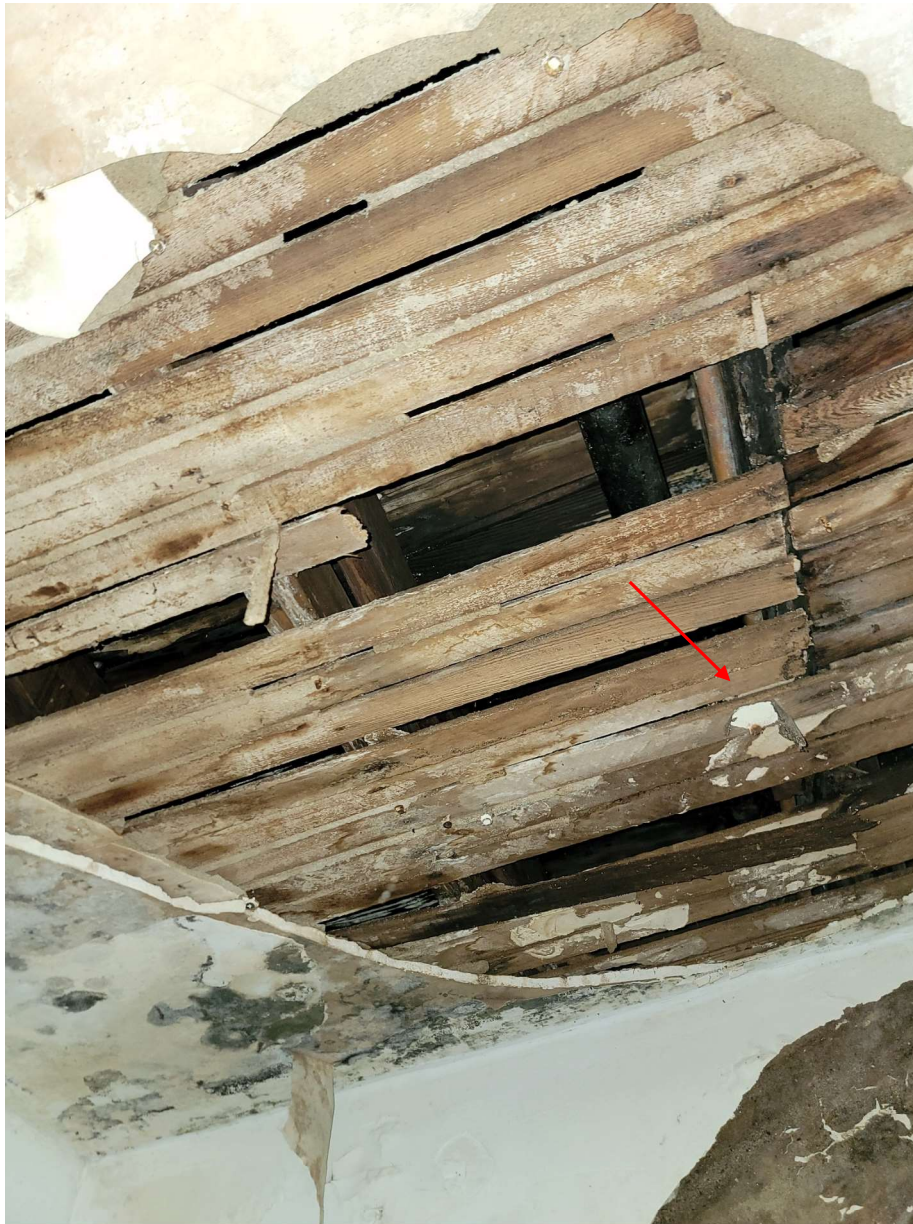
Rotted wood is noticed on the wood joist that make up the second floor of the property

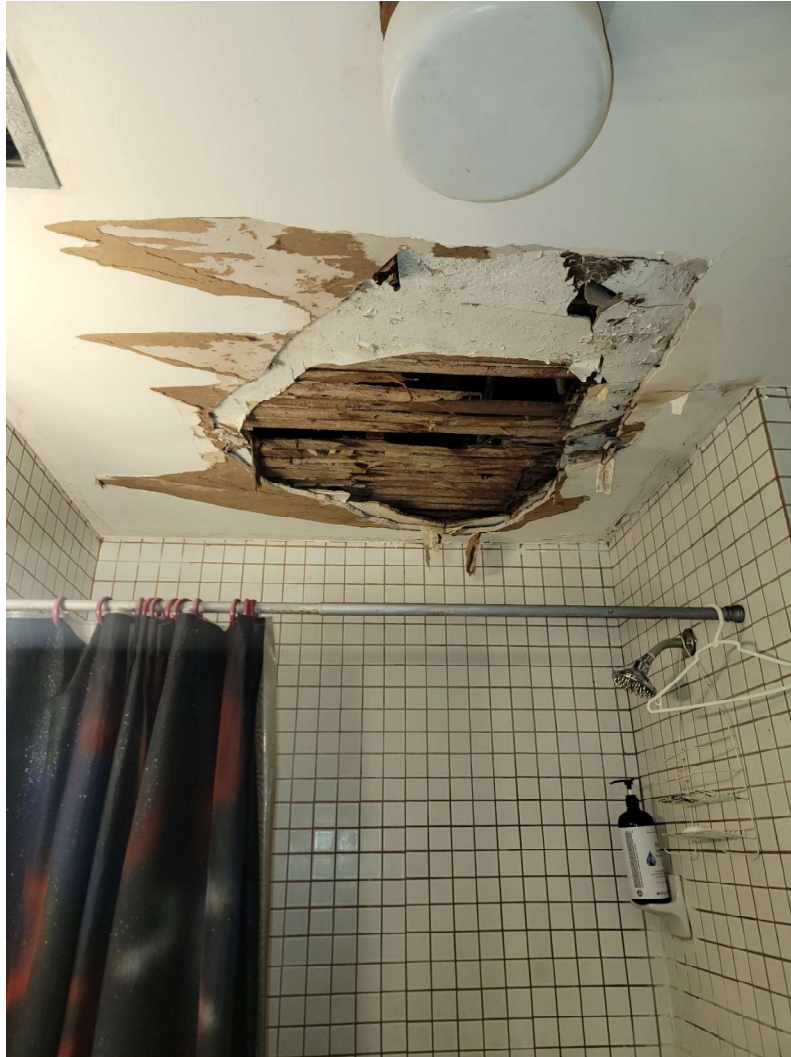
Water intrusion is present throughout the entire property

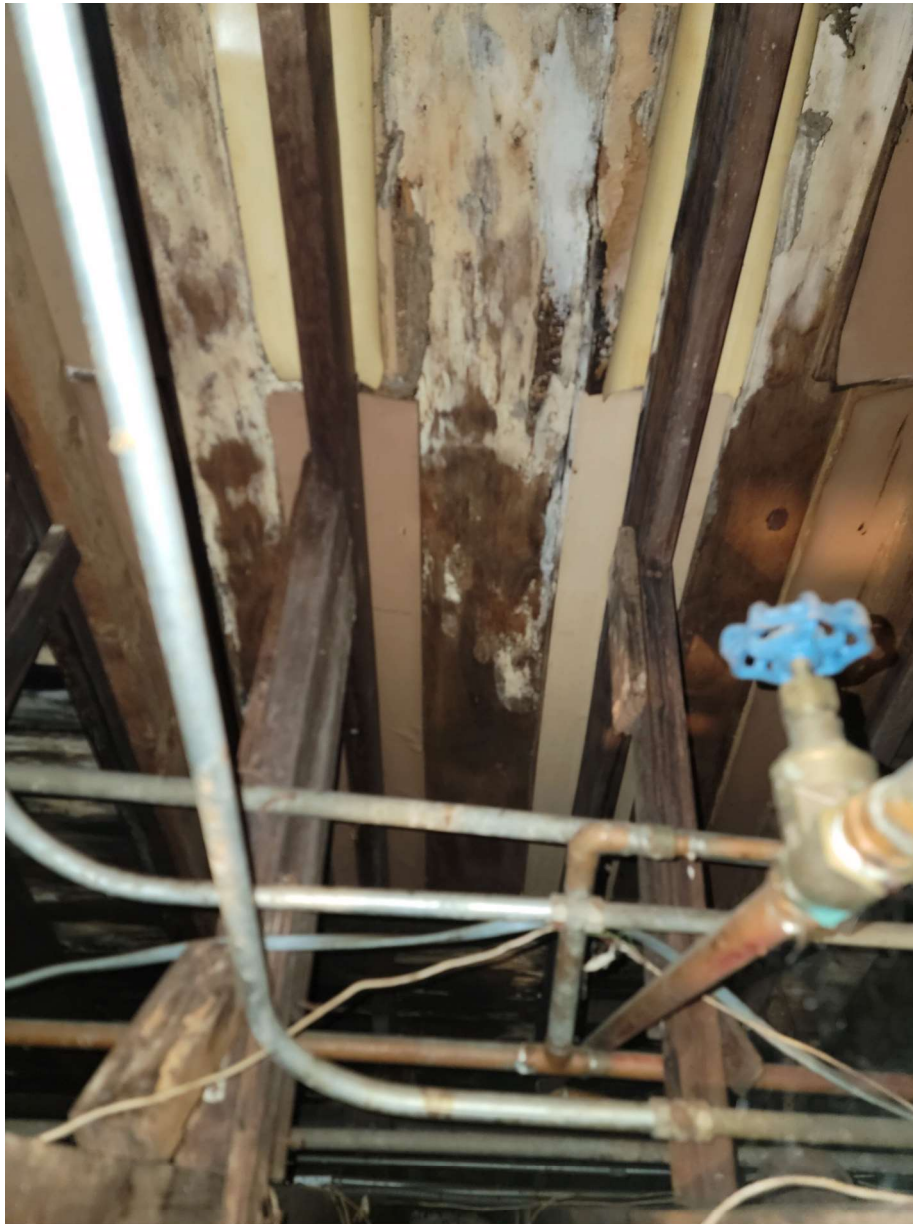
Water intrusion is present throughout the entire property

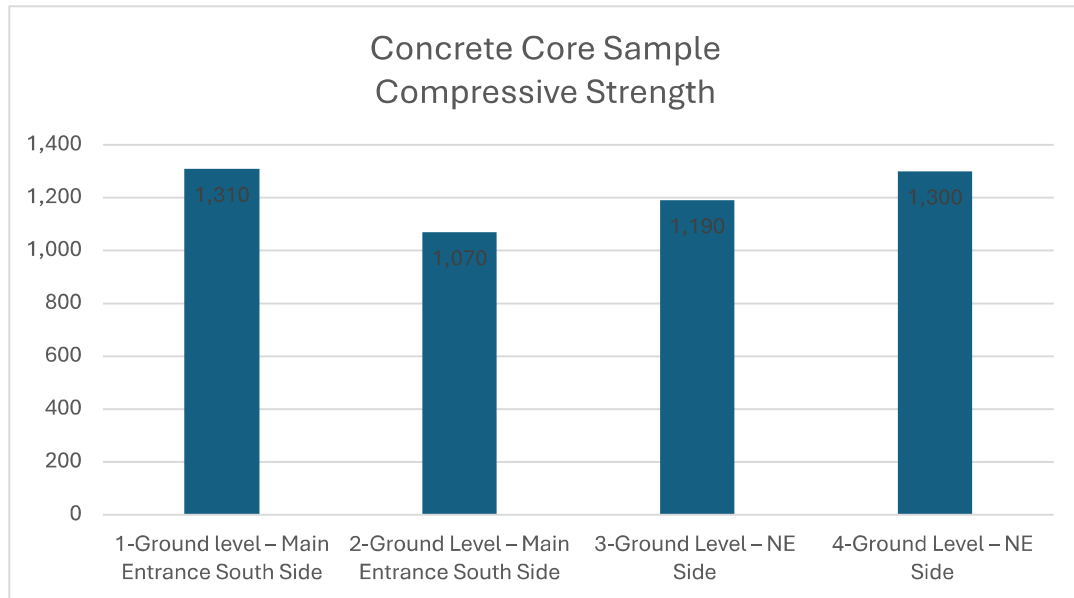
The Concrete compressive strength ranged from 1,070 to 1,310 PSI. Per Florida Building Code the concrete strength should be 5,000 PSI.

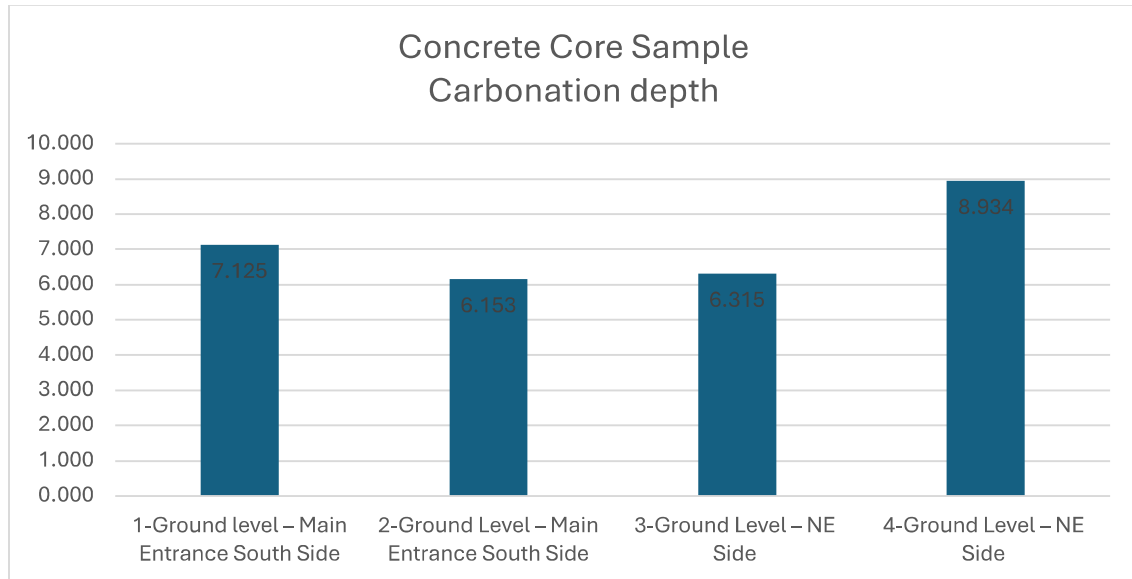
The carbonation found in the samples ranged between 6.153" – 8.934"

The carbonation is extensive and exposes the reinforcing rebars to corrosion

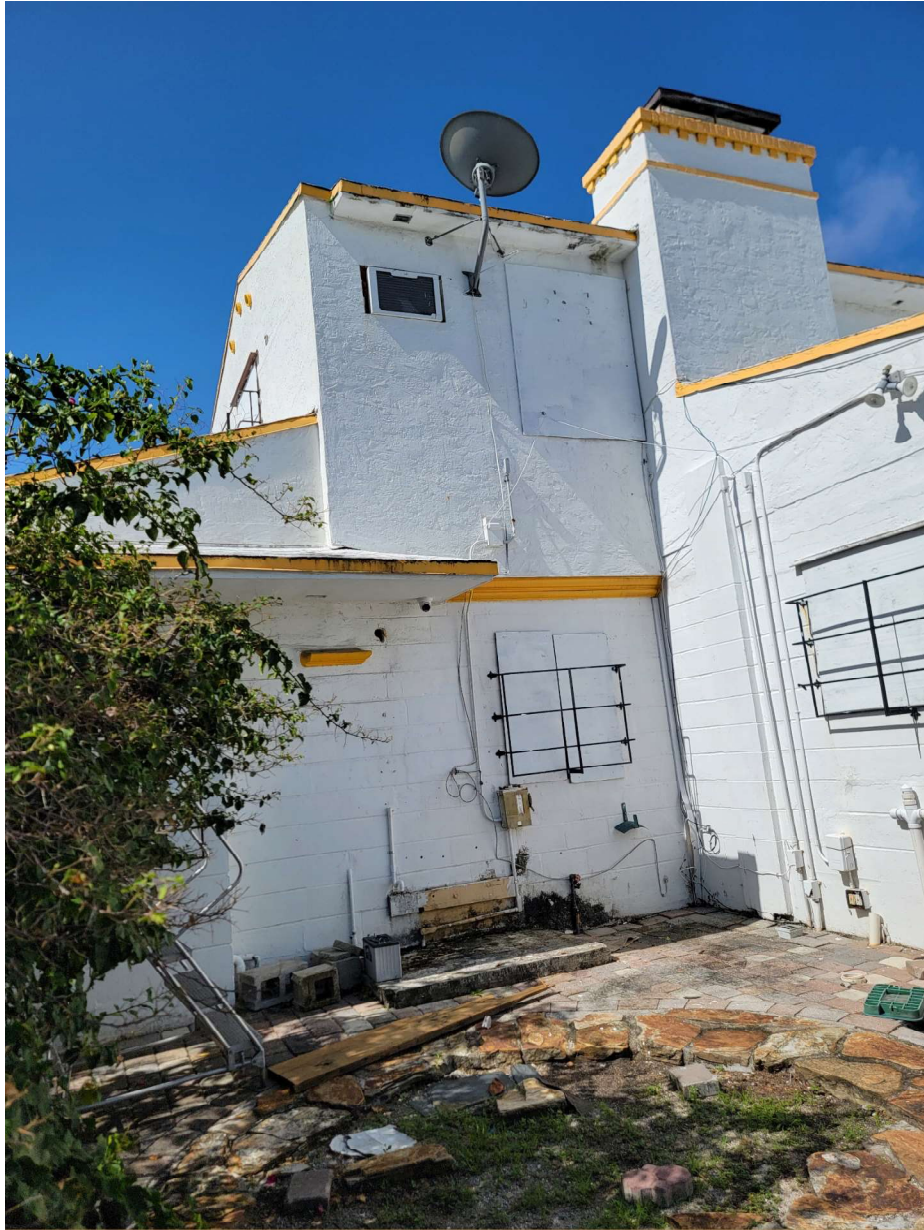
Spall and delaminated stucco present

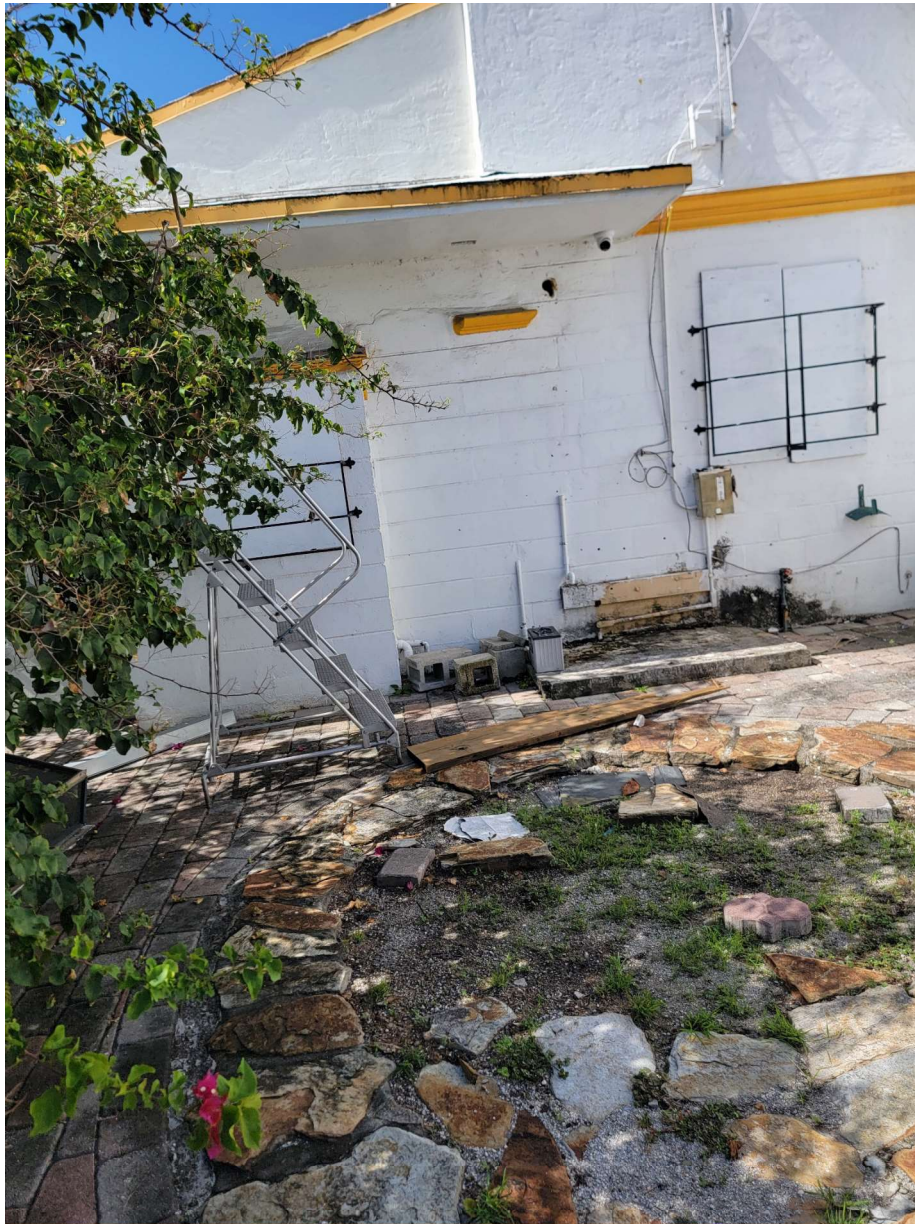
Spall and delaminated stucco present

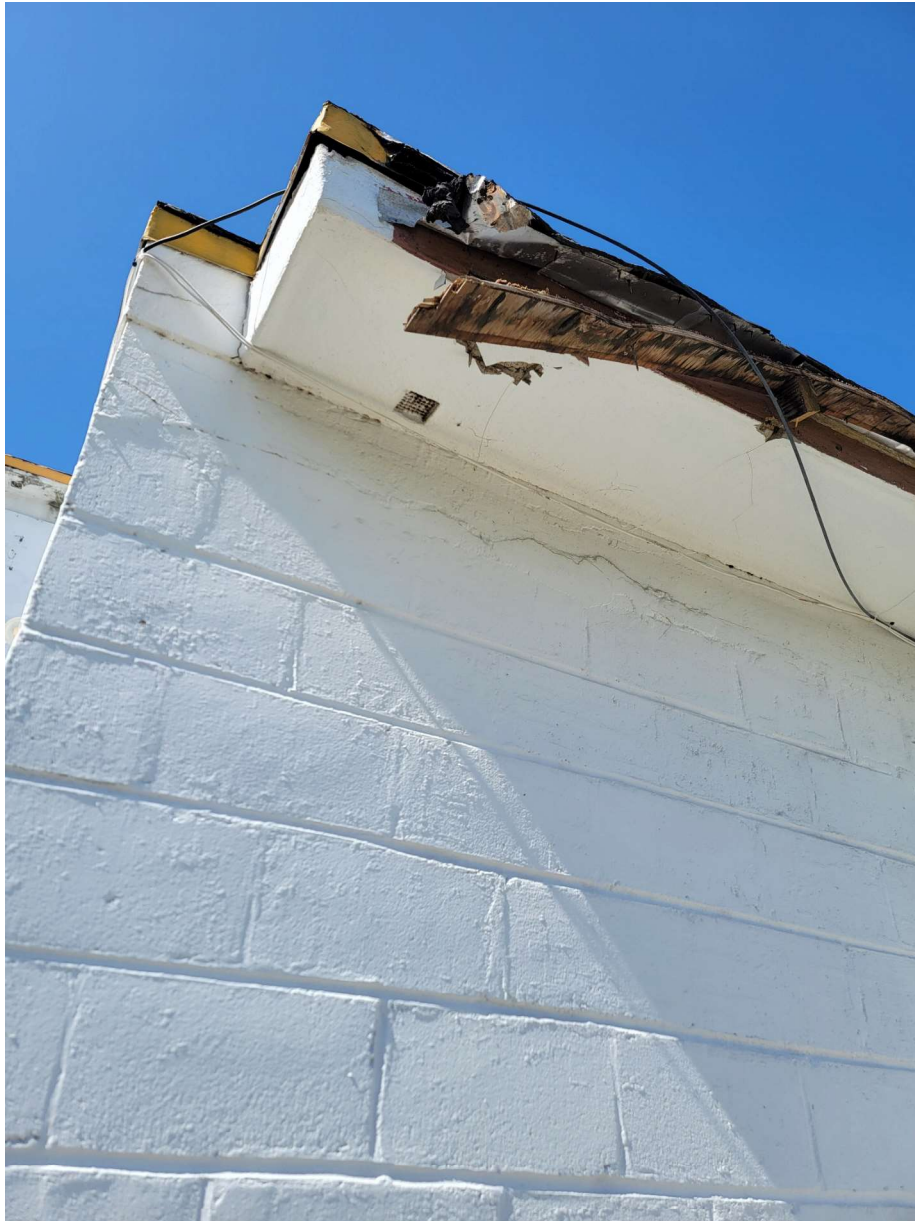
Rotted wood present on fascia

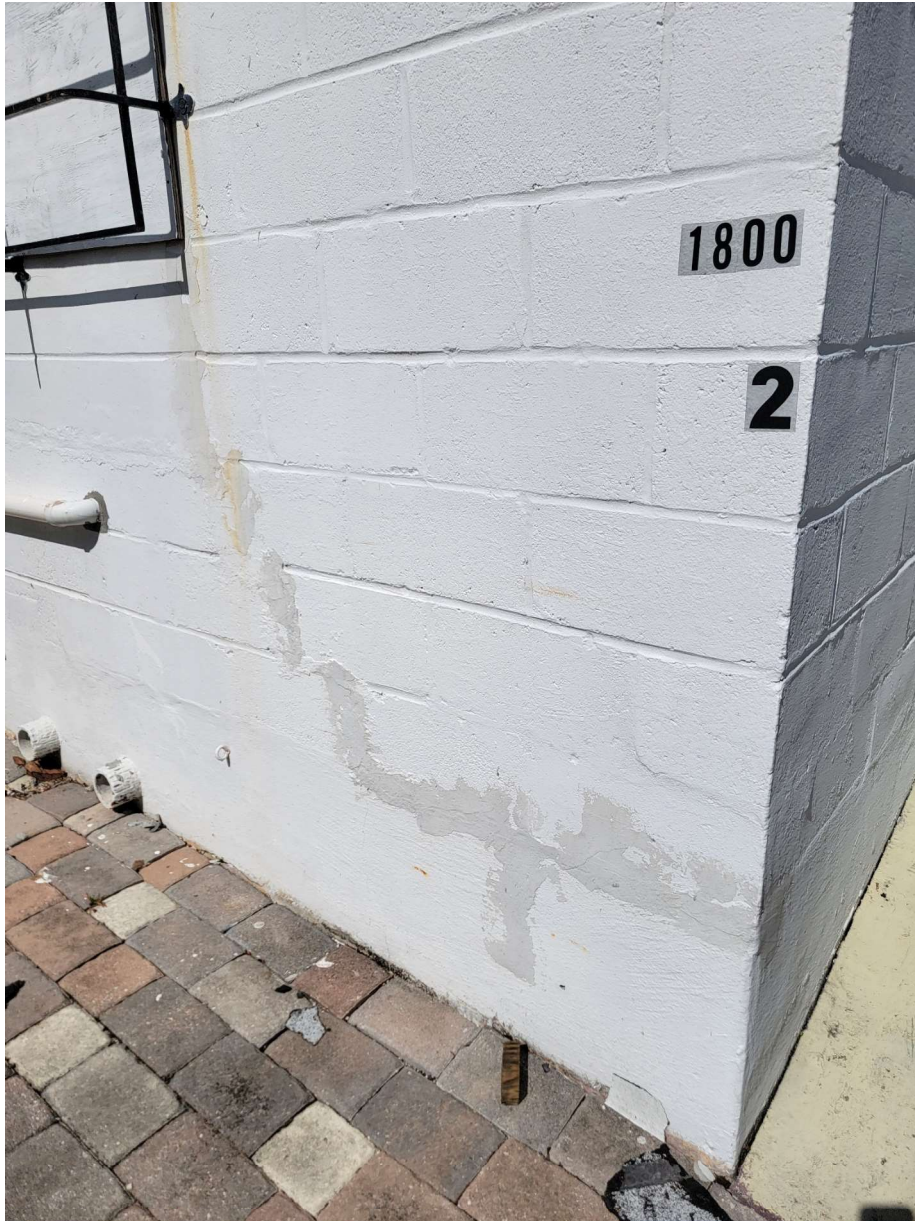
Cracks noted leading to foundations

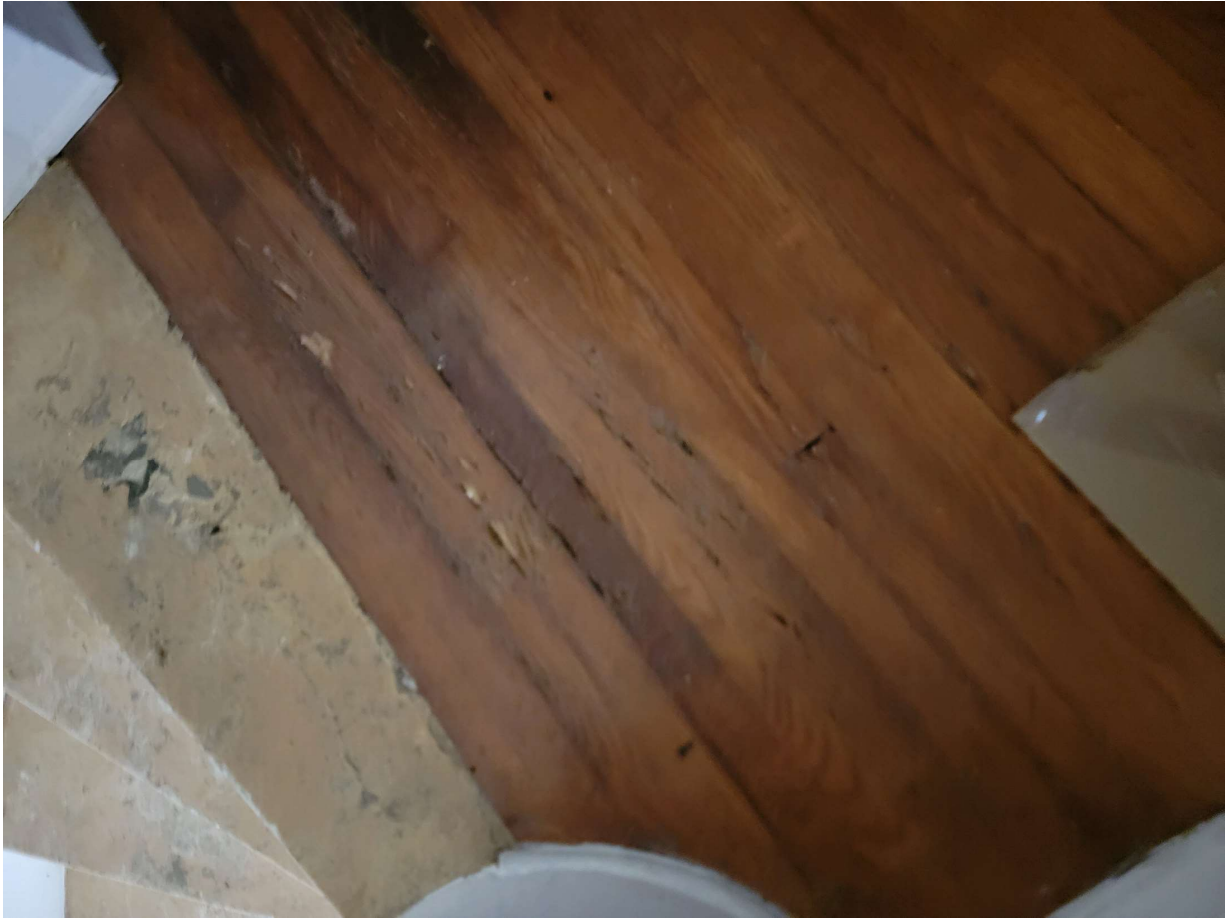
Termite damages noticed on wood floors

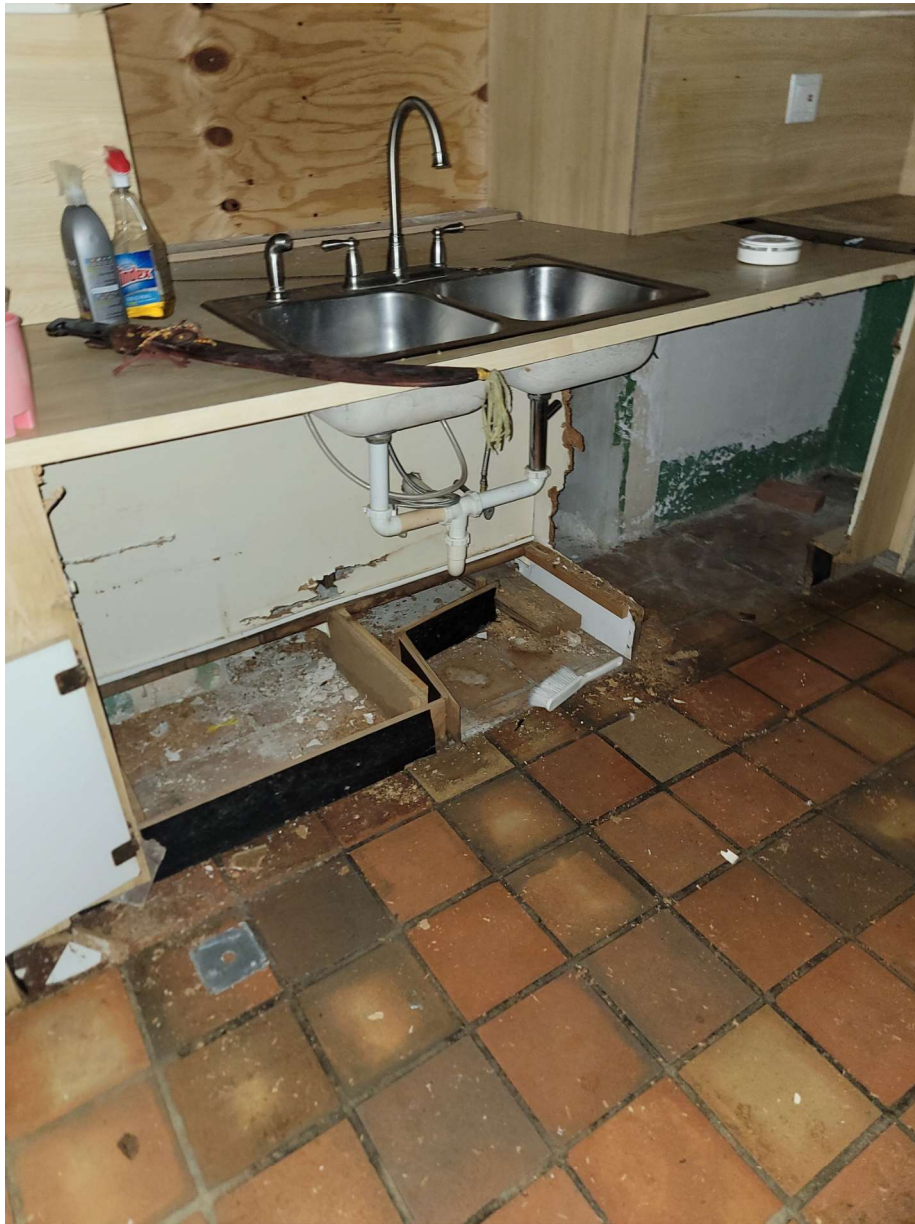
Water intrusion damages noted

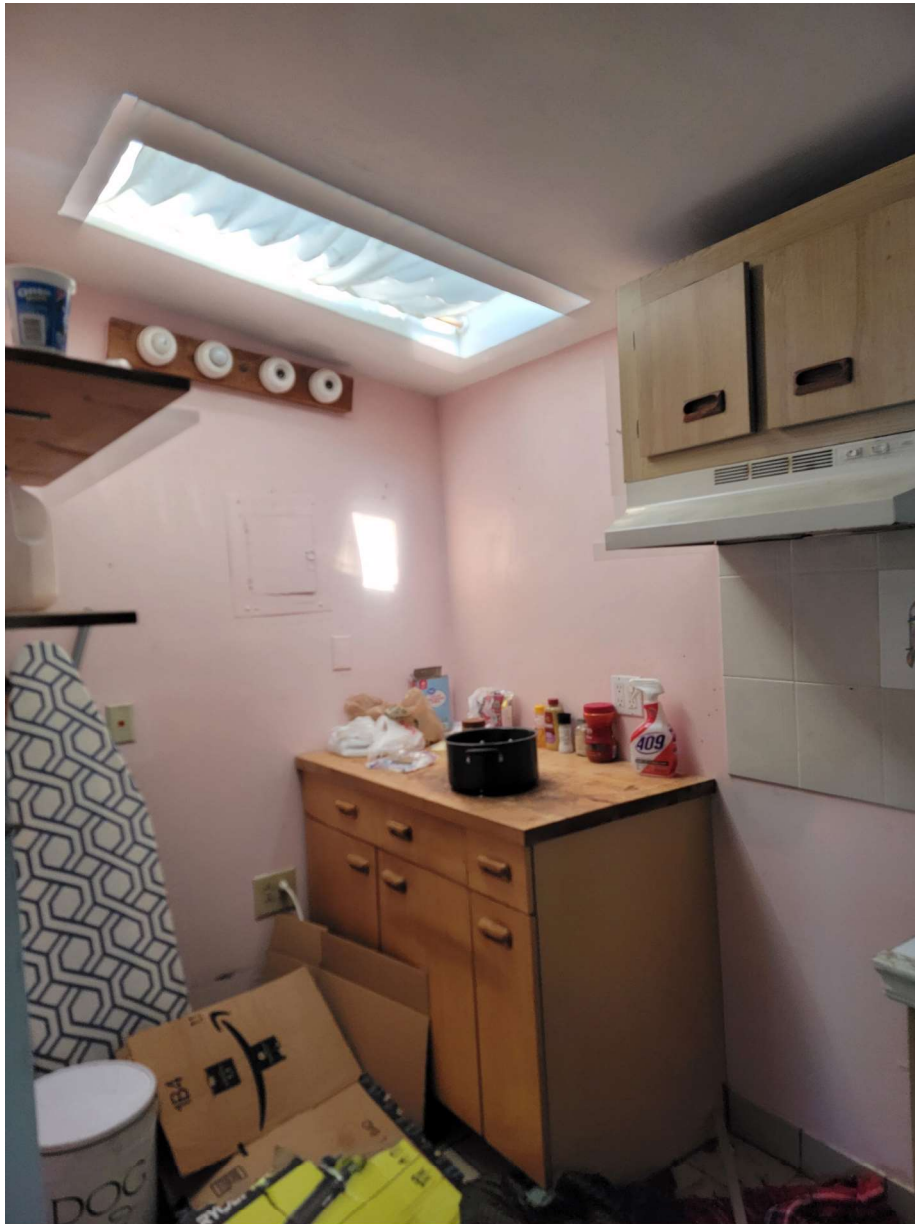
Skylights failure noticed

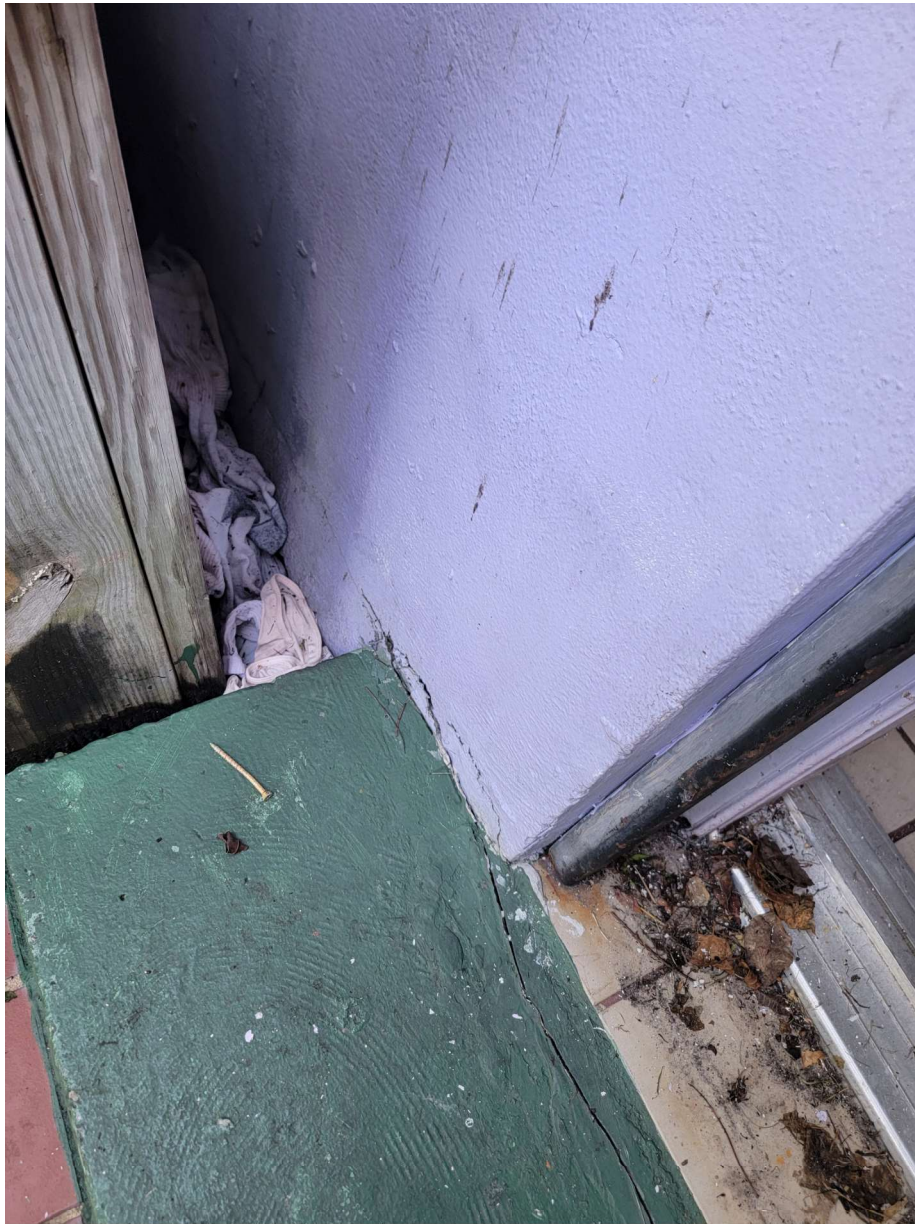
Deflections noticed on foundations

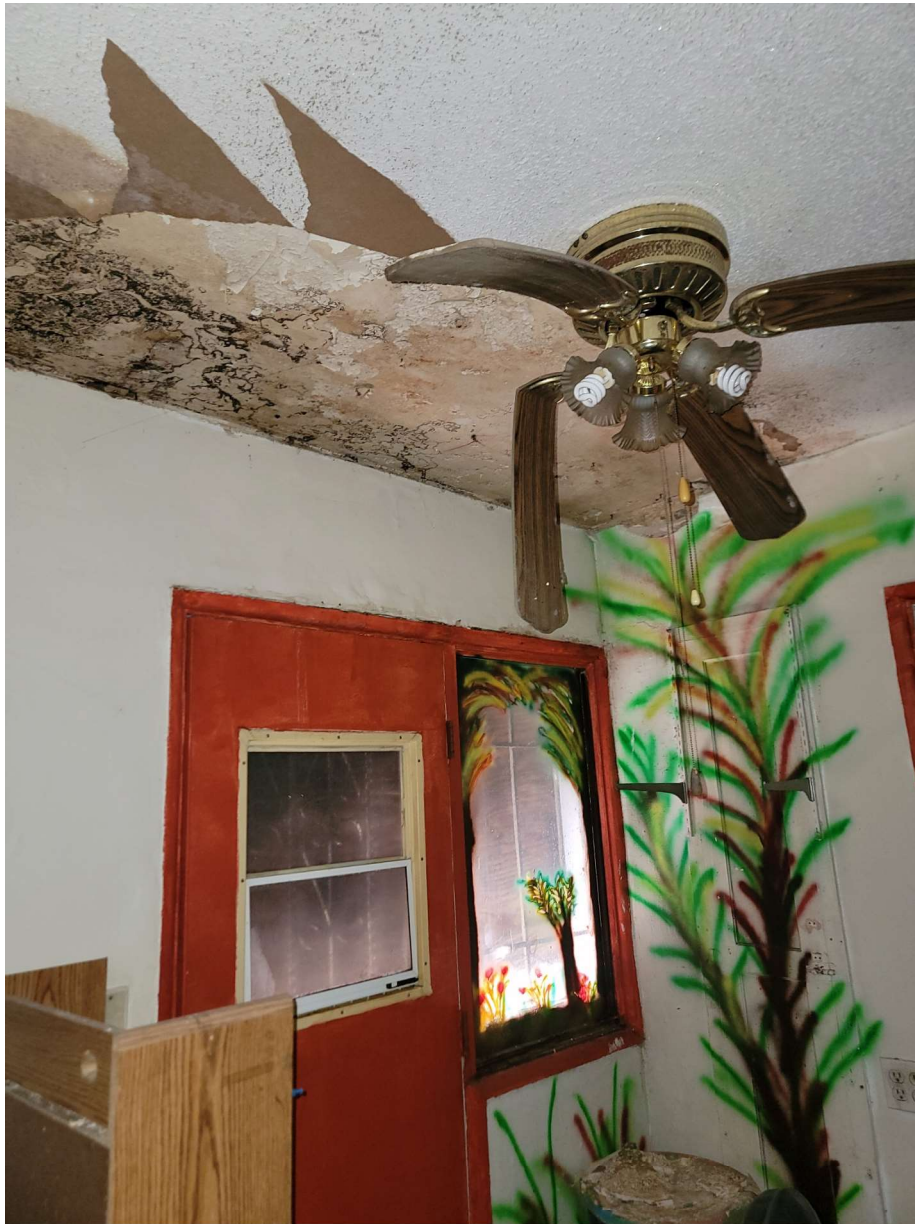
Mold present in interior finishes due to water intrusion

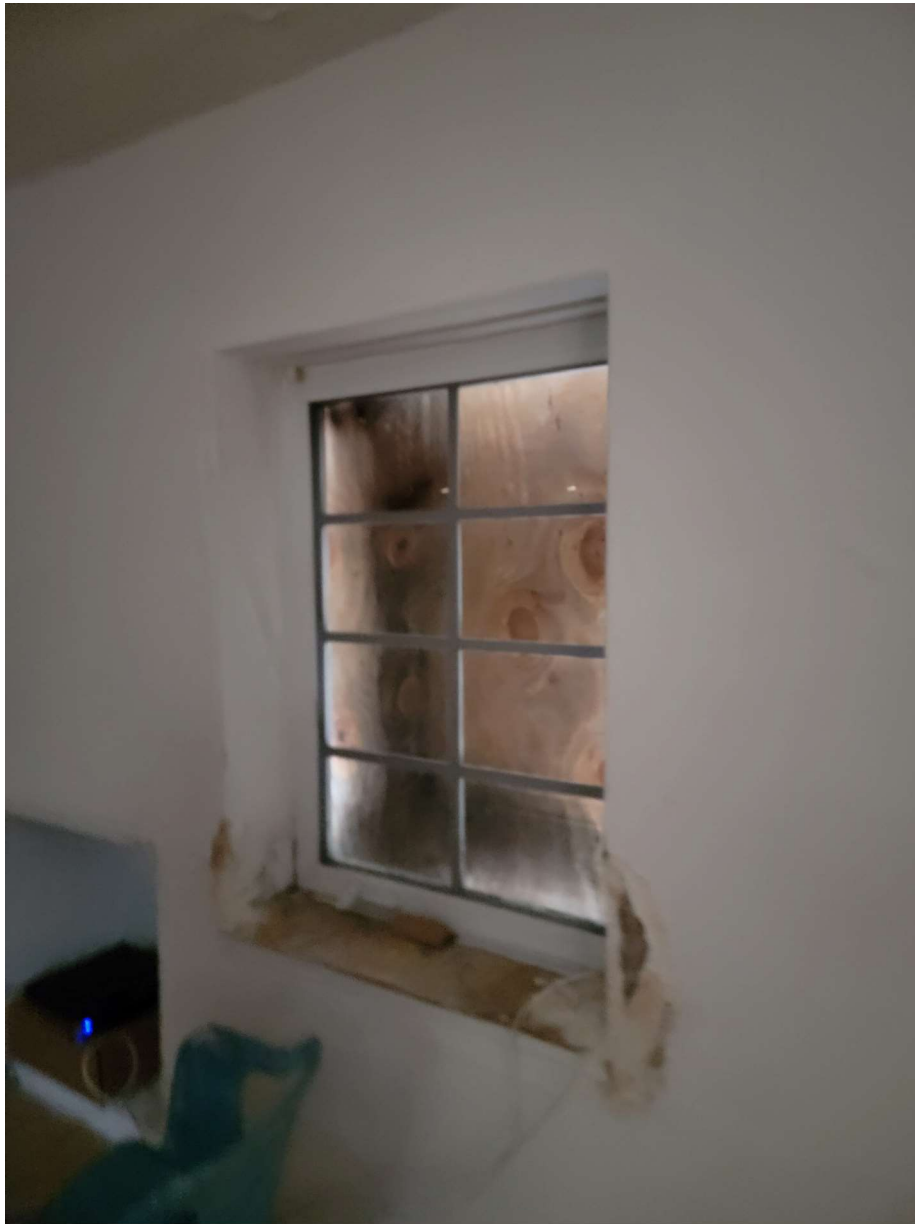
Water intrusion thru windows

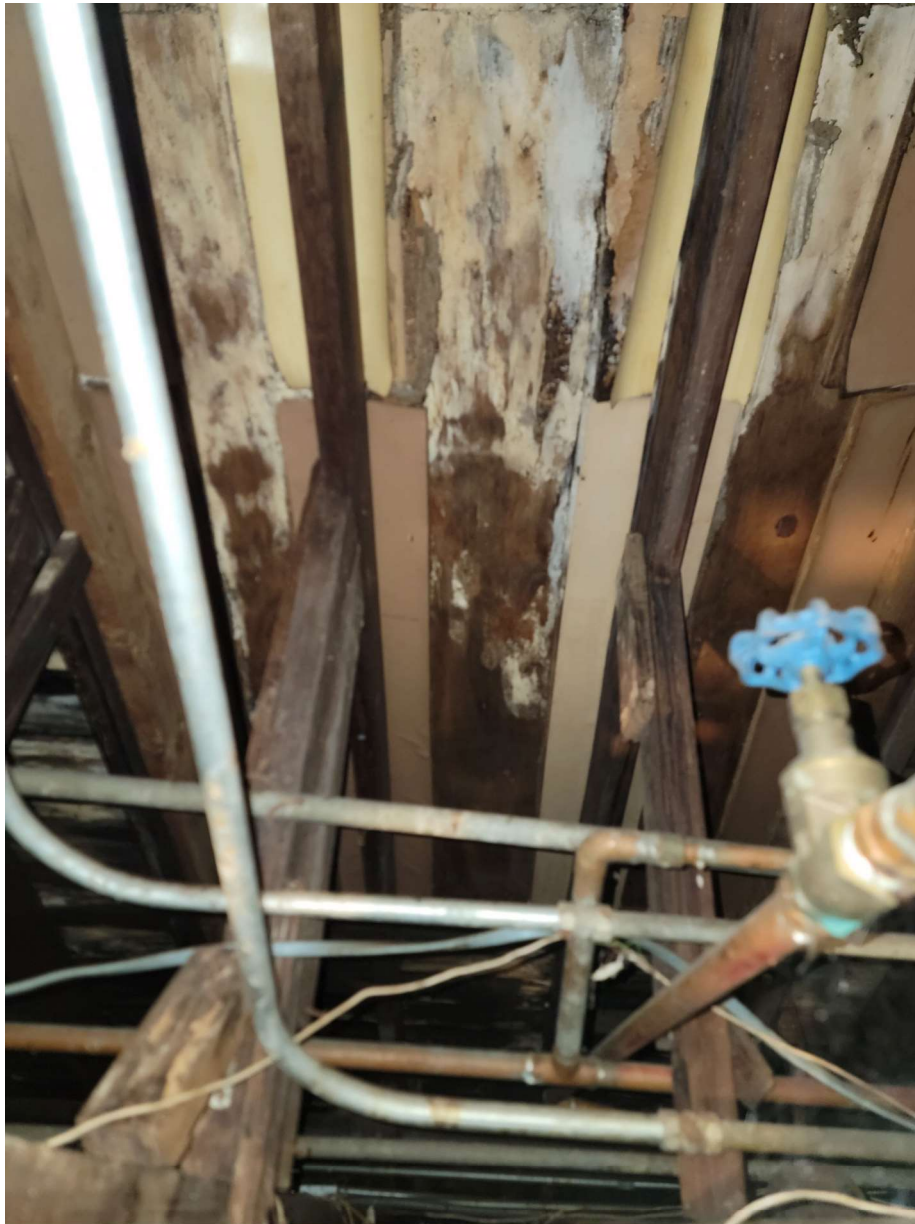
Water intrusion noticed coming from roof

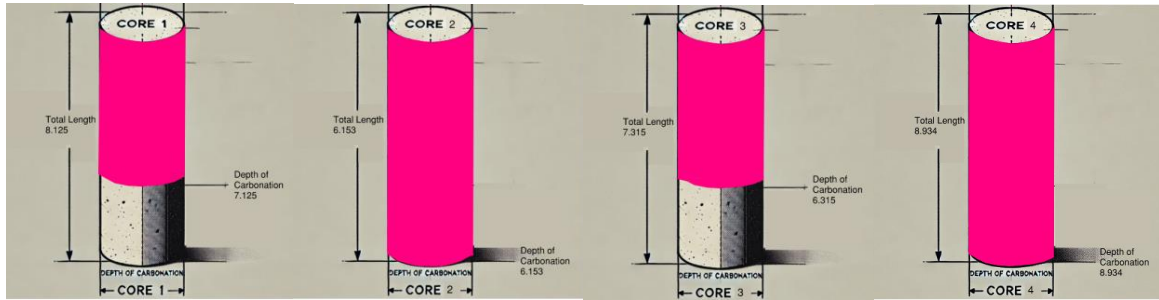
Figure 1- Depth of Carbonation (Core 1) Figure 2- Depth of Carbonation (Core 2) Figure 3- Depth of Carbonation (Core 3) Figure 4- Depth of Carbonation (Core 4)

The depth of carbonation ranged between approximately 6.153 and 8.934. A summary of the test results is summarized below in table 2 and illustrated in Figure 1 through 4.
