# Specimen Trees Report

8 - 14 Star Island Drive

Miami Beach

7/19/2024

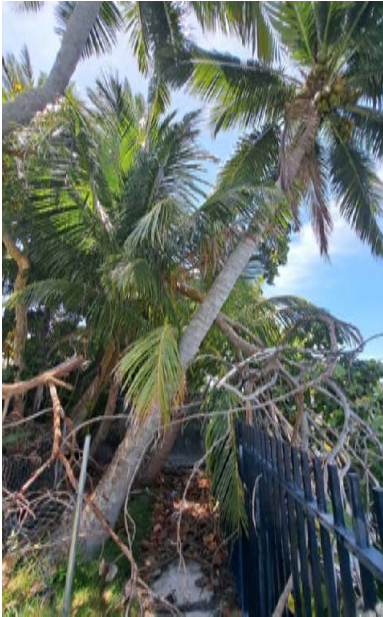
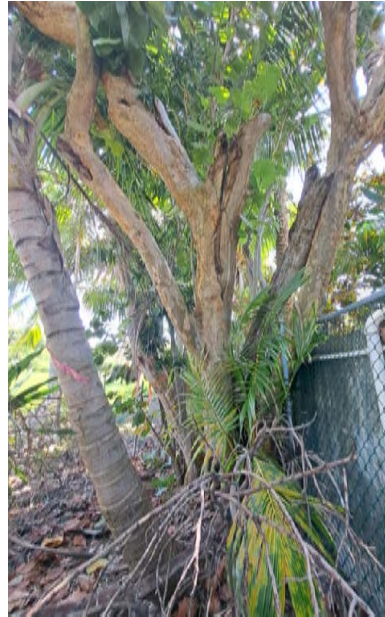
## Tree #8043

Tree #8043 is a SEAGRAPE TREE in poor condition. It is located on lot #8. The tree is double-trunked and there are a number of broken limbs. The canopy curves into the neighbor's yard. A large broken main limb is hanging over the water. There are many dead branches.

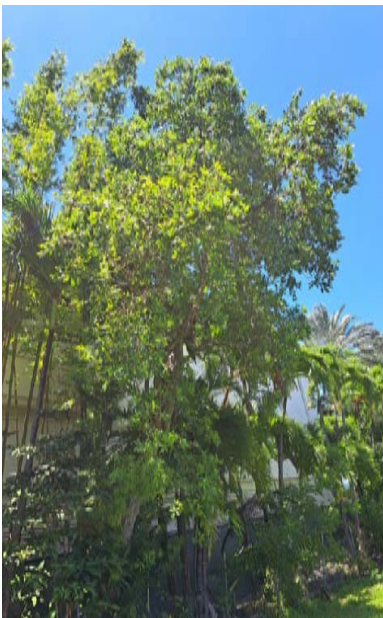
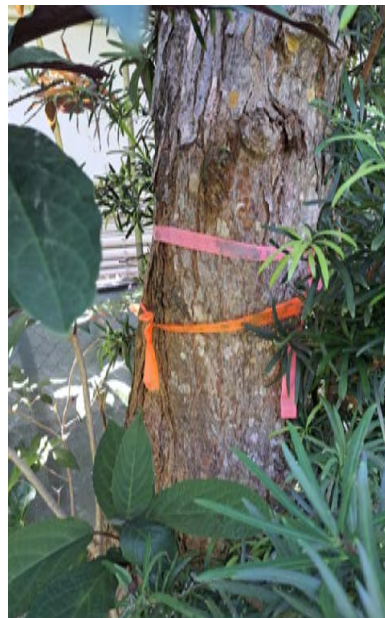
## Tree #8077

Tree #8077 is a PINK TRUMPET TREE in fair condition. It is located on lot #8. There is a small pocket of potential decay at the base of the trunk and adventitious root growth. Pests are affecting the foliage. Small deadwood is present.

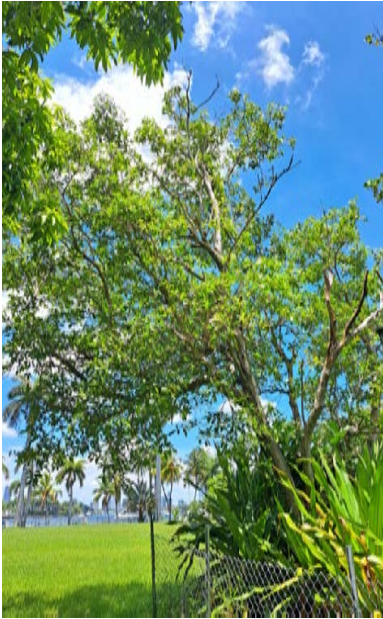
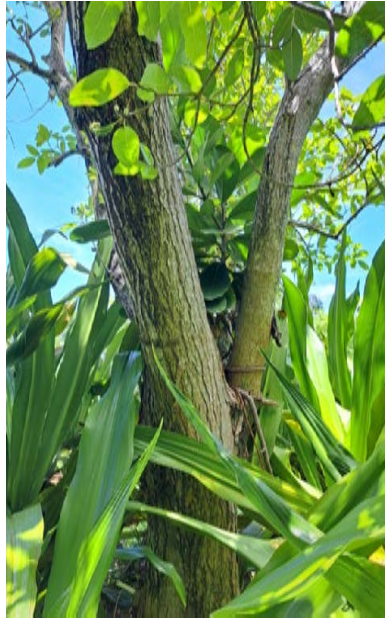
## Tree #8091

Tree #8091 is a PINK TRUMPET TREE in poor condition. It is located on lot #8. The tree has low vigor and moderately sized deadwood. The tree has poor form and included bark is between the limbs. Pests are affecting the foliage.

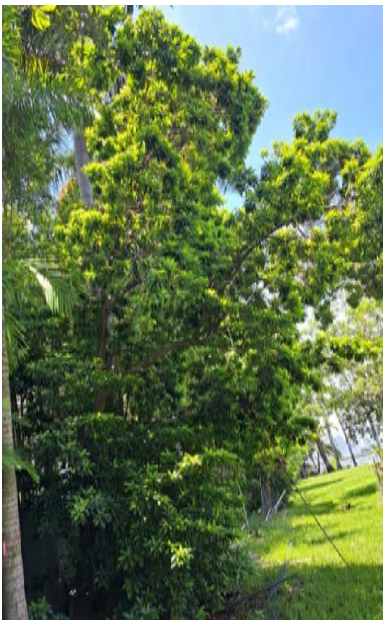
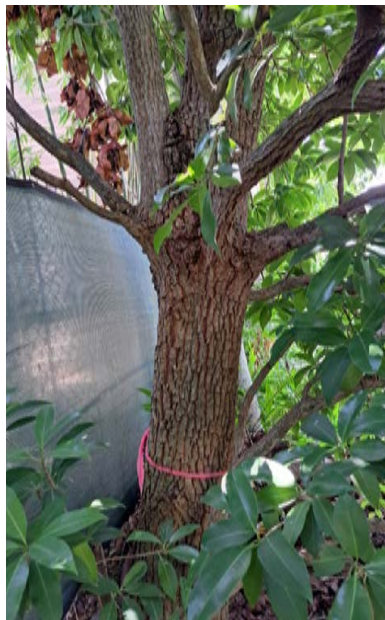
## Tree #8097

Tree #8097 is a SAPODILLA in fair condition. It is located on lot #8. It has a dense canopy with healthy new foliage. The canopy is asymmetrical and there are long, curving branches.

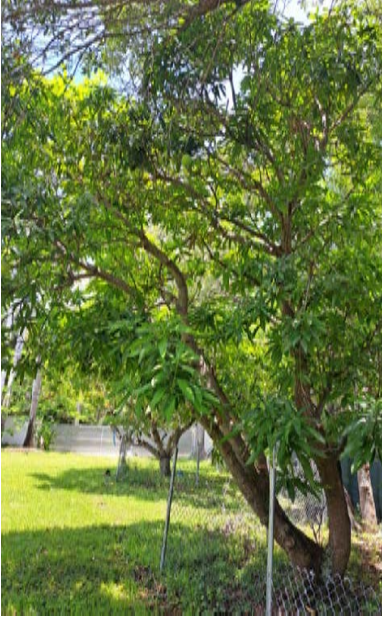
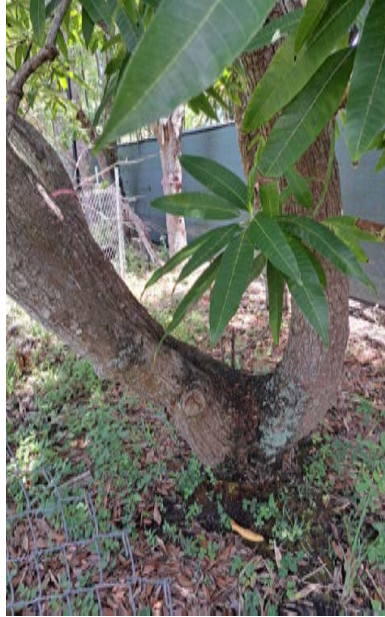
## Tree #8107

Tree #8107 is a MANGO TREE in good condition. It is located on lot #8. It is multi-trunked and has good vigor. Some deadwood is present.

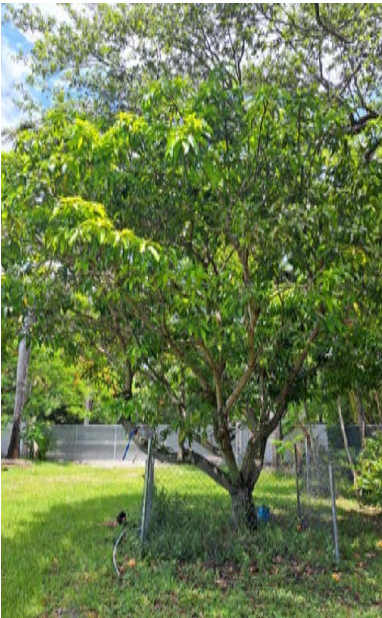
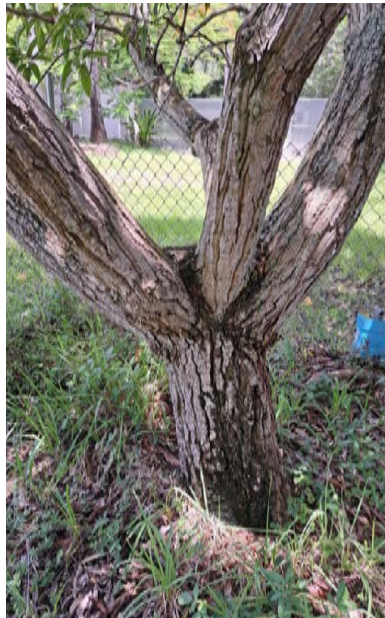
## Tree #8112

Tree #8112 is a MANGO TREE in fair condition. It is located on lot #8. The main limbs originate from the same point on the trunk. The tree has low vigor and there are branch stubs with decay.

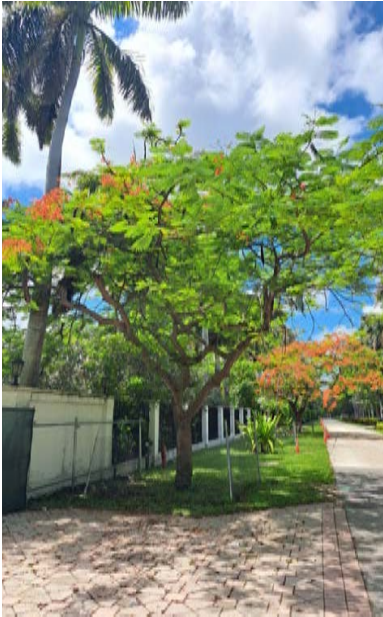
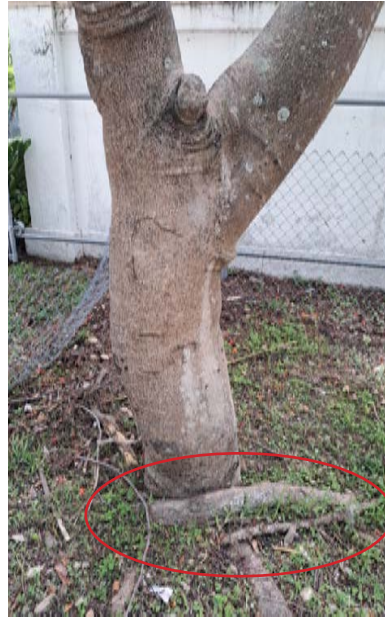
## Tree #9067

Tree #9067 is a ROYAL POINCIANA TREE in good condition. It is located in front of lot #8. It is a street tree with a nice form. There is a large girdling root which should be removed (circled in red). There are a number of branch stubs with decay and crossing limbs. Prune to increase clearance over the street. Prune to remove deadwood.

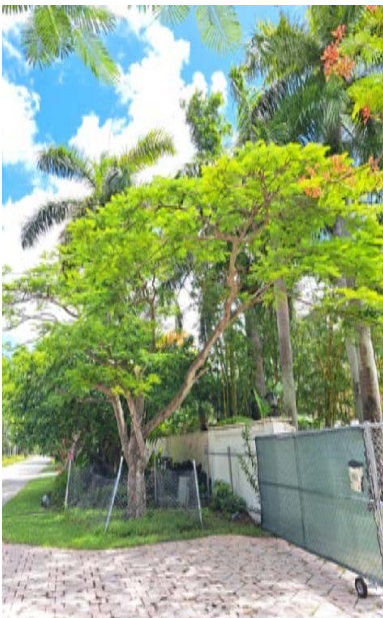
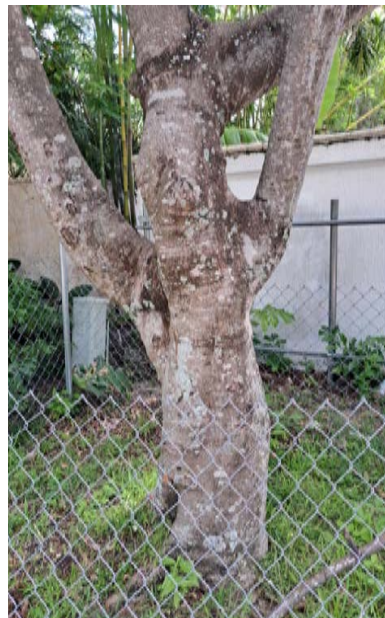
## Tree #9068

Tree #9068 is a ROYAL POINCIANA TREE in fair condition. It is located in front of lot #8 and is a street tree. The tree has large heading cuts from poor pruning and an asymmetrical canopy. Prune to maintain clearance over the street. Prune to remove deadwood.

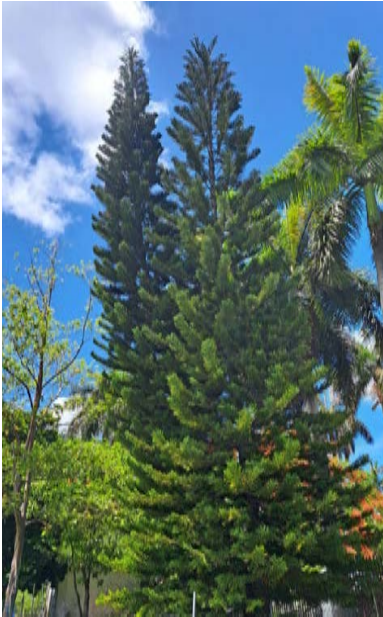
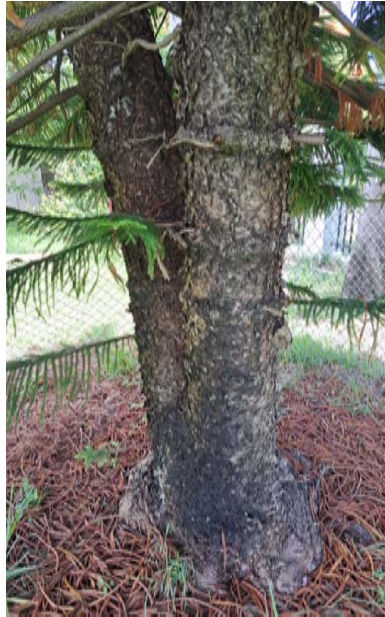
## Tree #8132

Tree #8132 is a NORFOLK ISLAND PINE in good condition. It is located on lot #9. The trunk divides into two with included bark.

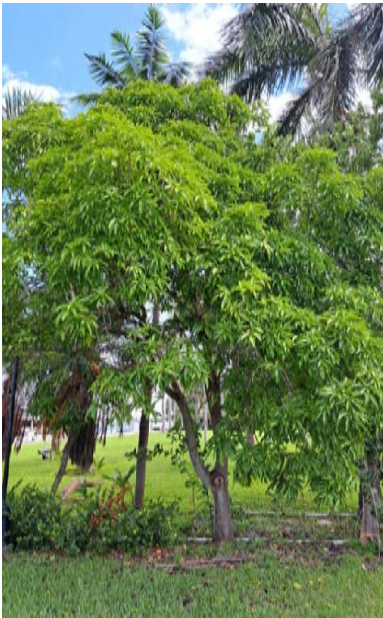
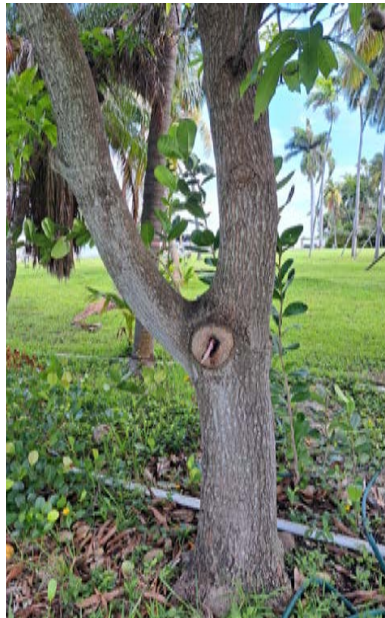
## Tree #9017

Tree #9017 is a MANGO TREE in fair condition. It is located on lot #9. There is small deadwood and an old pruning cut with wetwood. The foliage is slightly chlorotic.

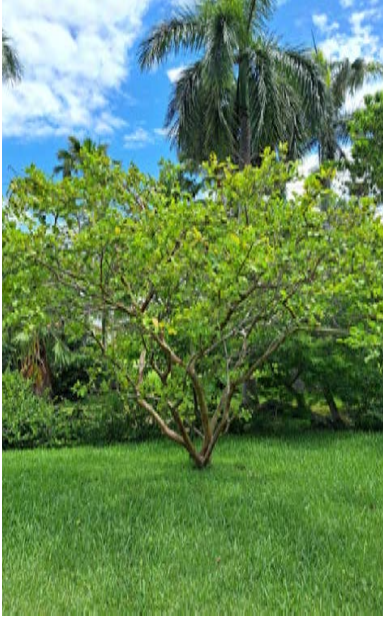
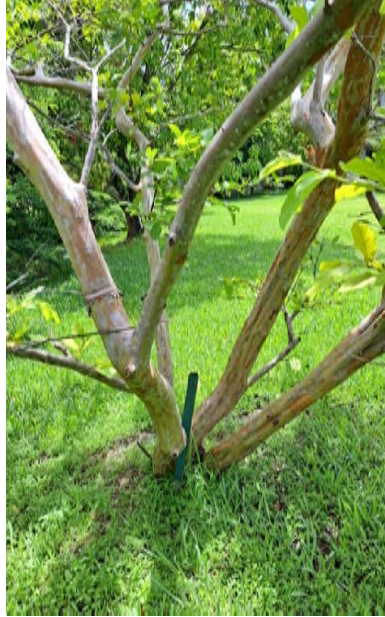
## Tree #9053

Tree #9053 is a GUAVA in fair condition. It is located on lot #9. It is multi-trunked with a nice form. The foliage is very chlorotic and there is some dieback.

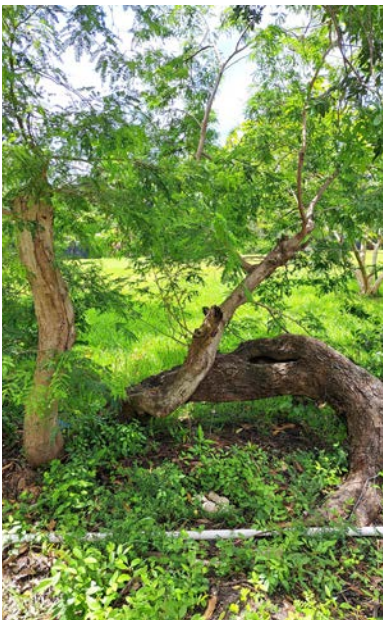
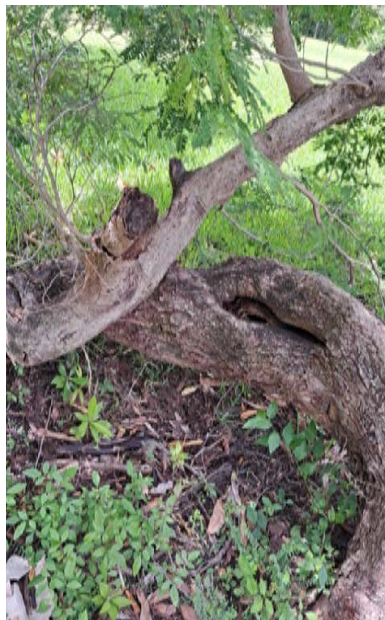
## Tree #9055

Tree #9055 is a WILD TAMARIND in poor condition. It is located on lot #9. The tree has been windthrown and there is extensive decay. The remaining canopy has been hatracked.

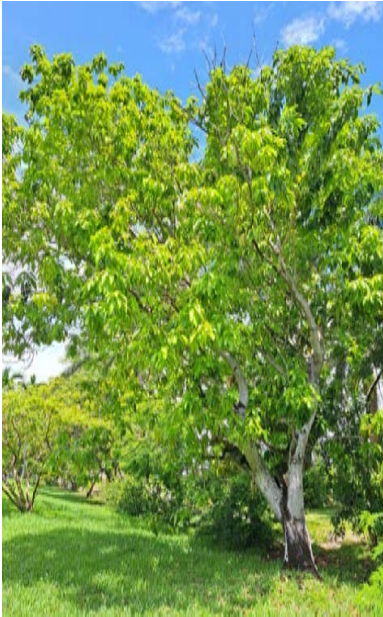
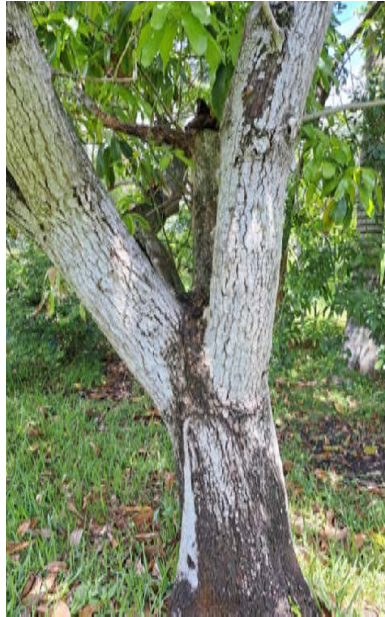
## Tree #9056

Tree #9056 is a MANGO TREE in poor condition. It is located on lot #9. There are long, overextended limbs and a crack in a limb. A number of limbs have been hatracked. The foliage is chlorotic.

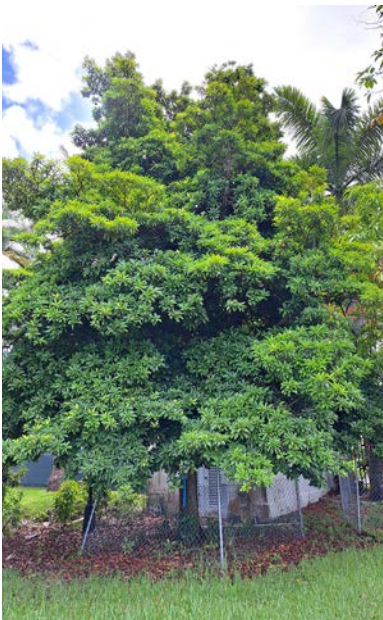
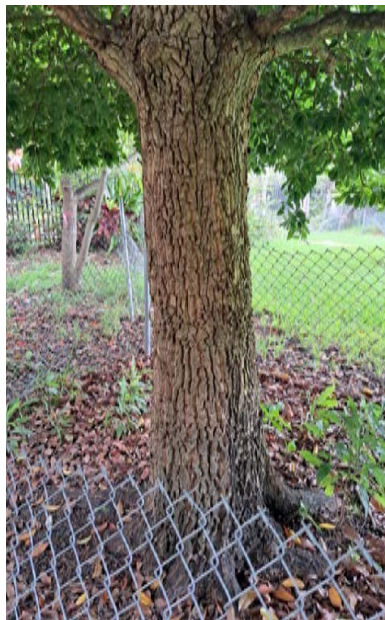
## Tree #9059

Tree #9059 is a SAPODILLA in good condition. It is located on lot #9. The tree has a dense canopy and a nice form. Some interior branch stubs are present.

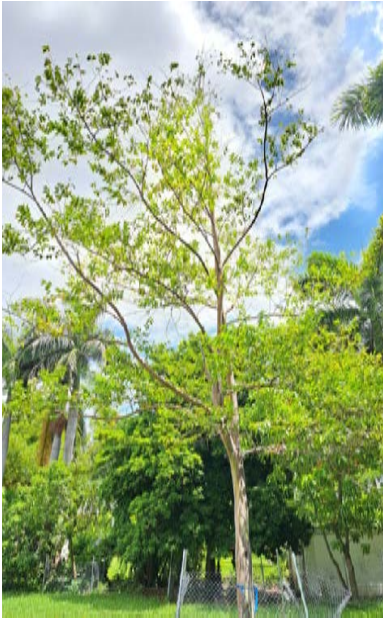
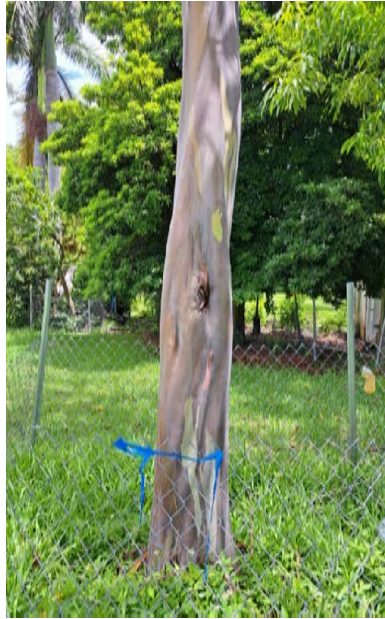
## Tree #9063

Tree #9063 is a RAINBOW EUCALYPTUS in fair condition. It is located on lot #9. The trunk divides into two with included bark. Small deadwood is present. There are long, overextended limbs. The foliage is chlorotic, and the canopy is thin.

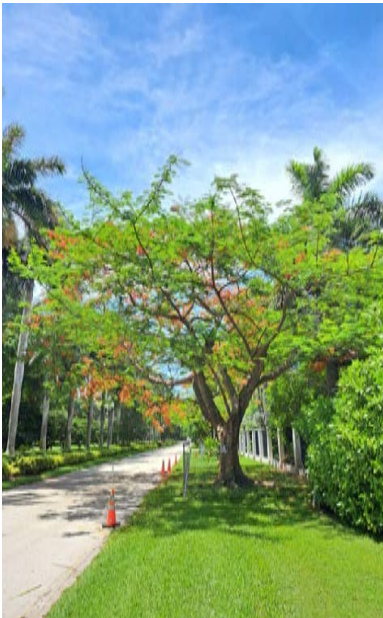
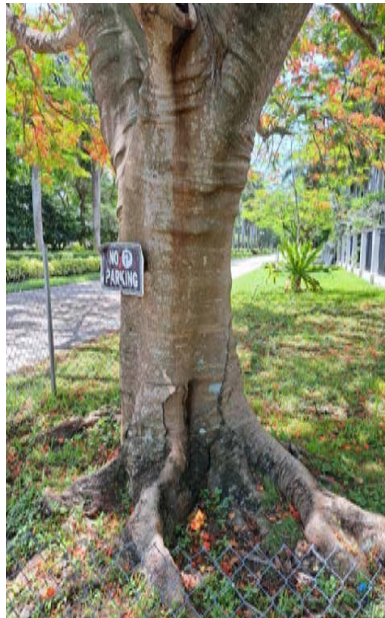
## Tree #9065

Tree #9065 is a ROYAL POINCIANA TREE in good condition. It is located in front of lot #9. It is a street tree with nice form. Large buttress roots are present. Old pruning cuts are not closing over well and have some decay. Prune to remove deadwood. Prune to increase clearance over the street.

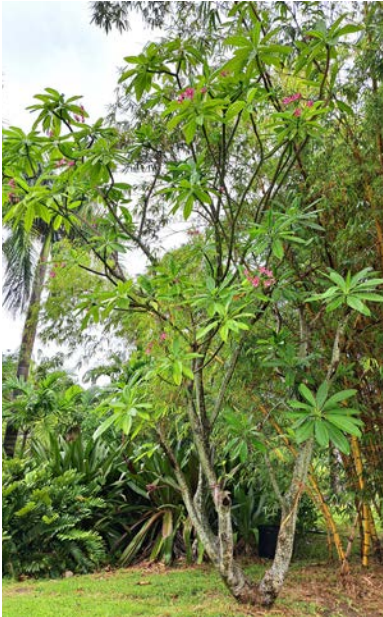
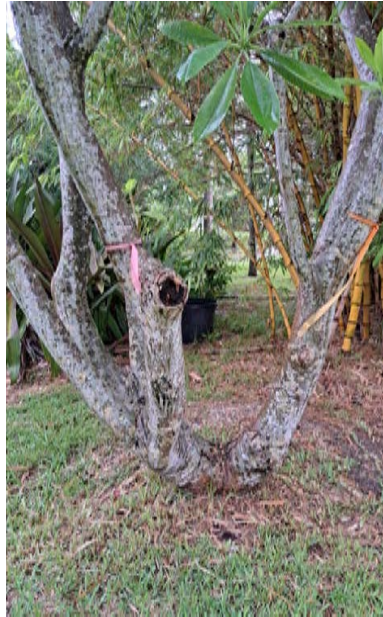
## Tree #10081

Tree #10081 is a FRANGIPANI in fair condition. It is located on lot #10. It is multi-trunked and has low vigor. There is deadwood and branch stubs present. Old pruning cuts are not closing over well.

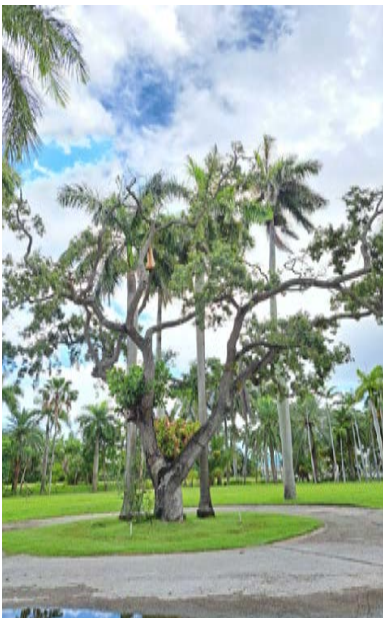
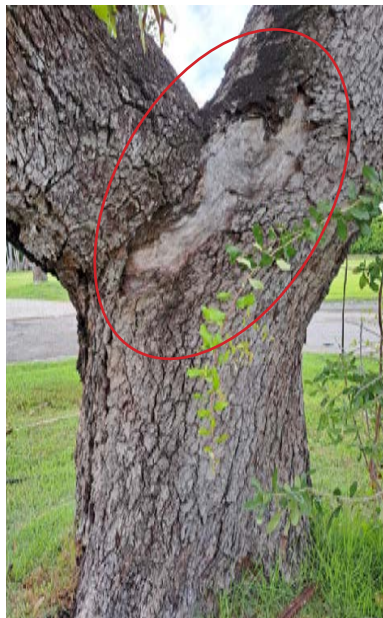
## Tree #11026

Tree #11026 is a LIVE OAK in poor condition. It is located on lot #11. The canopy is thin and there is not much foliage remaining. There is dieback at the top of the canopy. There is a large staghorn fern on the tree. A decay conk was observed at the base of the trunk. There is bark missing from about 75% of the circumference of one of the three main leaders. Old pruning cuts are not closing over.

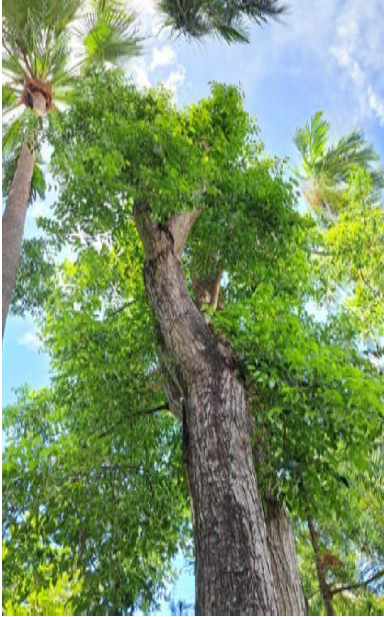
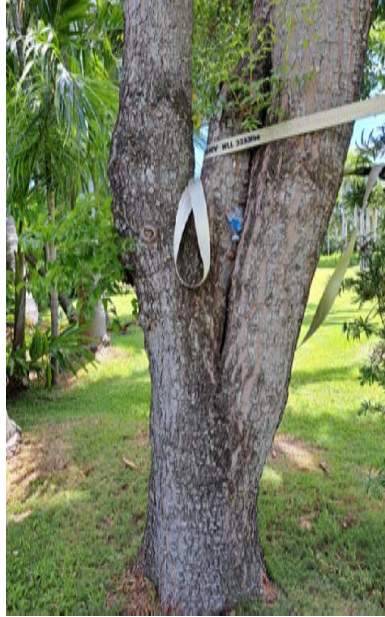
## Tree #12040

Tree #12040 is a MAHOGANY in poor condition. It is located on lot #12. The canopy has been hatracked and not much of the tree remains. There is included bark between the leaders.

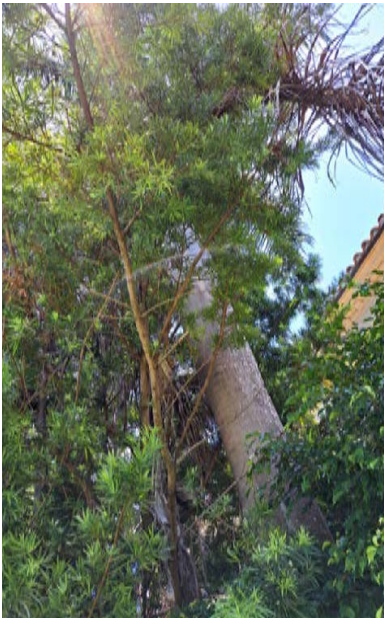
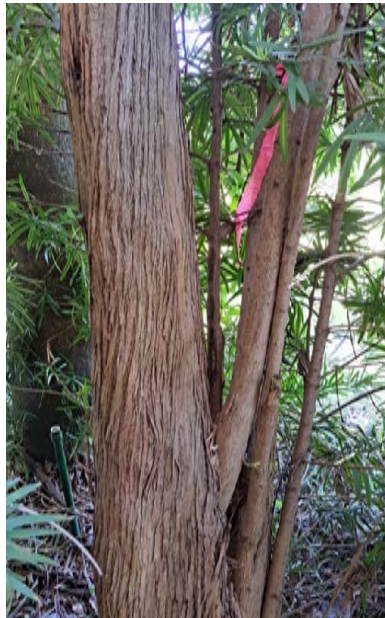
## Tree #12069-70

Tree #12069-70 is a JAPANESE YEW in good condition. It is located on lot #12. It is one tree that is multi-trunked. The tree is vigorous with healthy new growth.

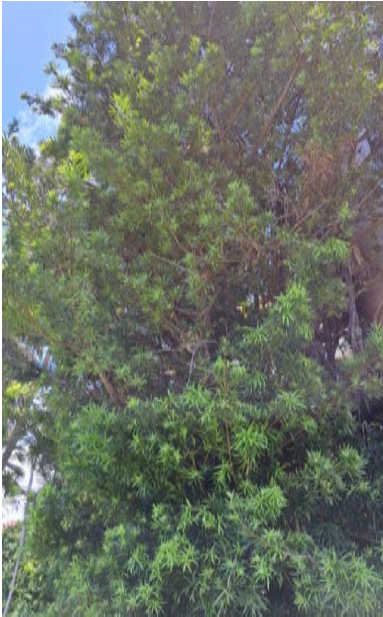
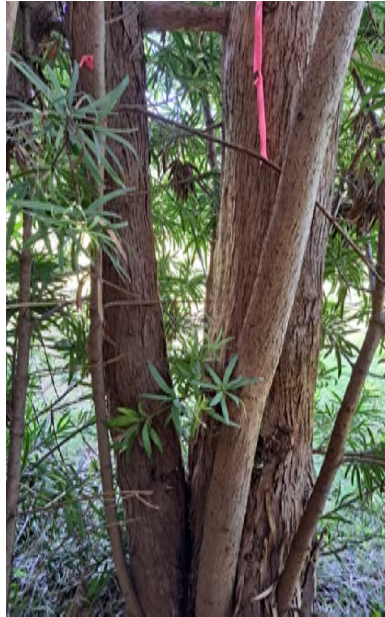
## Tree #12071-72

Tree #12071-72 is a JAPANESE YEW in good condition. It is located on lot #12. It is one tree that is multi-trunked. The tree is vigorous with healthy new growth.

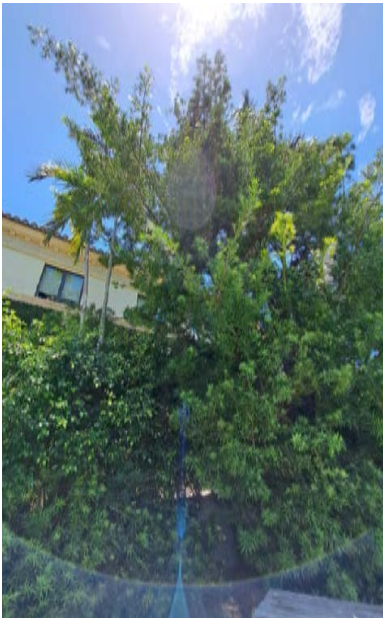
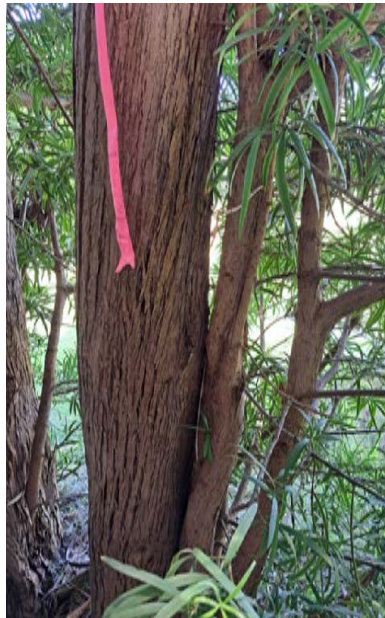
## Tree #12073-74

Tree #12073-74 is a JAPANESE YEW in good condition. It is located on lot #12. It is one tree that is multi-trunked. The tree is vigorous with healthy new growth.

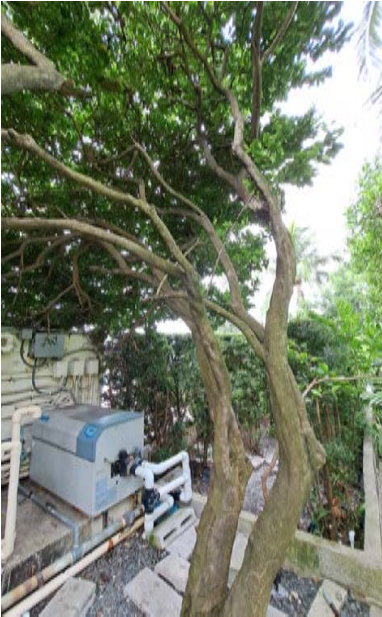
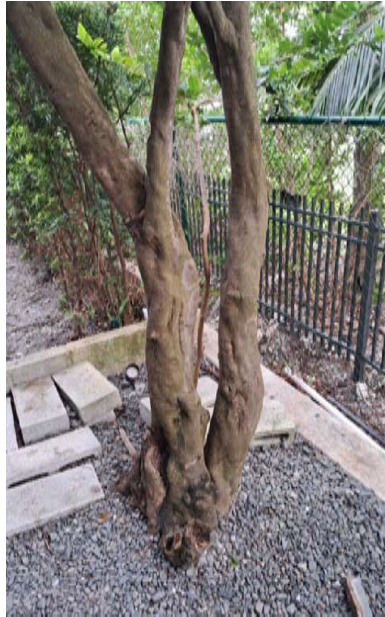
## Tree #13008

Tree #13008 is a JAPANESE PRIVET in good condition. It is located on lot #13. It is multi-trunked and forms a hedge with the other nearby privet.

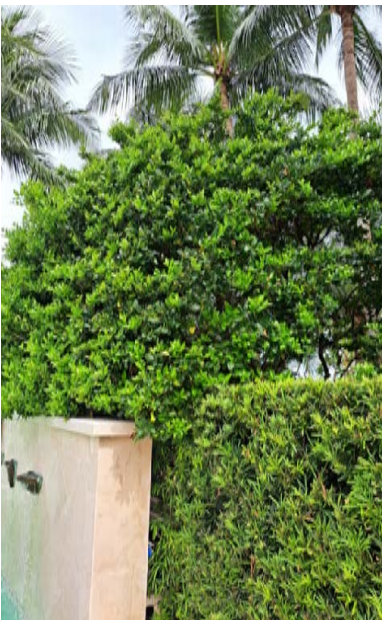
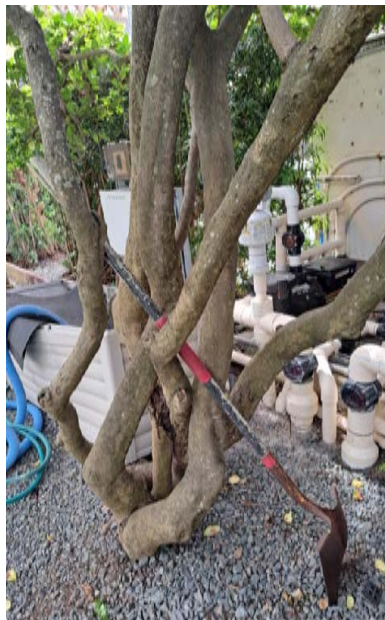
## Tree #13011

Tree #13011 is a JAPANESE PRIVET in good condition. It is located on lot #13. It is multi-trunked and forms a hedge with the other nearby privet. Decay was observed in one leader.

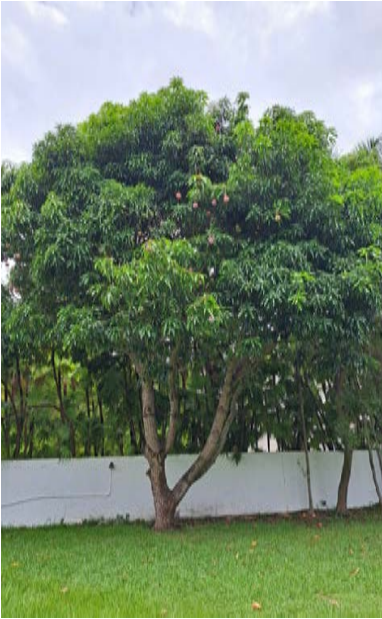
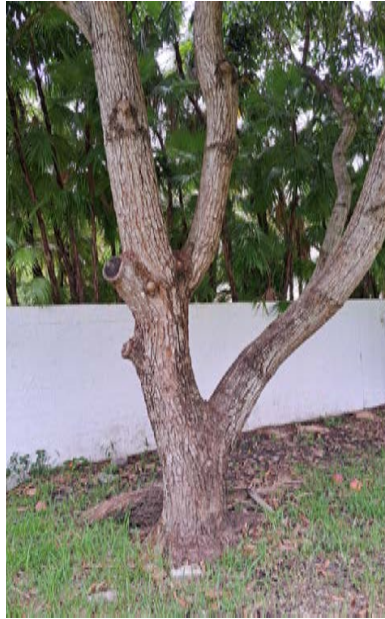
## Tree #14094

Tree #14094 is a MANGO TREE in good condition. It is located on lot #14. The tree has a dense green canopy with little deadwood. There are many fruits at this time of year. Old pruning cuts are closing over slowly.

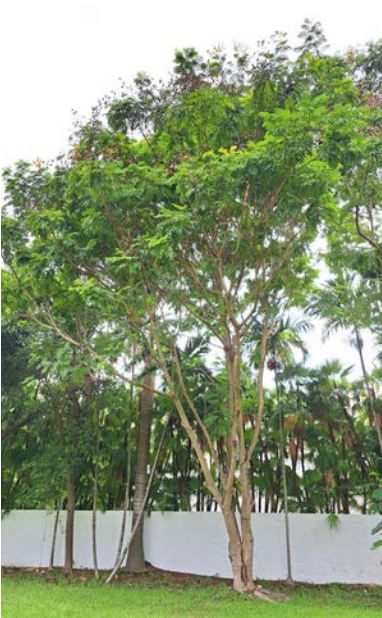
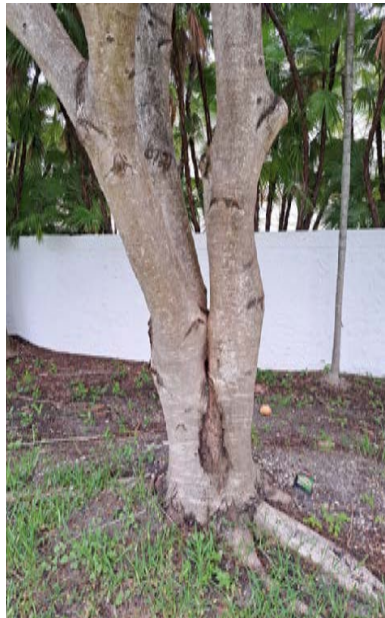
## Tree #14102

Tree #14102 is a YELLOW POINCIANA in fair condition. It is located on lot #14. There is included bark between the main leaders. The tree has a low live crown ratio and small interior deadwood. Large surface roots are present and old pruning cuts are closing over slowly.

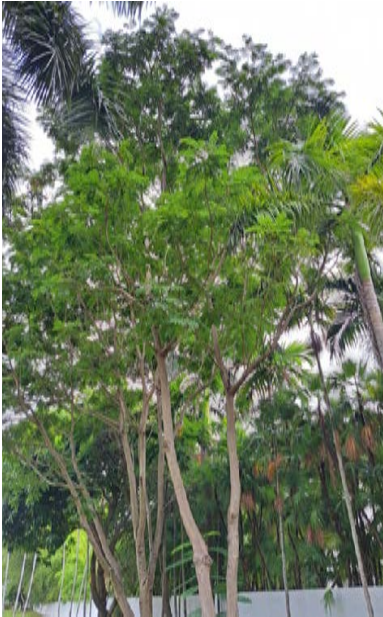
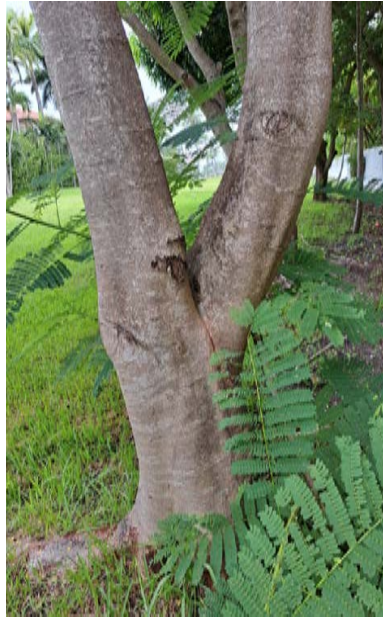
## Tree #14105

Tree #14105 is a YELLOW POINCIANA in fair condition. It is located on lot #14. It is double-trunked with included bark. Old pruning cuts are closing over slowly. The tree has a low live crown ratio.
