ARBORIST REPORT
1265 N. Biscayne Point Rd.
Miami Beach, FL 33141

Treage LLC was contacted by Andres Montero of AMLA Studio to conduct a Certified Arborist Report at 1265 N. Biscayne Point Rd., Miami Beach, FL

The site consists of an existing single-family home proposed for demolition and new construction of a single-family home. There are 34 trees located onsite, as well as 5 trees located offsite, that are referenced below.

A site visit was conducted on May 2, 2024. A Level 2 inspection of all trees was conducted and documented with photographs. Measurements of DBH, height, and canopy were taken and recorded, and the condition of each tree was noted as Good, Fair, Moderate or Poor. Tree measurements were taken as follows: DBH was recorded with a metal Spencer ProTape; height and canopy were estimated from the ground; and overall condition was done by visual inspection from ground level. Critical Root Zone (CRZ) and Tree Protection Zone (TPZ) were determined based on ANSI A-300 Standards for the *Management of Trees and Shrubs During Site Planning, Site Development and Site Construction*. Trees are numbered in accordance with the Vegetation Survey provided by the Client.

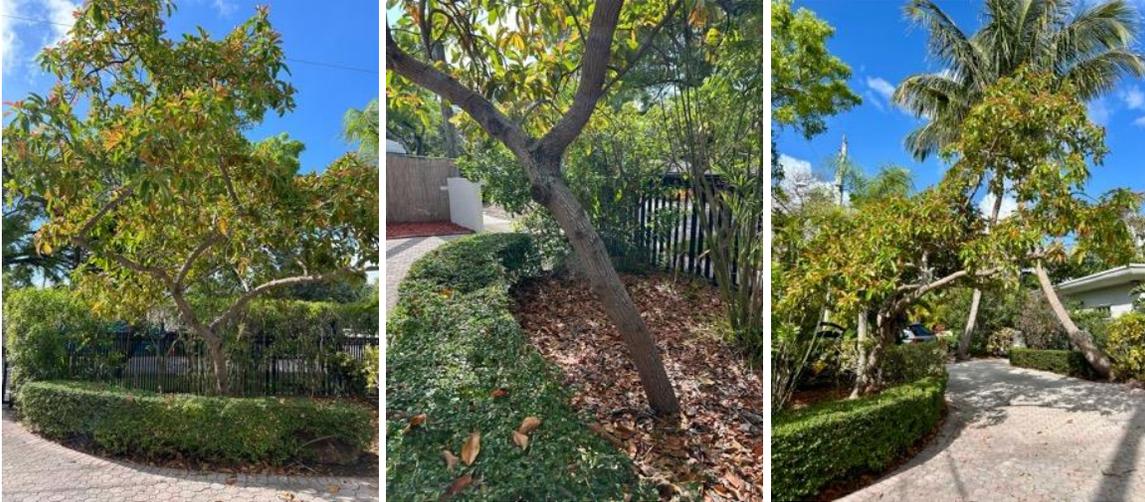
Tree #1 – *Persea americana*, Avocado – this tree is growing on the northeast side of the circular driveway cutout on the southeast side of the property. It has a slightly weak structure with minor lean. There are some small poor cuts present. Overall, it is in moderate to borderline fair condition. It is just under regulation size, so it should be eligible for removal without regulation; however, it is advised to confirm with the City prior to conducting any removals.

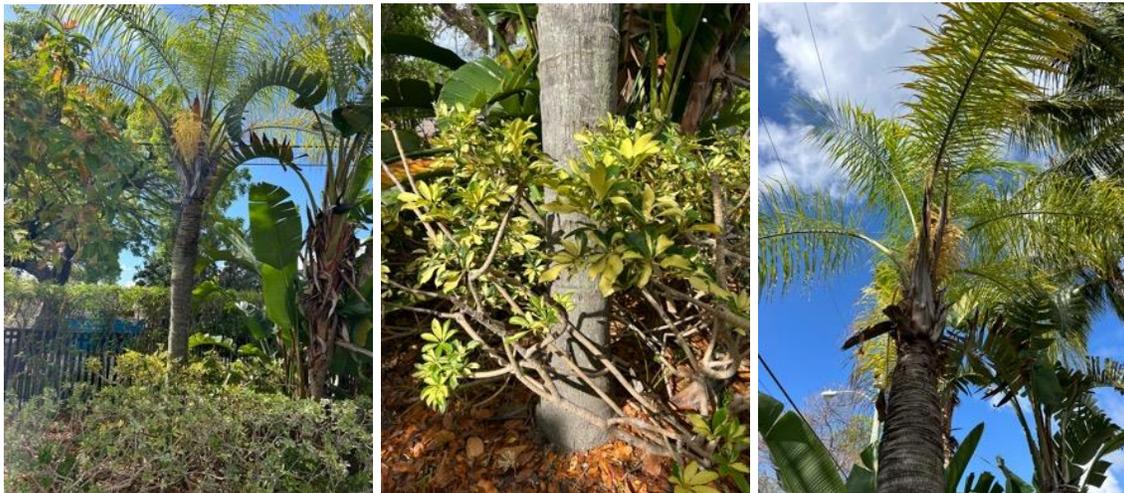
Tree #2 – *Syagrus romanzoffiana*, Queen Palm – this palm is located slightly southwest of Tree #1 in the circular driveway cutout. It shows signs of nutrient deficiency and is in borderline fair condition. It is just under regulation size, so it should be eligible for removal without regulation if necessary. It is also a possible, although not ideal, candidate for relocation onsite per specifications below; it is recommended for fertilization per BMP's if it remains or is relocated.

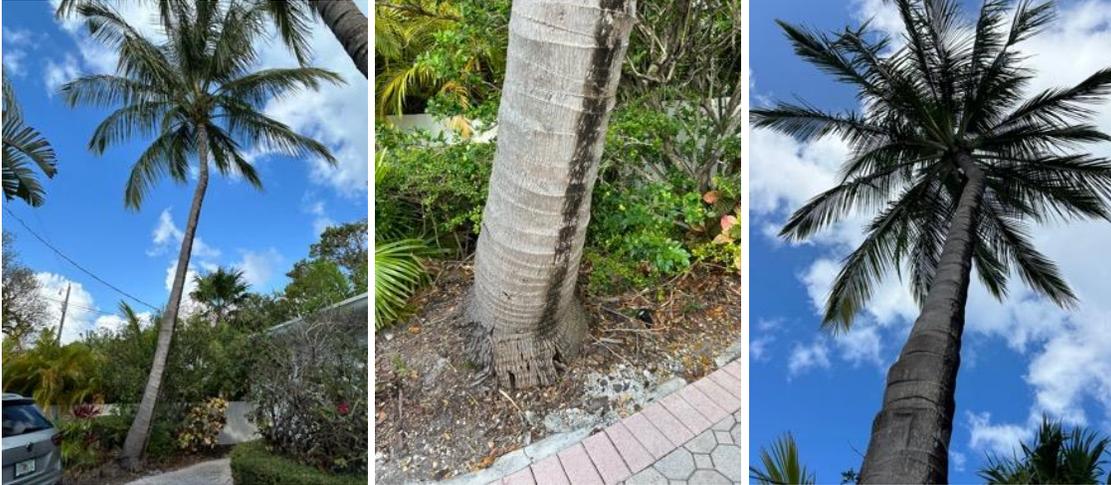
Tree #3 – *Cocos nucifera*, Coconut – this palm is located on the southwest side of the driveway area within 1’ of the driveway. It is in fair condition with a bend in the trunk but no other significant defects. This palm is a possible candidate to remain with protection due to its compact root zone and location near the perimeter of the property.

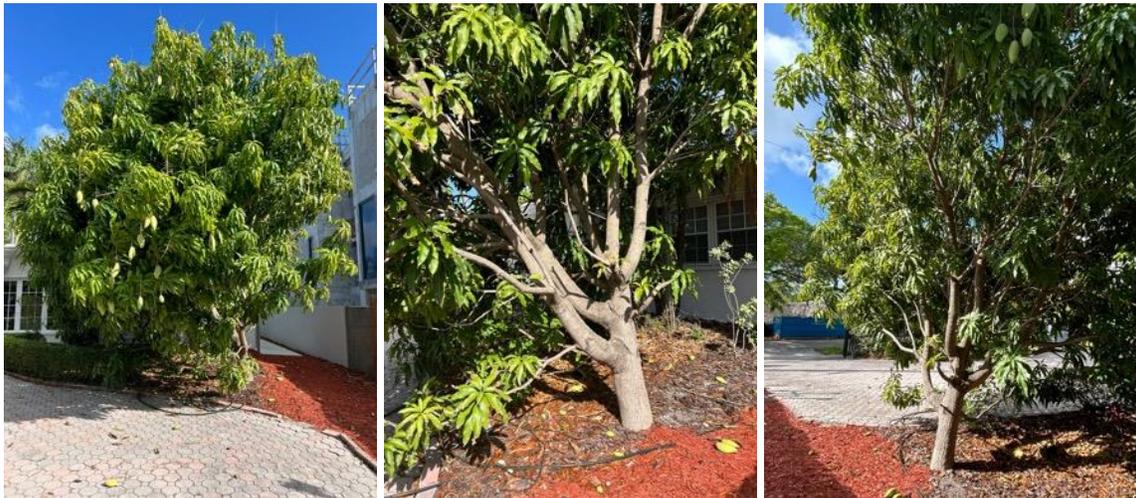
Tree #4 – *Mangifera indica*, Mango – this tree is located near the northeast side of the driveway in front of the southeast corner of the residence. It splits into multiple trunks between 3-4’ height. It is slightly crowded with a dense canopy, minor deadwood and small tears along the east side of the canopy adjacent to the walkway. Overall, it is in fair condition.

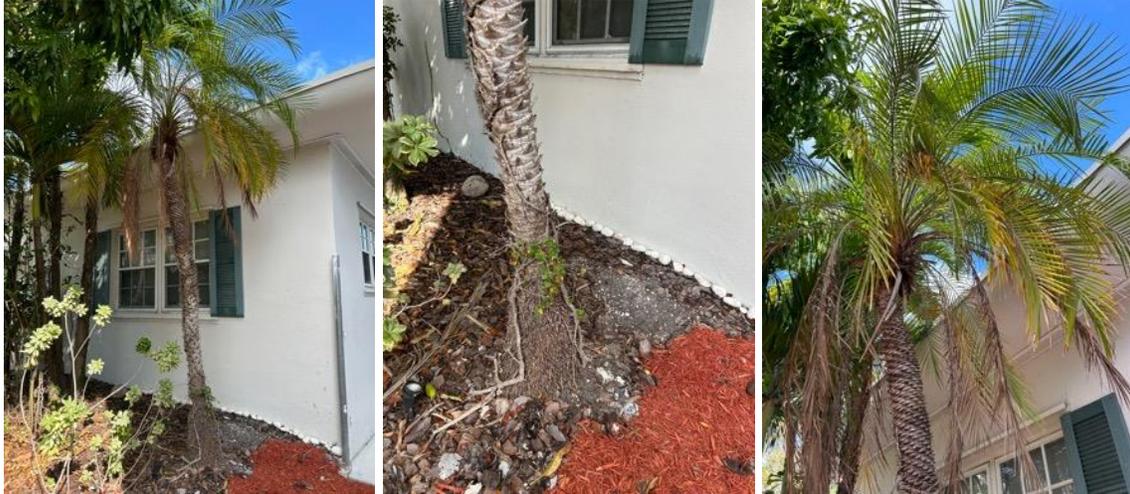
Tree #5 – *Phoenix roebellini*, Pygmy Date Palm – this palm is located within 3.5’ of the southeast corner of the existing residence. It exhibits minor chlorosis and is in fair condition. It is under regulation size, so it should be eligible for removal without regulation if necessary.

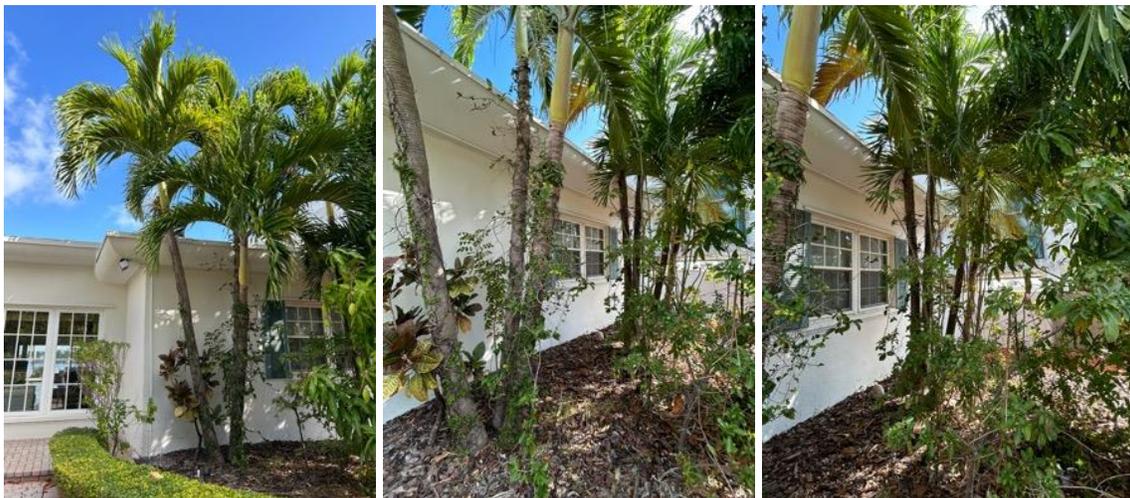
Tree #6 – *Adonidia merrillii*, Christmas Palm – this refers to a triple palm growing just south of the southeast side of the existing residence. It is crowded and has a slightly weak growth habit as a result. Overall, it is in fair condition. It will require a permit and mitigation if it is removed. It is a possible candidate for relocation onsite; see Relocation Specifications below.

Tree #7 – *Adonidia merrillii*, Christmas Palm – this refers to a triple palm growing just west of Tree #6 on the east side of the entrance to the existing residence. It is slightly crowded with minor chlorosis but otherwise is in fair condition. It will require a permit and mitigation if it is removed. It is a possible candidate for relocation onsite; see Relocation Specifications below.

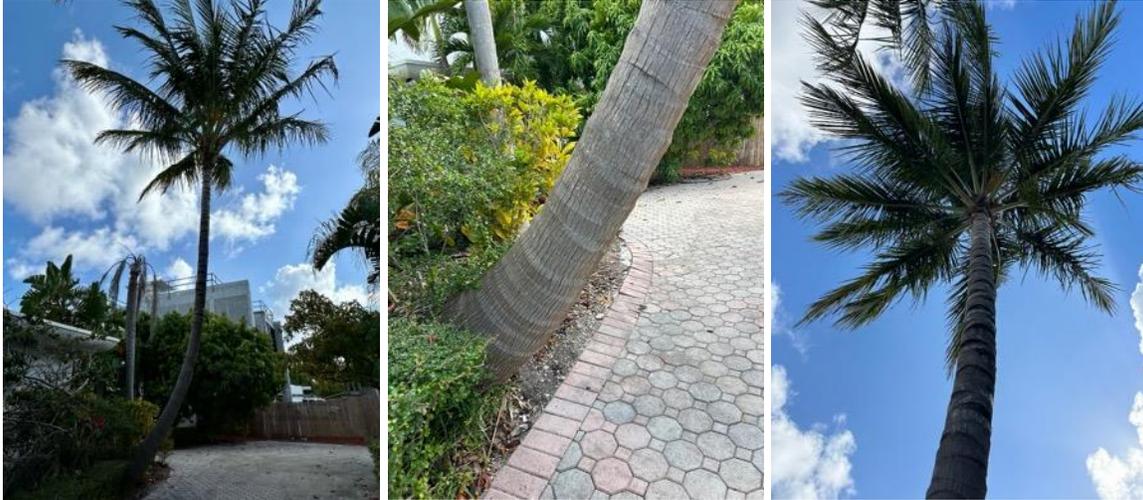
Tree #8 – *Cocos nucifera*, Coconut – this palm is located in a planting area on the north side of the driveway and west side of the entrance to the house. It is slightly crowded and is leaning over the driveway. It exhibits signs of minor nutrient deficiency but overall is in fair condition. This palm will likely require removal with a permit and mitigation, but if it remains it will require protection per measures below.

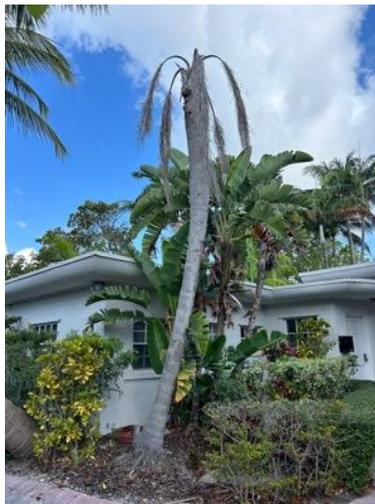
Tree #9 – *Syagrus romanzoffiana*, Queen Palm – this palm is located just northeast of Tree #8 on the west side of the front walkway/entrance. It is dead with no remaining live fronds. It should be eligible for removal without regulation, to be confirmed by the City.

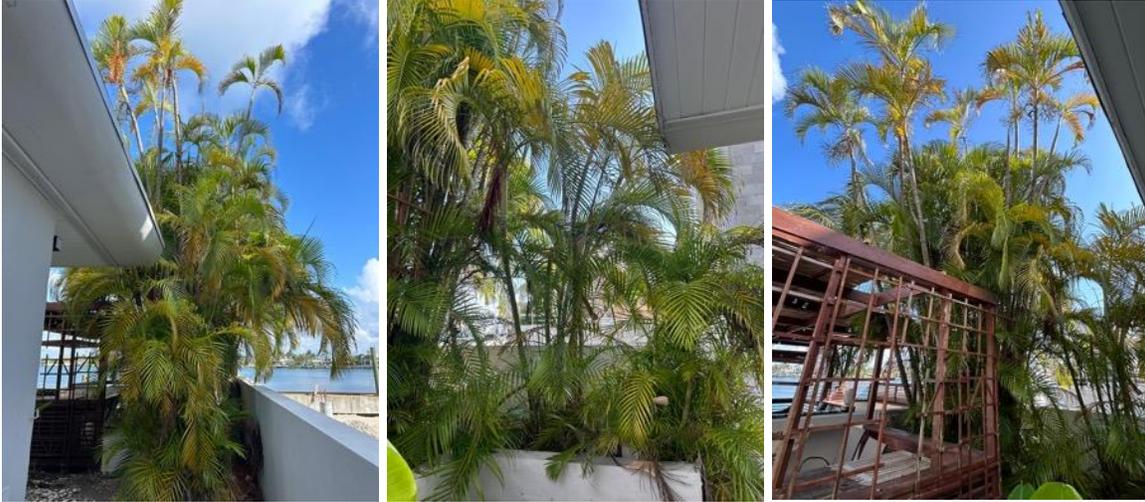
Trees #10-12 – *Dypsis lutescens*, Areca Palm – this refers to 3 Areca clusters growing in a planter on the southeast side of the wooden pergola in the northeast corner of the property. They are all crowded and chlorotic. Trees #10-11 are under regulation size and should be eligible for removal without regulation; Tree #12 is over regulation size and will require a permit and mitigation if it is removed.

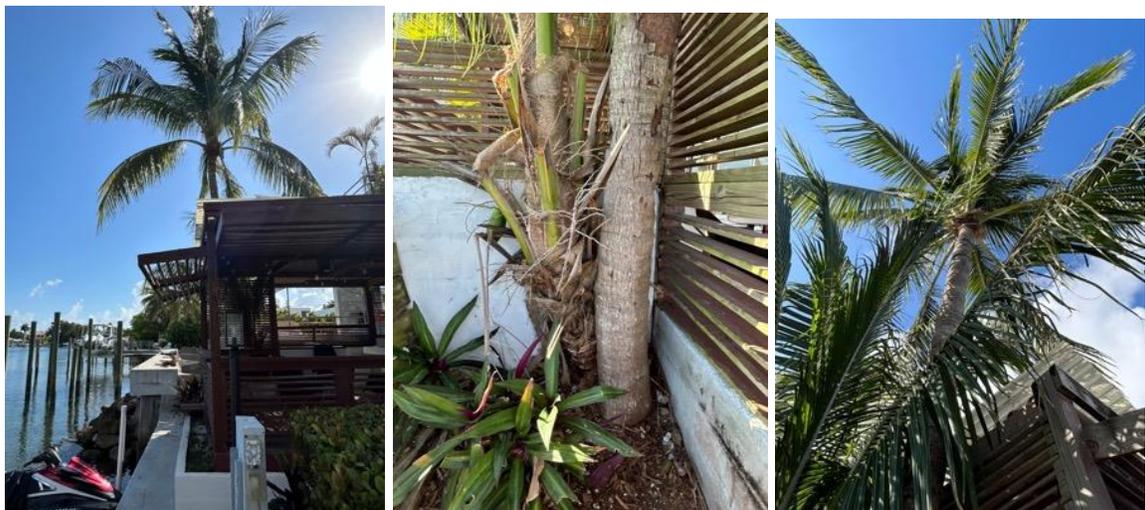
Tree #13 – *Cocos nucifera*, Coconut – this palm is growing in the northeast corner of the property near the seawall. It is growing next to a pergola and is within less than 1' of a CBS wall. It has moderate trunk damage but otherwise is in fair condition. It will require a permit and mitigation if it is removed. Otherwise, it will require very careful protection per measures below during all work activities, including demolition. There is a small seedling Coconut next to it with no clear trunk; it is under regulation size and should be eligible for removal without regulation.

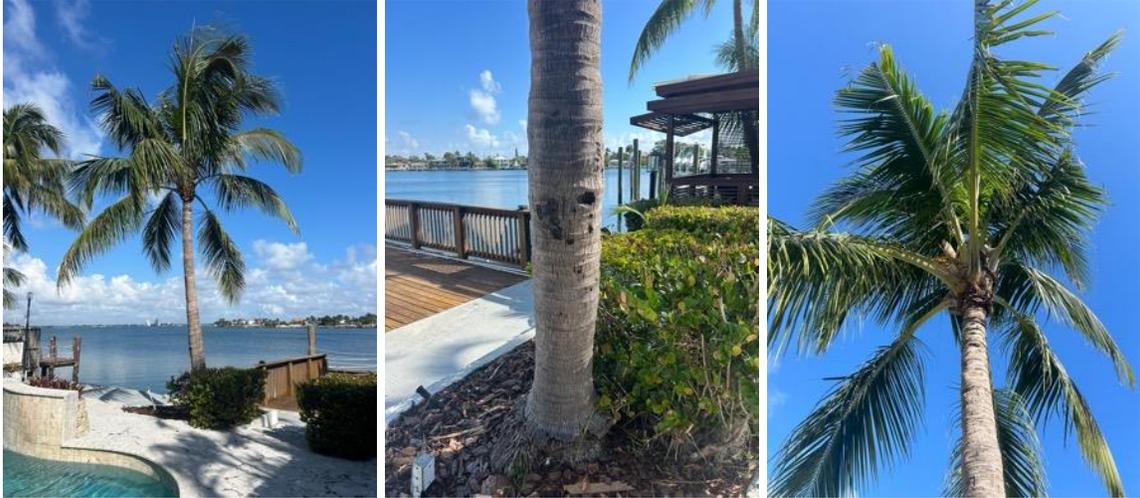
Tree #14 – *Cocos nucifera*, Coconut – this palm is growing on the north side of the pool in a small planting area near the seawall. It has minor trunk damage but otherwise is in fair condition. It will require a permit and mitigation if it is removed. Otherwise, it will require very careful protection per measures below during all work activities, including demolition.

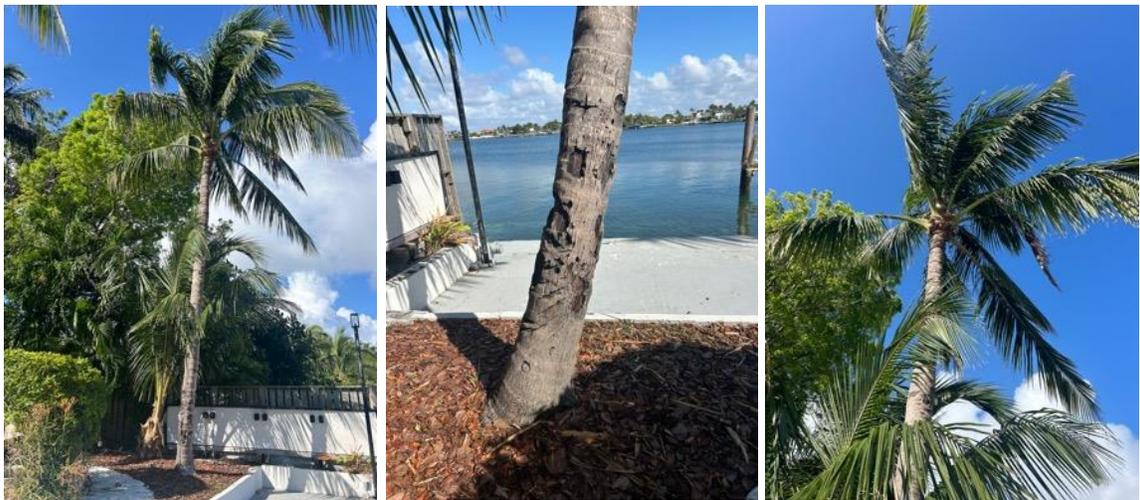
Tree #15 – *Cocos nucifera*, Coconut – this palm is growing on the northwest side of the property/pool area near the seawall and within 3’ of the limestone path. It has minor to moderate trunk damage but otherwise is in fair condition. It is a possible candidate to remain with protection due to its compact root zone and location near the perimeter of the property. Otherwise, it will require a permit and mitigation if it is removed. There is a small seedling Coconut approximately 5’ behind it with no clear trunk that should be eligible for removal without regulation.

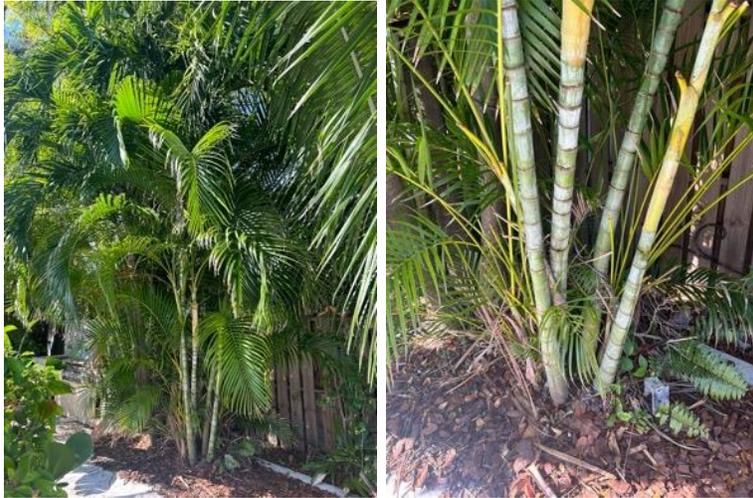
Tree #16 – *Dypsis lutescens*, Areca Palm – this palm is growing next to the property line in the northwest corner of the property. It is very crowded but otherwise in fair condition. It is under regulation height, so it should be eligible for removal without regulation if necessary. Otherwise, it is recommended for protection per measures below if it remains.

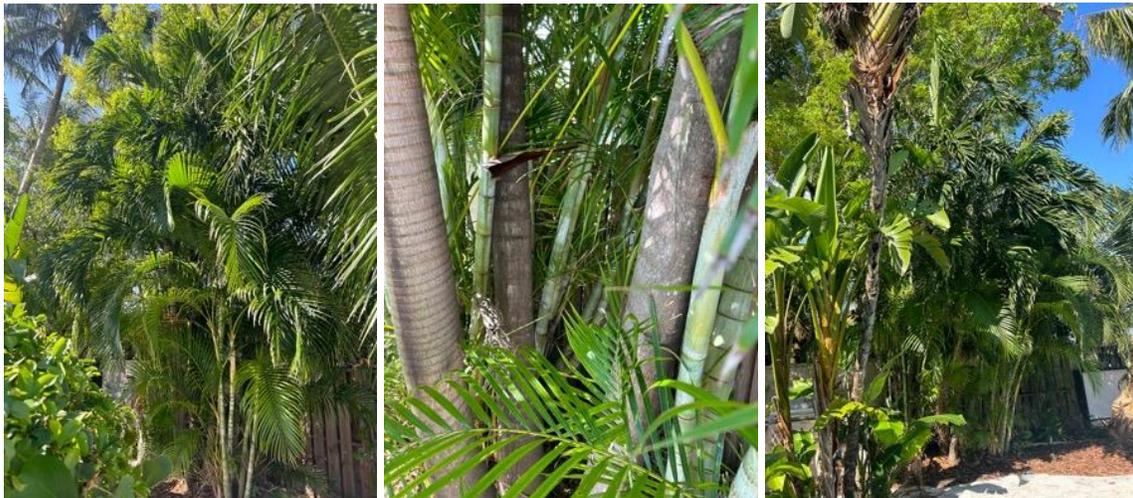
Tree #17 – *Adonidia merrillii*, Christmas Palm – this refers to a triple palm growing next to Tree #16. It is very crowded but otherwise in fair condition. It will require a permit and mitigation if it is removed, or protection per measures below if it remains.

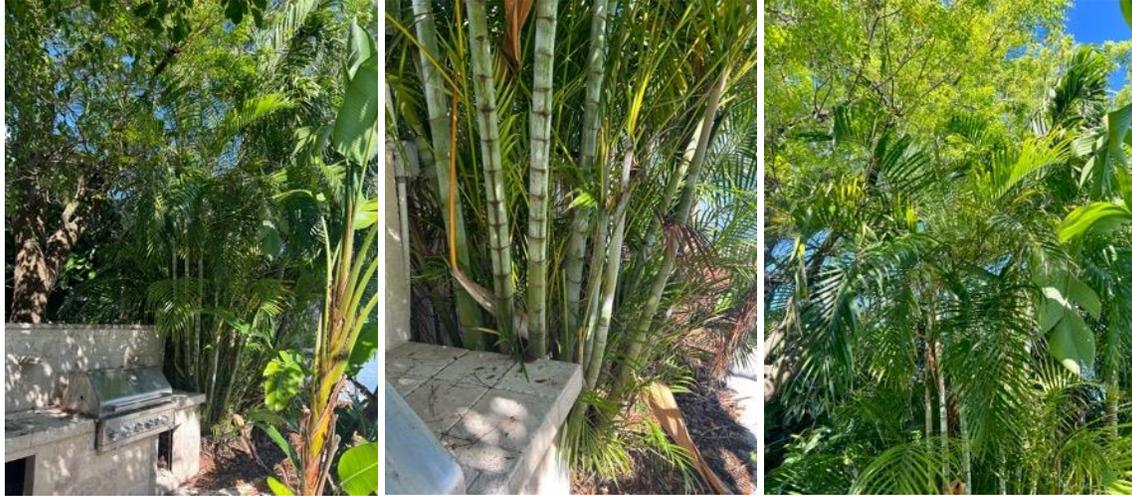
Tree #18 – *Dypsis lutescens*, Areca Palm – this refers to a small Areca cluster growing on the south side of Tree #17. It is very crowded but otherwise in fair condition. It is under regulation height, so it should be eligible for removal without regulation if necessary. Otherwise, it is recommended for protection per measures below if it remains.

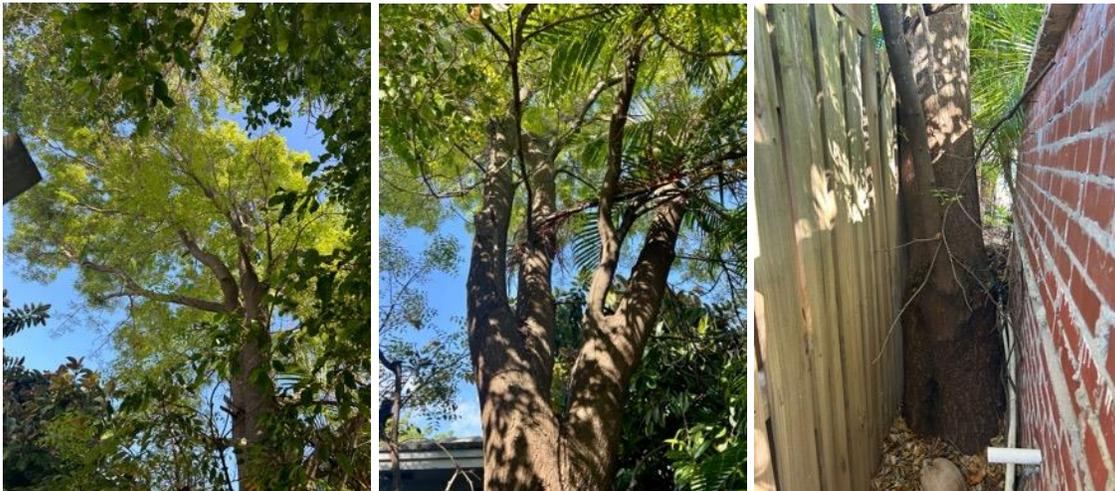
Tree #19 – *Swietenia mahogani*, Mahogany – this tree is growing between the fence line and an outdoor kitchen area on the northwest side of the property. It is very crowded and its DBH could not be exactly measured due to the fence. It has a somewhat poor branching structure with multiple areas of codominance and included bark. The canopy is constricted and is growing largely over the neighboring property with limited visibility. Overall, this tree appears to be in moderate to borderline fair condition. It will require careful protection per measures below if it remains onsite. Otherwise it will require a permit and mitigation if it is removed.

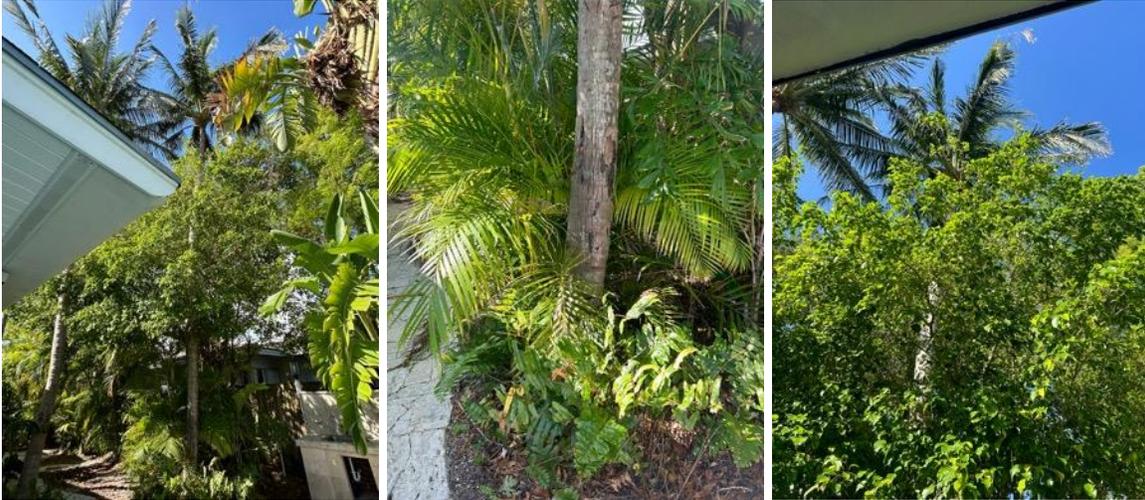
Tree #20 – *Cocos nucifera*, Coconut – this palm is growing along the walkway on the southwest side of the residence. It is crowded with minor trunk damage but otherwise is in fair condition. It will require a permit and mitigation if it is removed. Otherwise, it will require very careful protection per measures below during all work activities, including demolition.

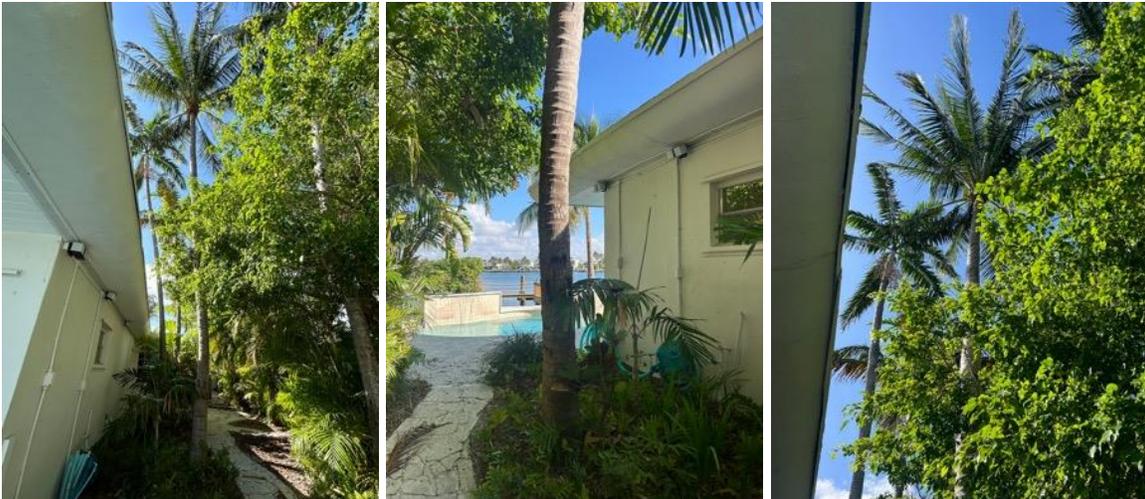
Tree #21 – *Cocos nucifera*, Coconut – this palm is growing on the opposite side of the walkway just southeast of Tree #20; it is within 2' of the path and 6' of the existing residence. It has minor to moderate trunk damage present but otherwise is in fair condition. It will require a permit and mitigation if it is removed. Otherwise, it will require very careful protection per measures below during all work activities, including demolition.

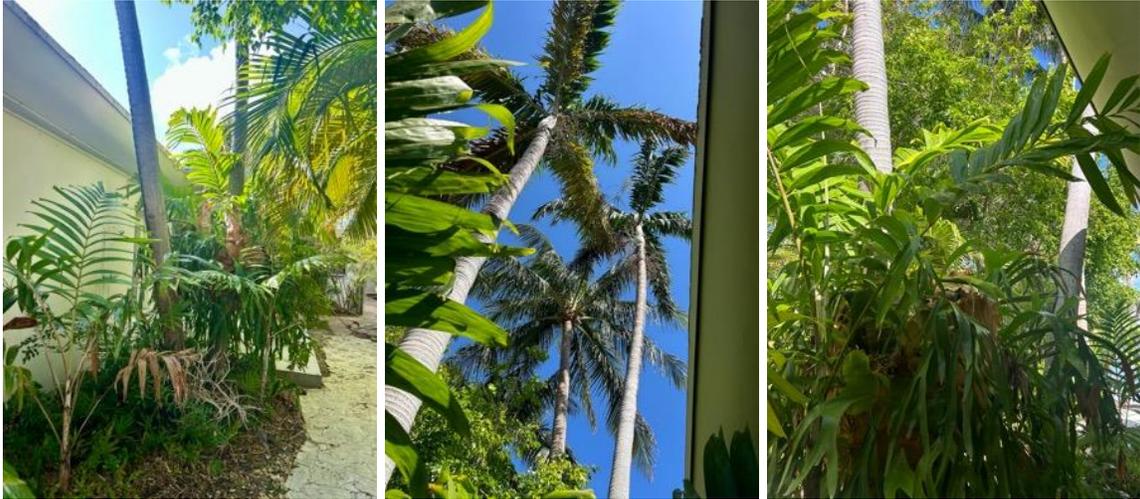
Trees #22-23 – *Veitchia arecina*, Montgomery Palm – this refers to 2 palms growing within less than 2’ of each other southeast of Tree #21 between the side walkway and the residence. They are both slightly crowded with some epiphytes growing up their trunks, but otherwise they are in fair condition. They will require careful protection per measures below during all work activities if they remain, or a permit and mitigation if they are removed. They are also possible candidates for relocation onsite per measures below as an alternative to removal; see Relocation Specifications below.

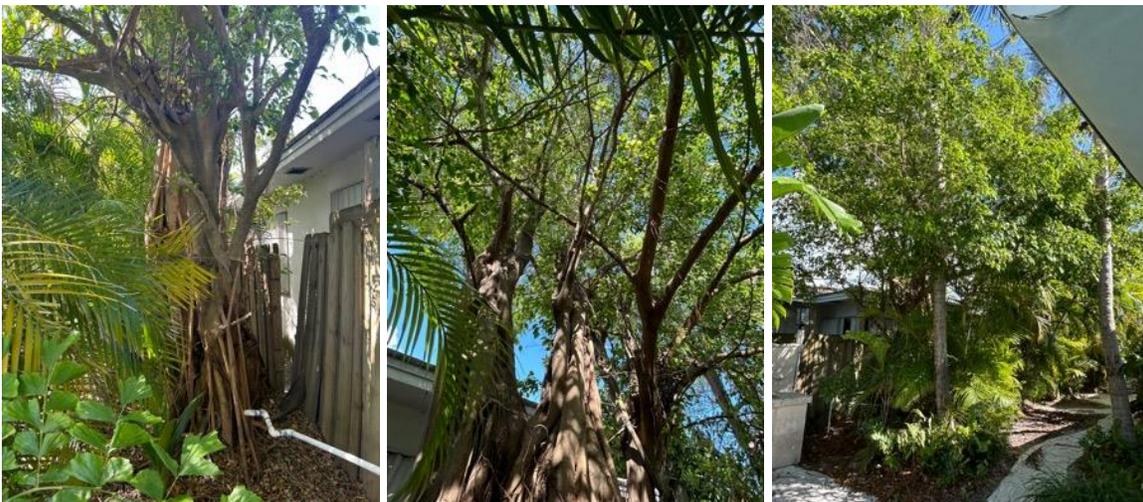
Tree #24 – *Ficus benjamina*, Weeping Fig – this tree is growing within less than 1’ of the west fence line just southeast of Tree #19 and the outdoor kitchen; it appears to be putting pressure on the fence which is broken in vicinity of this tree. It is crowded and somewhat overgrown with minor deadwood, small tears, and an uneven canopy due to pruning cuts over the neighboring property. Overall, it is in moderate condition. If it remains, it will require protection per measures below and is recommended for canopy cleaning/maintenance pruning per ANSI Standards. Otherwise, it will require a permit and mitigation if it is removed.

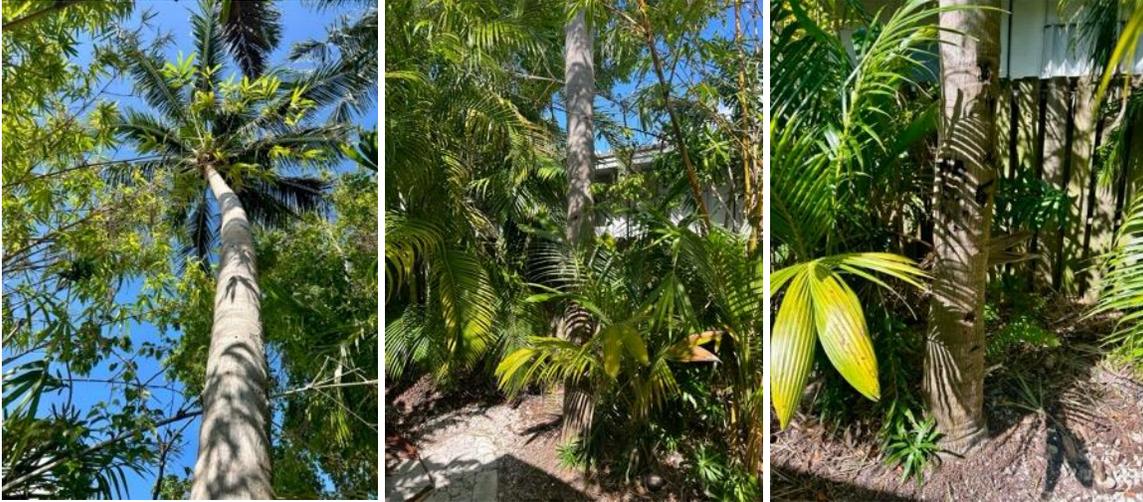
Tree #25 – *Dypsis lutescens*, Areca Palm – this palm is growing on the southeast side of Tree #24. It is crowded but otherwise in fair condition. It is under regulation size, so it should be eligible for removal without a permit or mitigation if necessary.

Tree #26 – *Cocos nucifera*, Coconut – this palm is growing slightly southeast of Tree #24 on the west side of the walkway. It is slightly crowded with minor trunk damage but otherwise is in fair condition. It will require a permit and mitigation if it is removed. Otherwise, it will require very careful protection per measures below during all work activities, including demolition.

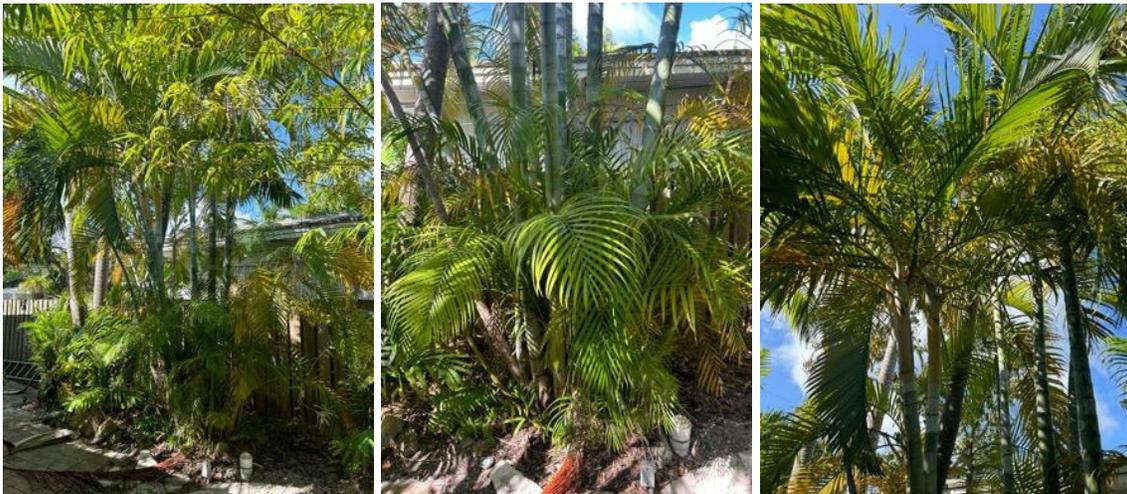
Tree #27 – *Dypsis lutescens*, Areca Palm – this palm cluster is growing approximately 7' southeast of Tree #26 and within 4' of the wall and 5' of the path on the west side of the property. It is crowded and overgrown but otherwise in fair condition. It is under regulation height so it should be eligible for removal without regulation if necessary.

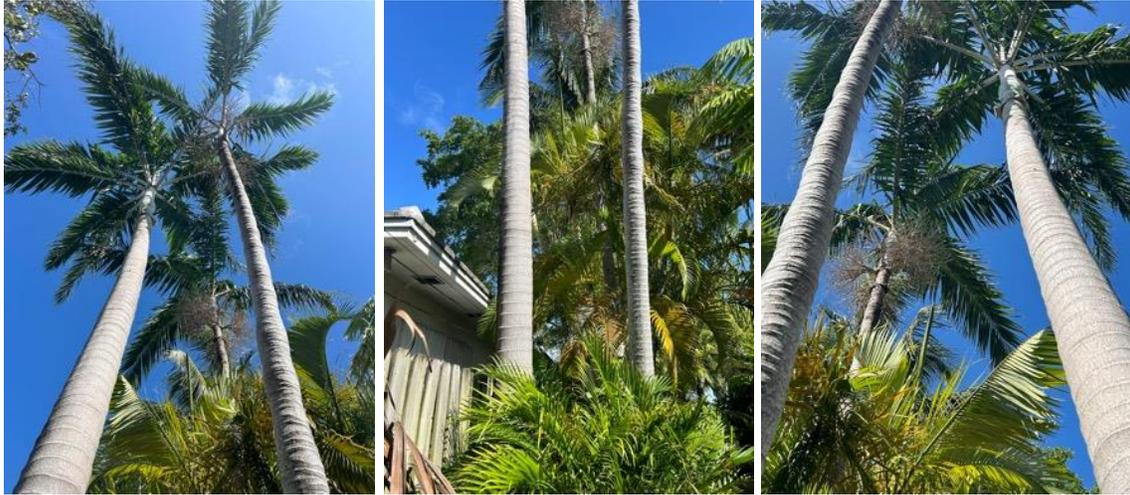
Trees #28-30 – *Veitchia arecina*, Montgomery Palm - this refers to 3 palms growing within approximately 3' of each other on the southeast side of Tree #27. They are all somewhat crowded but otherwise in fair to good condition. They are possible candidates to remain with protection during construction per measures below due to their compact root zones and location on the perimeter of the property. If they are removed, they will require a permit and mitigation. They are also possible candidates for relocation onsite as an alternative to removal; see Relocation Specifications below.

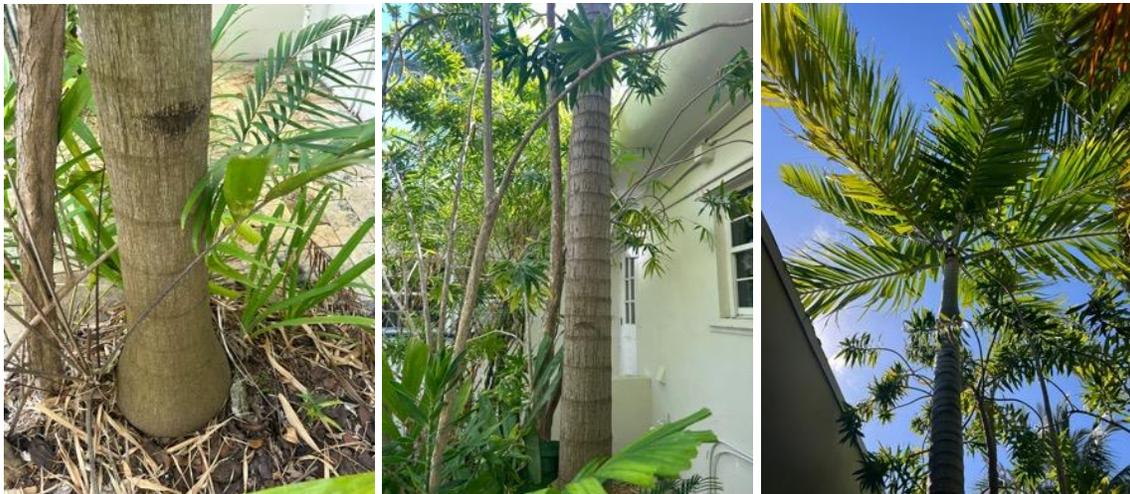
Tree #31 – *Veitchia arecina*, Montgomery Palm – this palm is growing on the south side of the AC unit on the east side of the path. It is slightly crowded and slightly chlorotic, but overall it is in fair condition. It is just under regulation height, so it may be eligible for removal without a permit or mitigation.

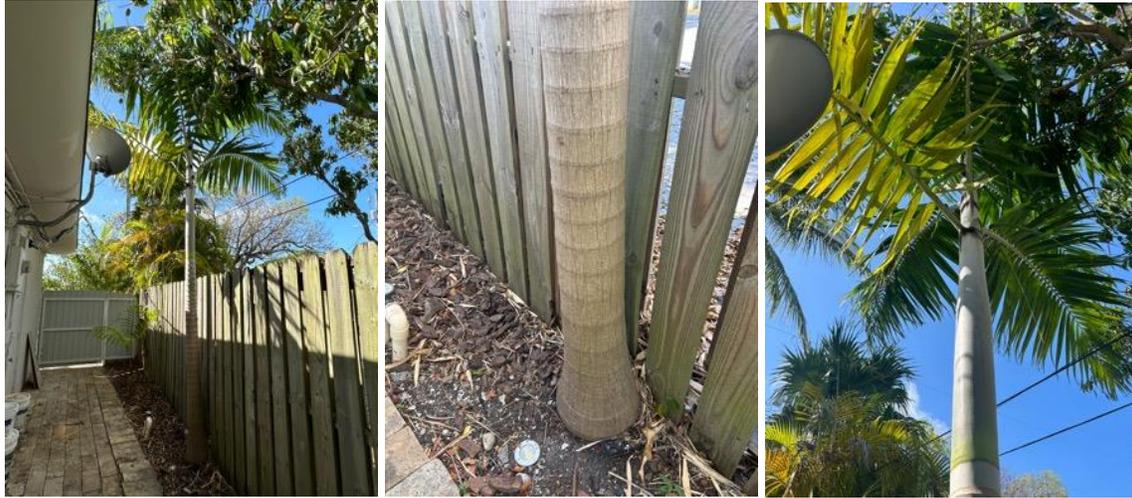
Tree #32 – *Veitchia arecina*, Montgomery Palm – this palm is growing against the fence line near the southwest corner of the existing residence. It is likely a volunteer/seedling. It is slightly crowded and slightly chlorotic but overall in fair condition. It is just under regulation size, so it should be eligible for removal without a permit or mitigation. It is also a possible candidate for relocation onsite per specifications below.

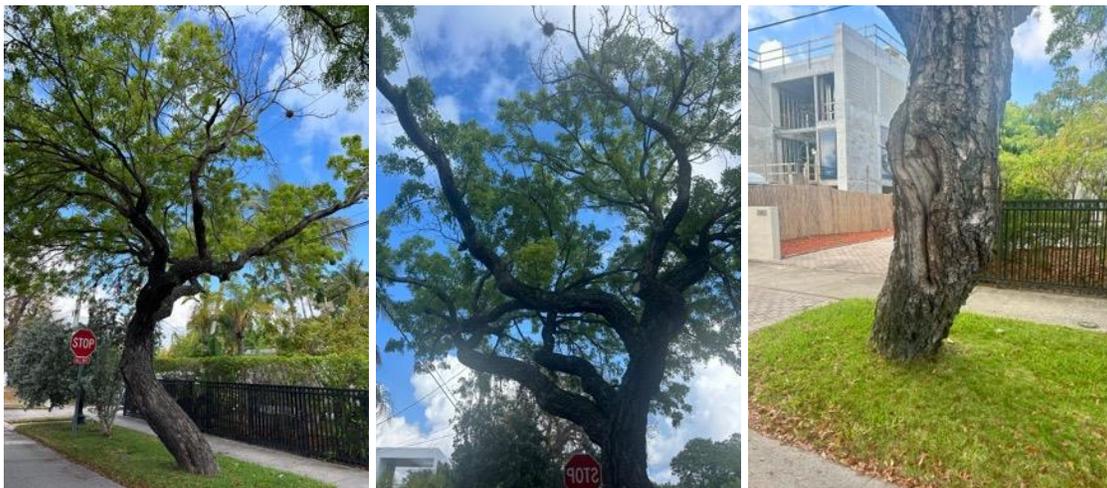
Tree #33 – *Swietenia mahogani*, Mahogany – this tree is growing in the ROW. It is leaning slightly and has a somewhat poor branching structure. It is growing in contact with the adjacent utility lines and there are poor cuts with deadwood, dieback and localized decay in this area. There is also a large tear on the trunk from approximately 3.5-5.5' height; it has been fairly well compartmentalized. Overall, this tree is in moderate to borderline fair condition. It will require careful protection per measures below during any staging/access activities within its TPZ, or a permit and likely doubled mitigation if it is removed due to its specimen size.

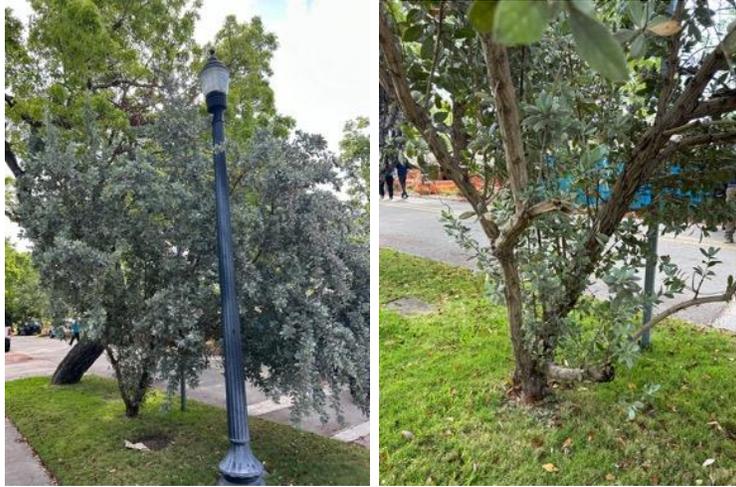
Tree #34 – *Conocarpus erectus* var. *sericeus*, Silver Buttonwood – this tree is growing just southwest of Tree #1 in the ROW. It splits into multiple small diameter trunks near ground level with some small tears present along the trunk and lower limbs. It is slightly crowded but otherwise is in fair condition. It is under regulation height, but it is recommended for protection per measures below during all staging/access activities.

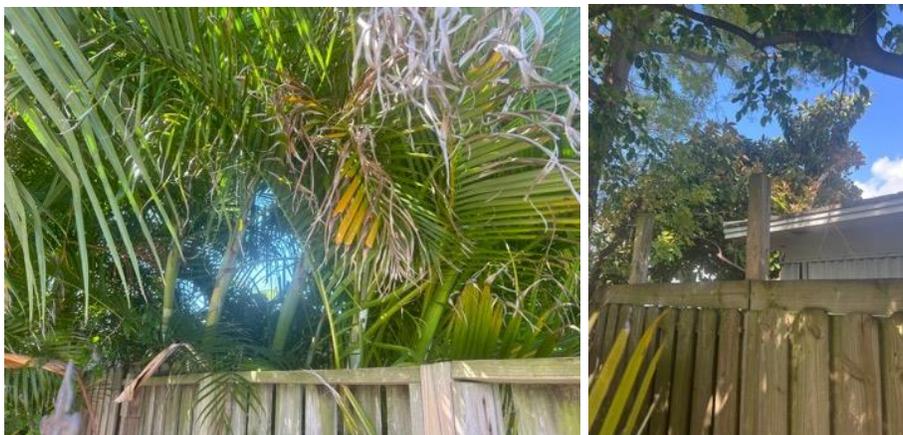
***Dypsis lutescens*, Areca Palm** – this palm cluster is growing outside of the northwest fence line adjacent to Trees #16-18. It is under regulation size. Its TPZ extends less than 1' over the property line, so it is not expected to be impacted, but protection measures below apply.

***Ficus elastica*, Rubber Tree** – this tree is growing on the property to the west adjacent to the backyard. Neither its canopy nor TPZ extend over the property line, so it is not expected to be impacted. In the unlikely event that any roots are encountered on this property, root pruning specifications below apply.

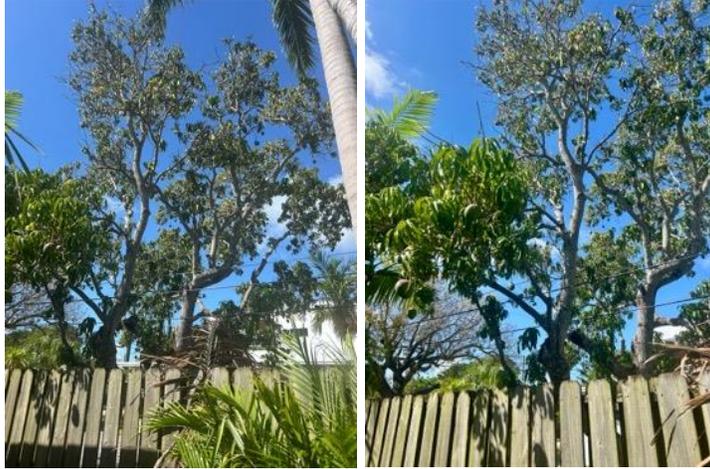
***Mangifera indica*, Mango** – this tree is located on the property to the west. Its trunk is not clearly visible but there is one limb extending approximately 4’ over the property line. This tree will require very careful protection if any work activities take place within its TPZ. Canopy pruning and root pruning specifications below apply.

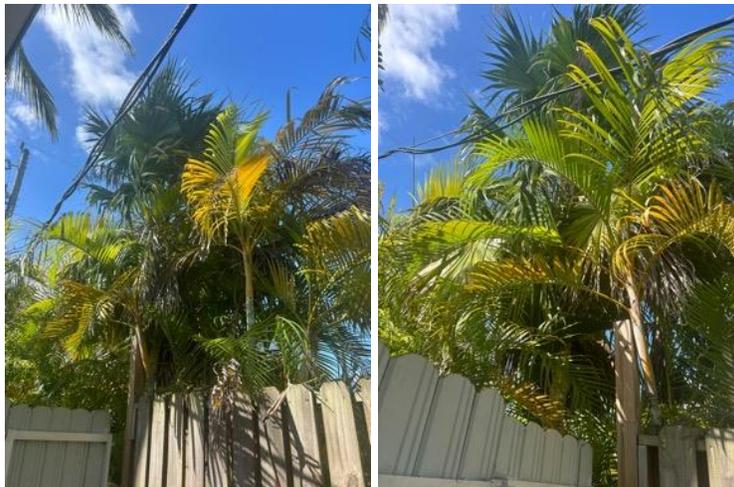
***Dypsis lutescens*, Areca Palm** – this palm cluster is growing outside of the southwest fence line adjacent to Tree #32. It is chlorotic and under regulation size. Its TPZ extends less than 1’ over the property line, so it is not expected to be impacted, but protection measures below apply.

***Thrinax radiata*, Thatch Palm** – this palm is growing in the cluster of Areca Palms on the southwest side of this residence. Its TPZ does not extend over the property line and it should not be impacted.
