## Arborist Report

The Standard Hotel  
40 Island Avenue  
Miami Beach

1/24/2024

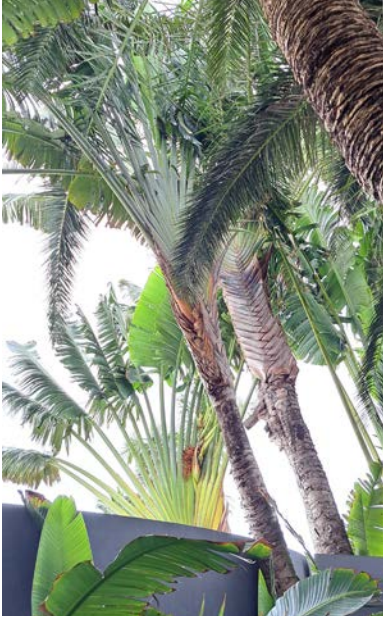
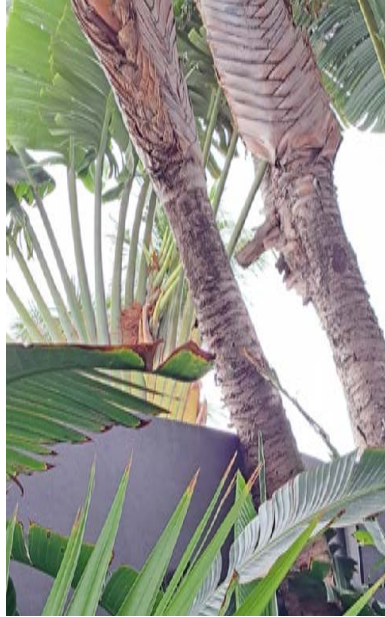
## Tree #3818

Tree #3818 is a Travelers Palm located on the north side of the central gardens. It is in good condition with healthy green fronds.

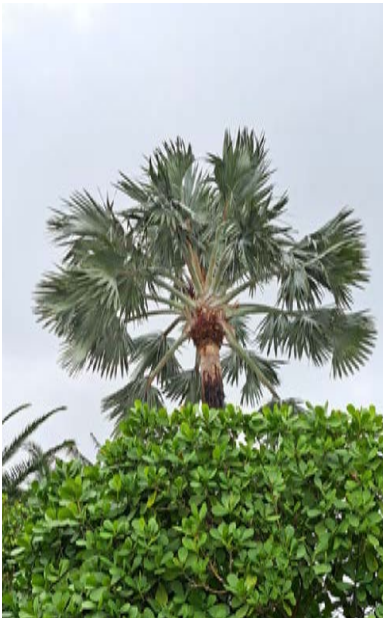
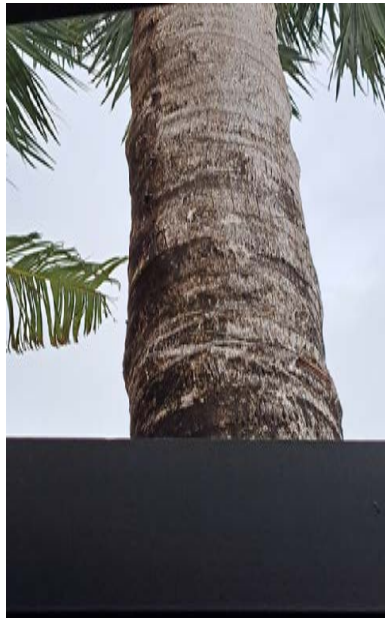
## Tree #3820

Tree #3820 is a Bismarck Palm located on the south side of the pool area. It is in good condition.

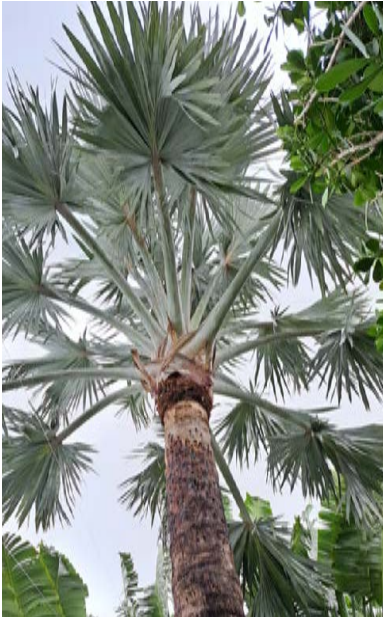
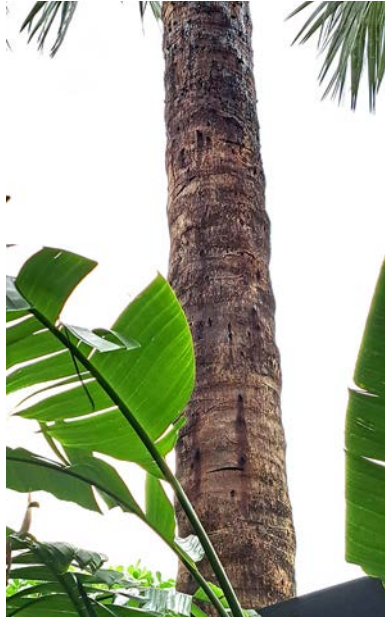
## Tree #3832

Tree #3832 is a Bismarck Palm located on the south side of the pool area. It is in fair condition with bleeding cankers on trunk

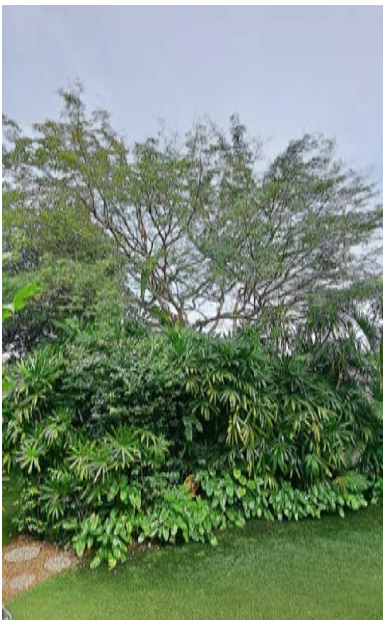
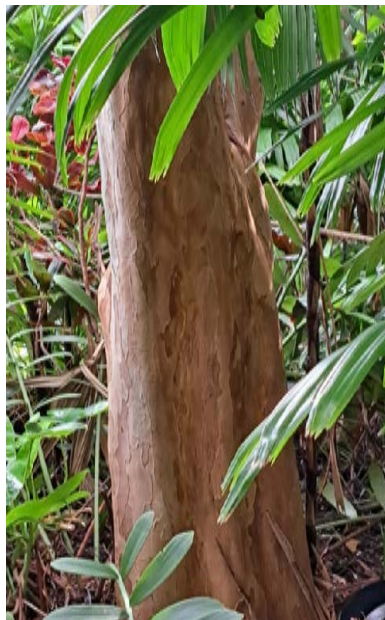
## Tree #3849

Tree #3849 is a Bridal Veil located on the east side of the central gardens. It is in good condition with a nice, spreading form and little deadwood.

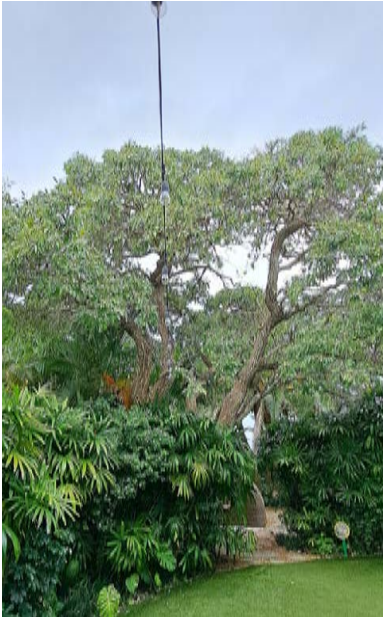
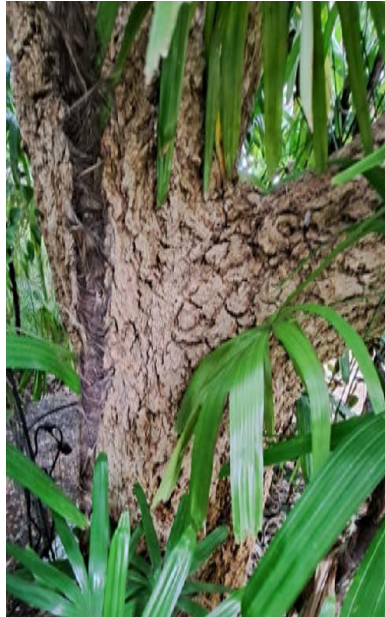
## Tree #3862

Tree #3862 is a Silver Trumpet Tree located in the central gardens. It is in good condition with a nice form. Some small deadwood is present. Prune to remove deadwood and broken limbs.

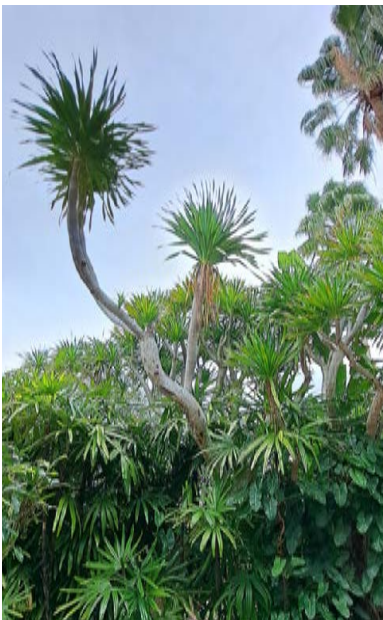
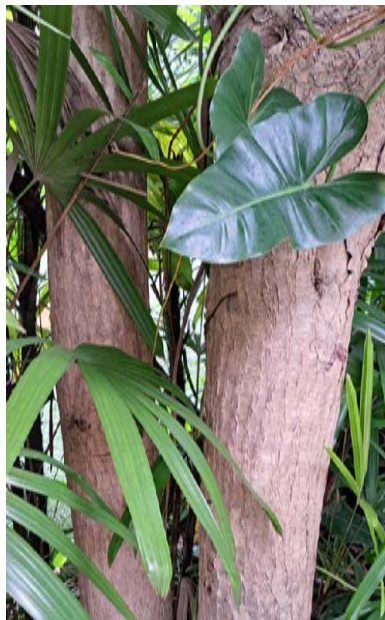
## Tree #3896

Tree #3896 is a Screw Pine located on the west side of the central gardens. It is in fair condition and appears to have been hatracked years ago. There are injuries on a main limb. It is double-trunked.

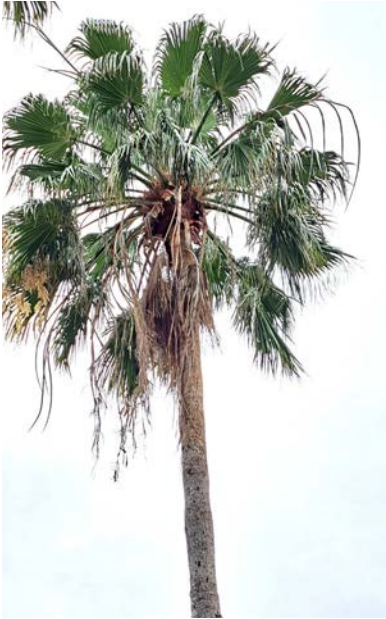
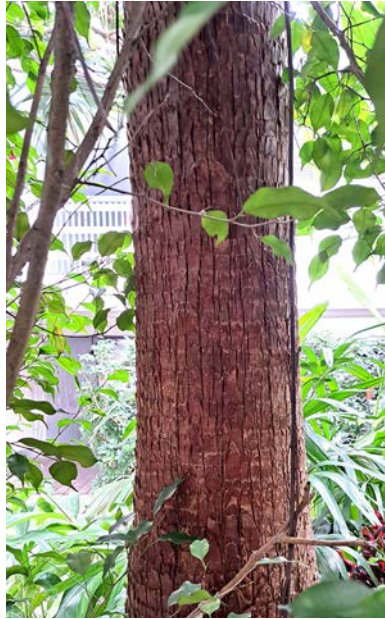
## Tree #3900

Tree #3900 is a Washingtonia Palm located on the south side of the central gardens. It is in fair condition. Prune to remove the lower dead fronds.

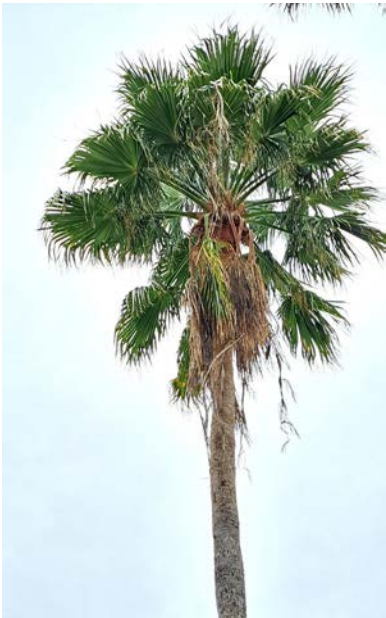
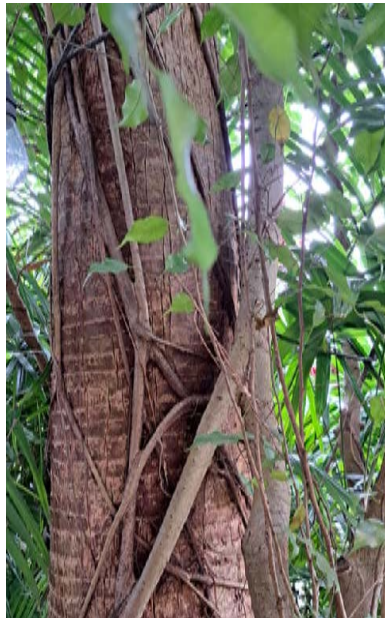
## Tree #3900B

Tree #3900B is a Washingtonia Palm located on the south side of the central gardens. It is growing through the Ficus hedge. It is in fair condition. Prune to remove the lower dead fronds.

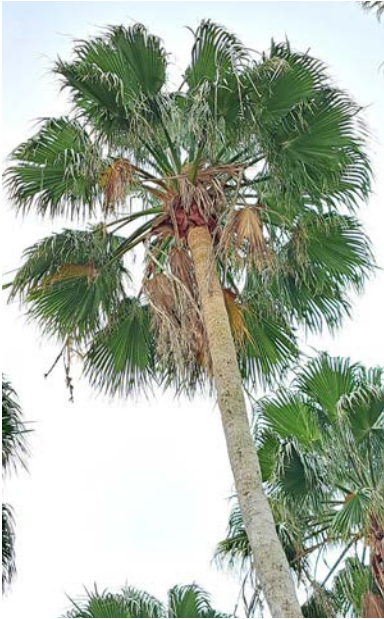
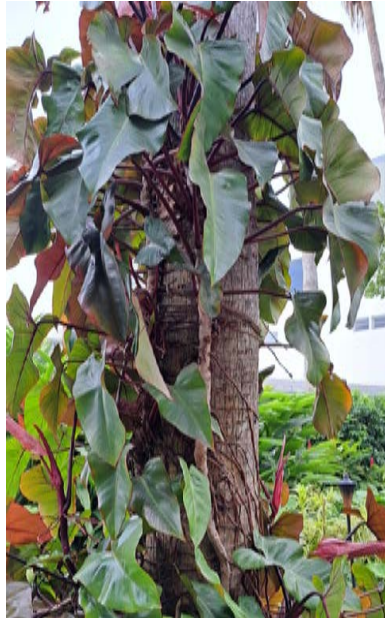
## Tree #3913

Tree #3913 is a Washingtonia Palm located along the central boardwalk area. It is in fair condition. Prune to remove the lower dead fronds.

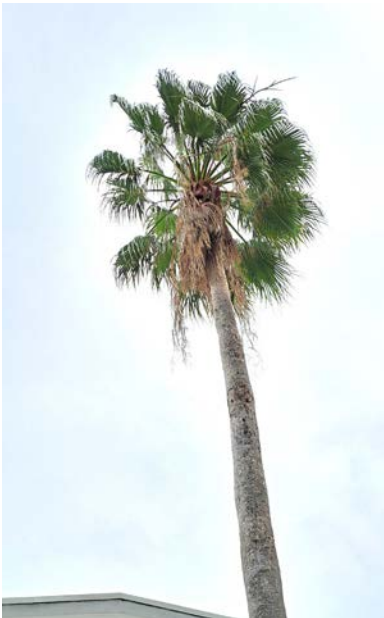
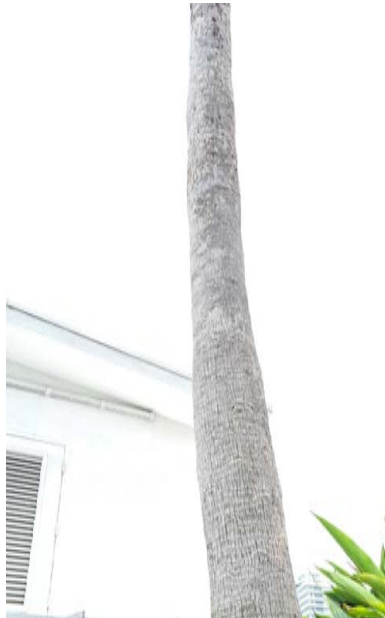
## Tree #3914

Tree #3914 is a Washingtonia Palm located along the central boardwalk area. It is in fair condition with some lower dead fronds and a pencilling trunk.

**Disposition -** REMOVE

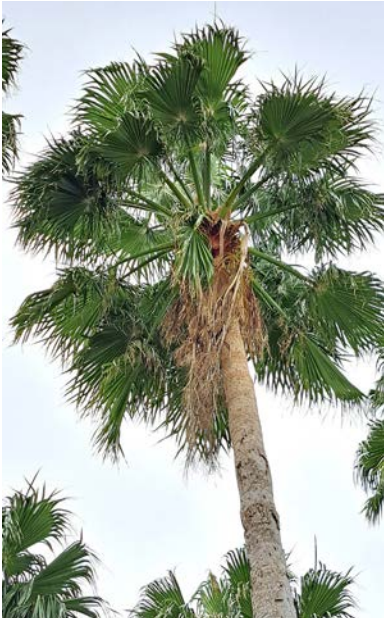
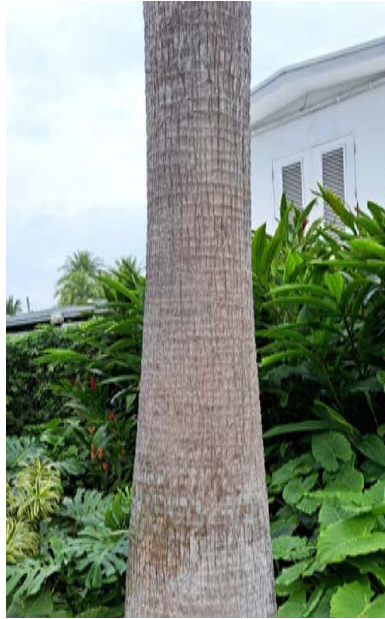
## Tree #3915

Tree #3915 is a Washingtonia Palm located along the central boardwalk area. It is in fair condition. Prune to remove the lower dead fronds.

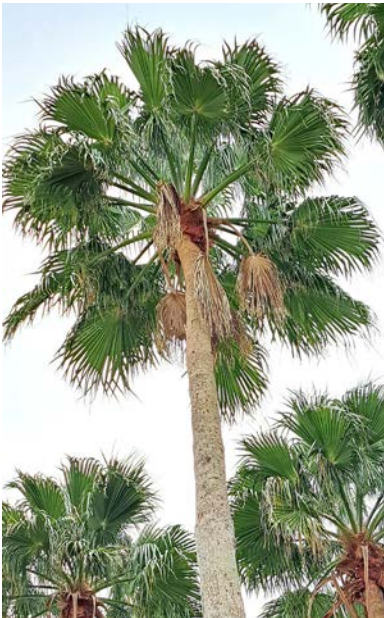
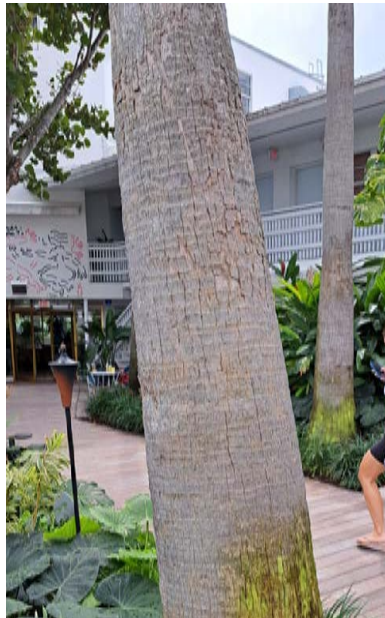
## Tree #3916

Tree #3916 is a Washingtonia Palm located along the central boardwalk area. It is in fair condition. Prune to remove the lower dead fronds.

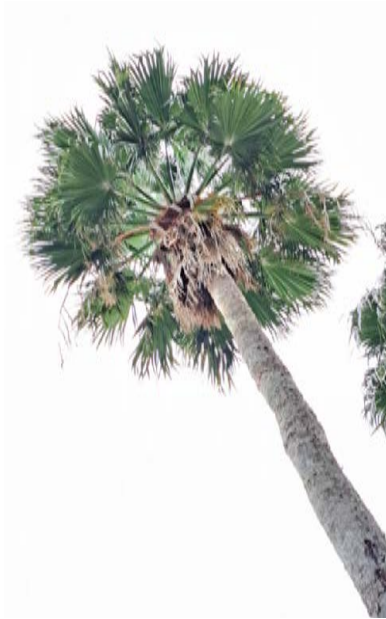
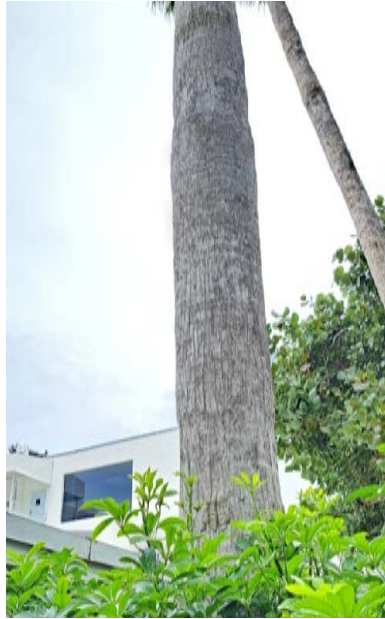
## Tree #3917

Tree #3917 is a Washingtonia Palm located along the central boardwalk area. It is in fair condition with some lower dead fronds.

**Disposition - REMOVE**

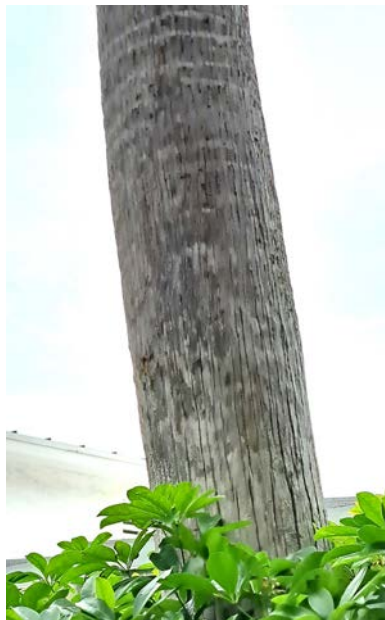
## Tree #3918

Tree #3918 is a Washingtonia Palm located along the central boardwalk area. It is in fair condition with some lower dead fronds.

**Disposition - REMOVE**

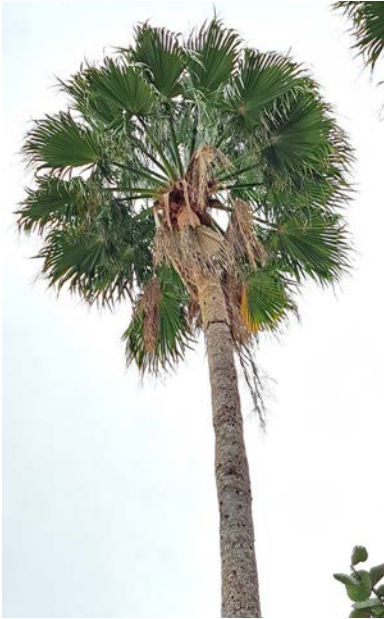
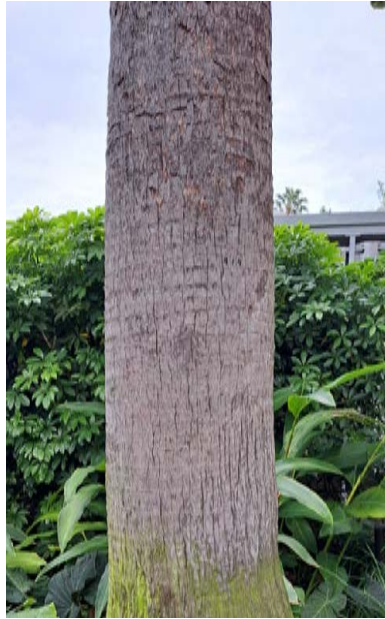
## Tree #3919

Tree #3919 is a Washingtonia Palm located along the central boardwalk area. It is in fair condition. Prune to remove the lower dead fronds.

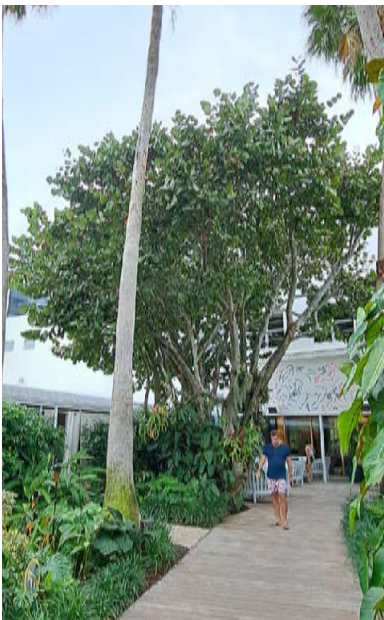
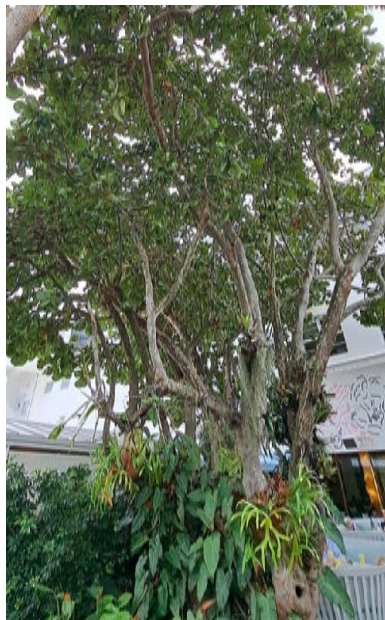
## Tree #3920

Tree #3920 is a large Seagrape located along the central boardwalk area. It is triple-trunked and in fair condition. The canopy is dense and crown spread appears to have been reduced over the years. There is an old cavity on one of the trunks that has nearly closed over. There is some deadwood and crossing limbs. Staghorn ferns and other epiphytes are growing on the tree.

This tree is a fine candidate for relocation. Prune to remove deadwood and broken limbs.

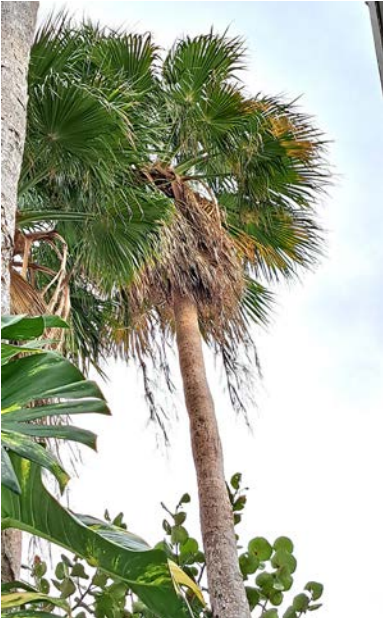
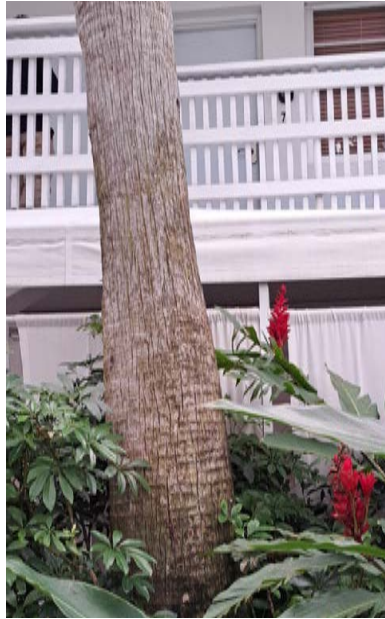
## Tree #3922

Tree #3922 is a Washingtonia Palm located along the central boardwalk area. It is in fair condition with some lower dead fronds.

**Disposition -** REMOVE

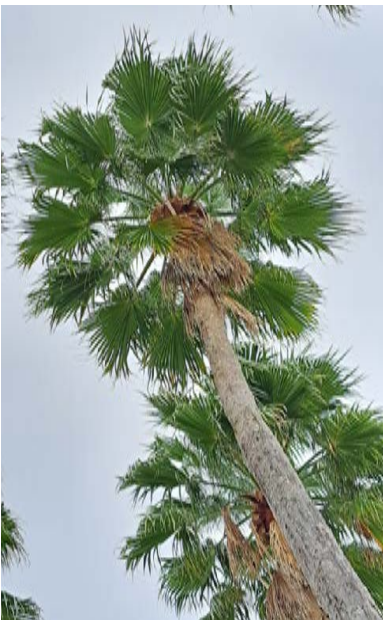
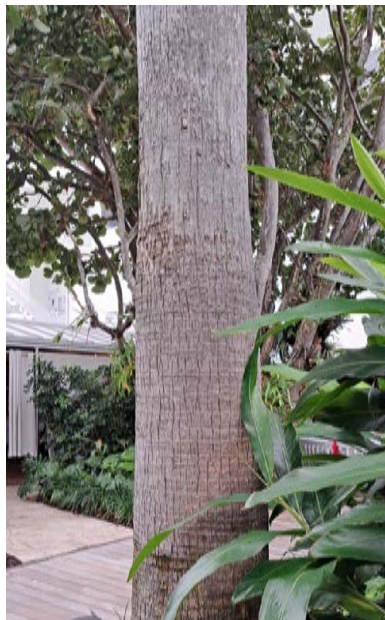
## Tree #3923

Tree #3923 is a Washingtonia Palm located along the central boardwalk area. It is in fair condition. Prune to remove the lower dead fronds.

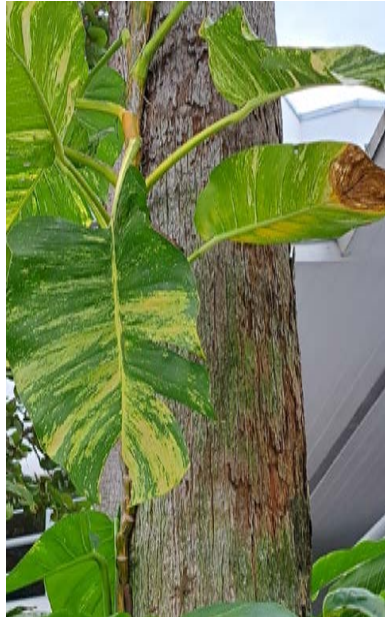
## Tree #3924

Tree #3924 is a Washingtonia Palm located along the central boardwalk area. It is in fair condition with some lower dead fronds. Pseudobark is sloughing off trunk.

**Disposition - REMOVE**

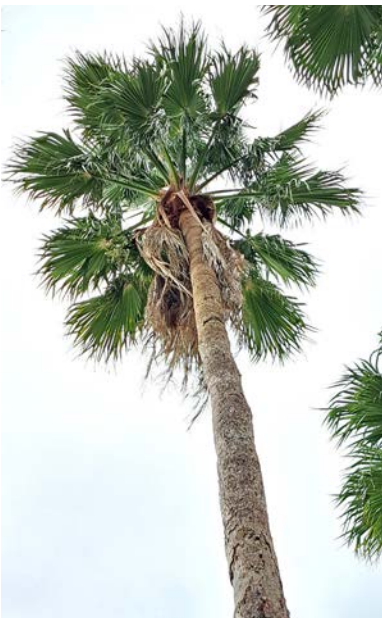
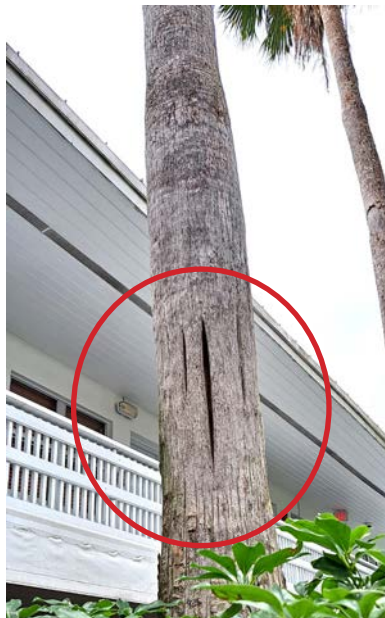
## Tree #3925

Tree #3925 is a Washingtonia Palm located along the central boardwalk area. It is in poor condition with some lower dead fronds. Trunk cracks are present (circled in red).

**Disposition - REMOVE**

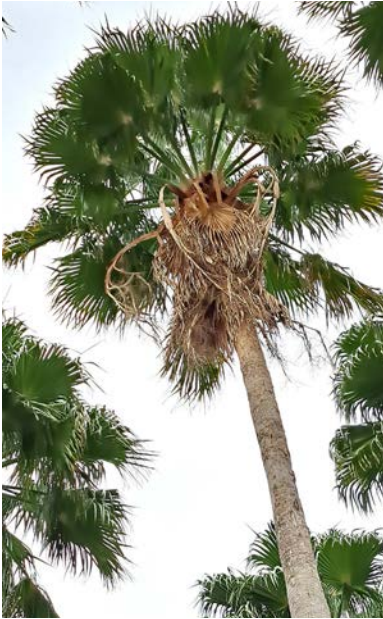
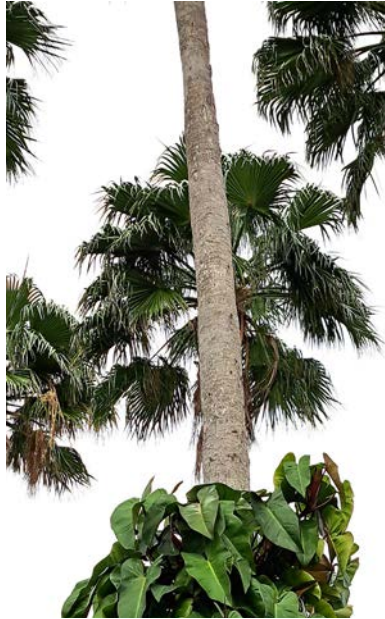
## Tree #3926

Tree #3926 is a Washingtonia Palm located along the central boardwalk area. It is in fair condition. Prune to remove the lower dead fronds.

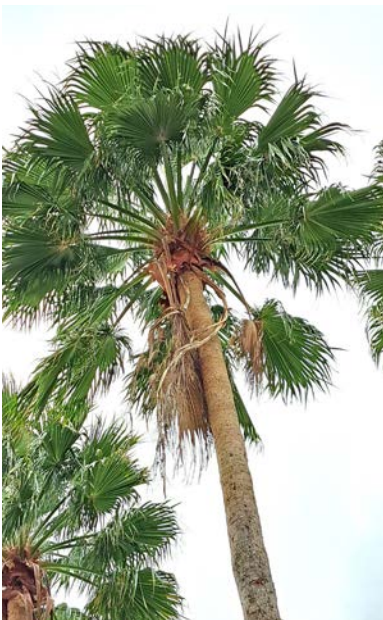
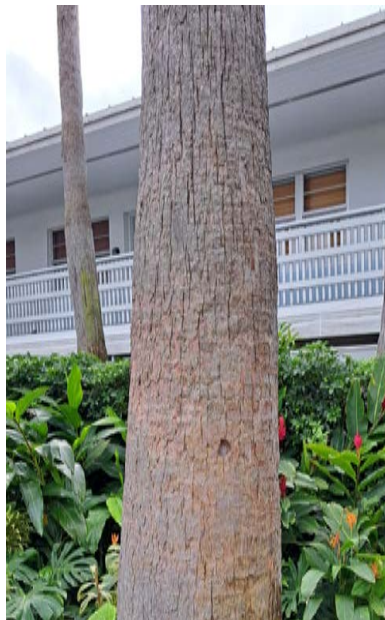
## Tree #3927

Tree #3927 is a Washingtonia Palm located along the central boardwalk area. It is in fair condition. Prune to remove the lower dead fronds.

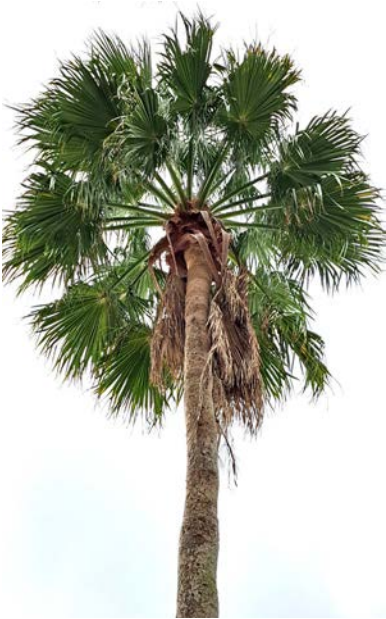
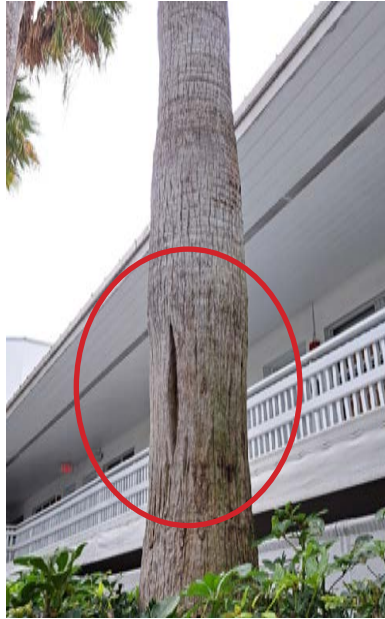
## Tree #3928

Tree #3928 is a Washingtonia Palm located along the central boardwalk area. It is in poor condition with some lower dead fronds. Trunk cracks are present (circled in red).

**Disposition -** REMOVE

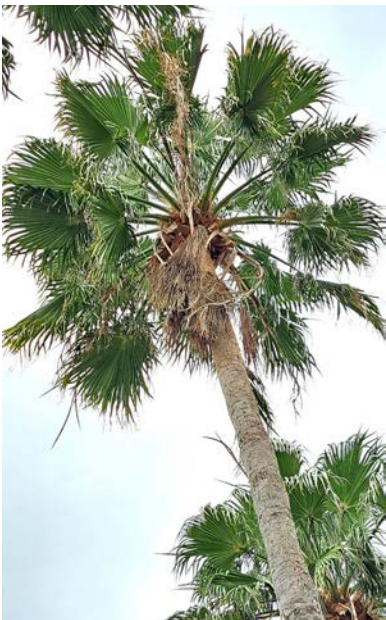
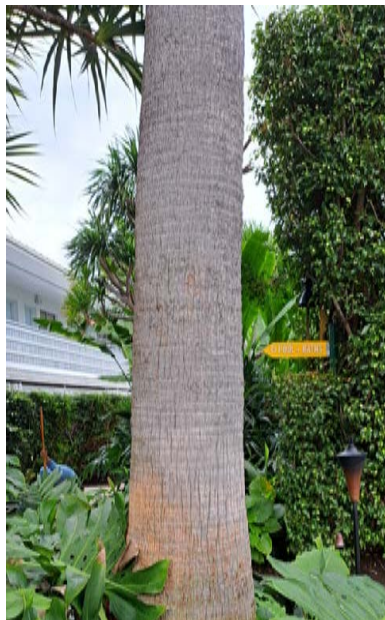
## Tree #3929

Tree #3929 is a Washingtonia Palm located along the central boardwalk area. It is in fair condition. Prune to remove the lower dead fronds.

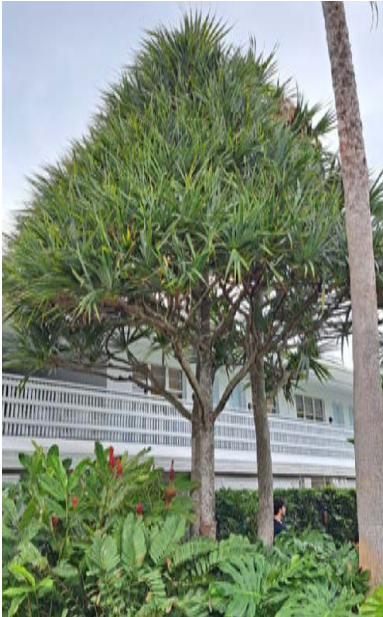
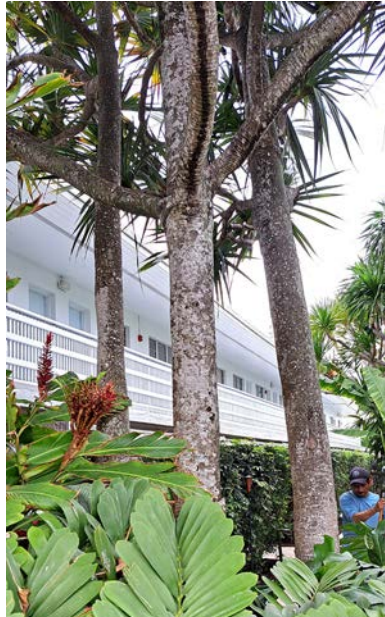
## Tree #3930

Tree #3930 is a Screw Pine located along the central boardwalk area. It is triple-trunked and in good condition. It has been pruned into a tight, pyramidal shape.

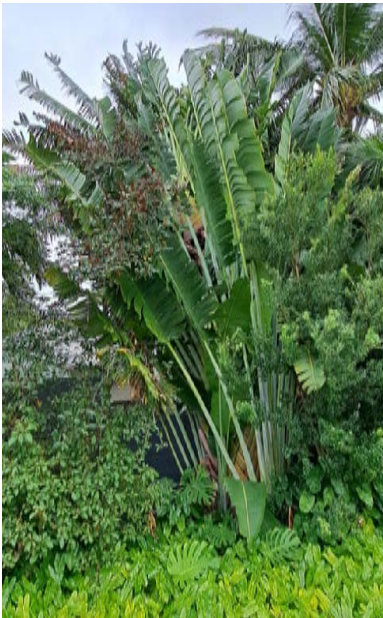
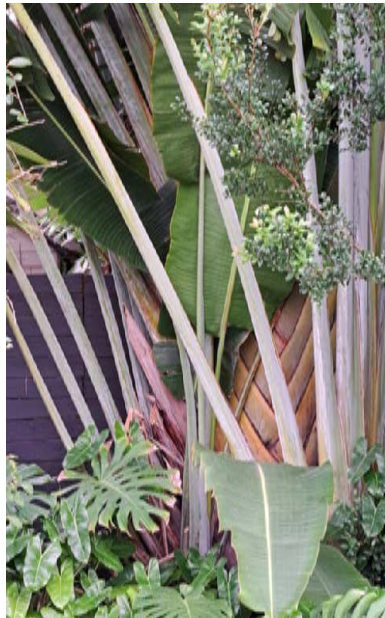
## Tree #3943

Tree #3943 is a Travelers Palm located on the east side of the property. It is in good condition with some tattered fronds.

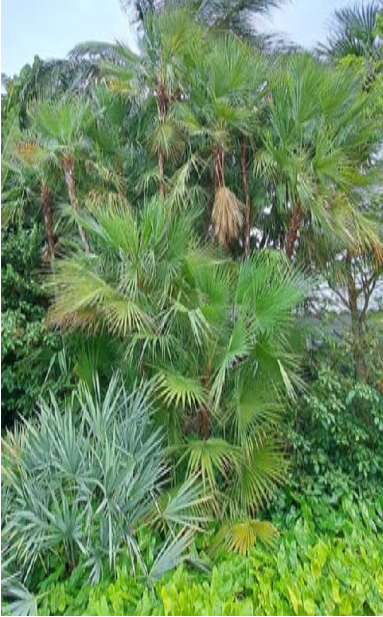
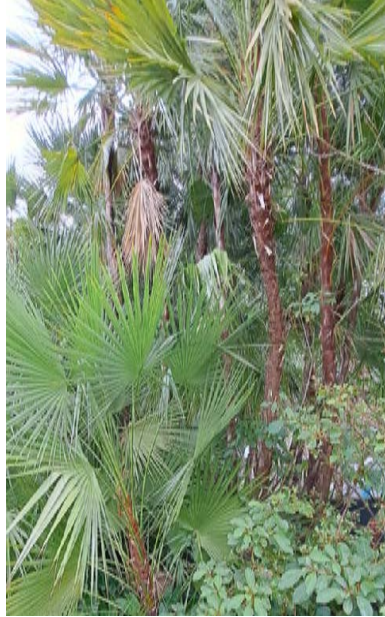
## Tree #3945

Tree #3945 is an Everglades Palm located on the east side of the property. It is multi-trunked and in good condition.

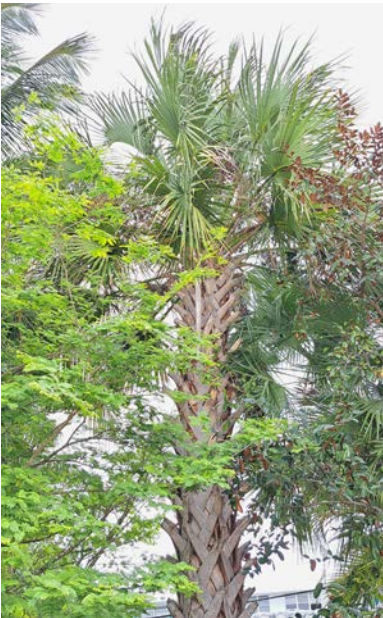
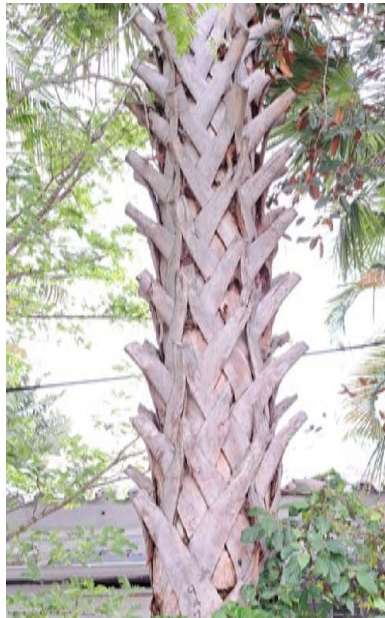
## Tree #3947

Tree #3947 is a Cabbage Palm located on the east side of the property. It is in good condition.

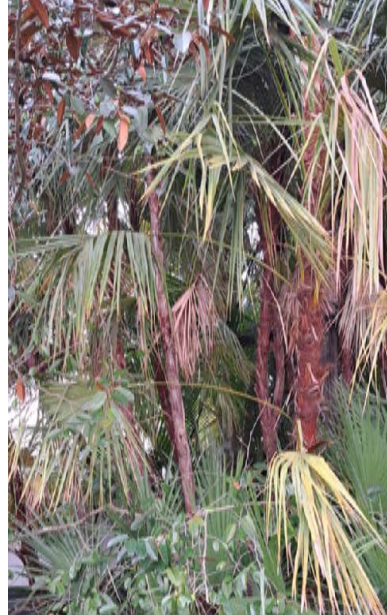
## Tree #3949

Tree #3949 is an Everglades Palm located on the east side of the property. It is multi-trunked and in fair condition with some yellowing fronds.

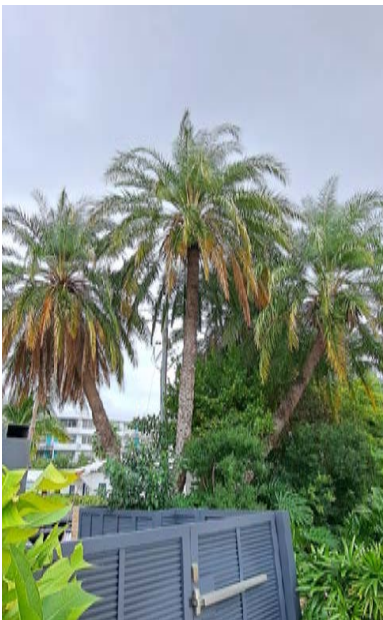
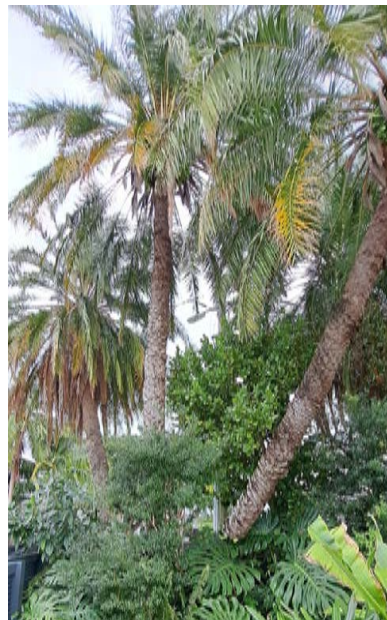
## Trees #3952 - 3955

Trees #3952 - 3955 are four Date Palms located on the east side of the property. They are in fair condition with some lower yellowing and brown fronds. Prune to remove the lower dead fronds.

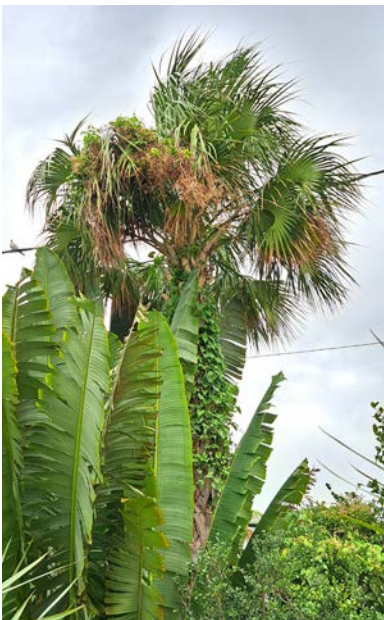
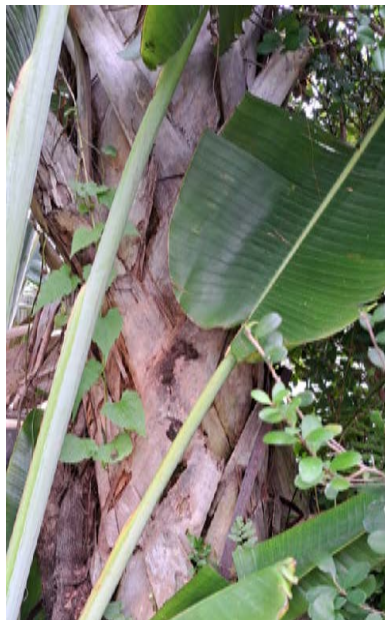
## Tree #3960

Tree #3960 is a Cabbage Palm located on the east side of the property. It is in fair condition. Remove the vines that are growing into the canopy.

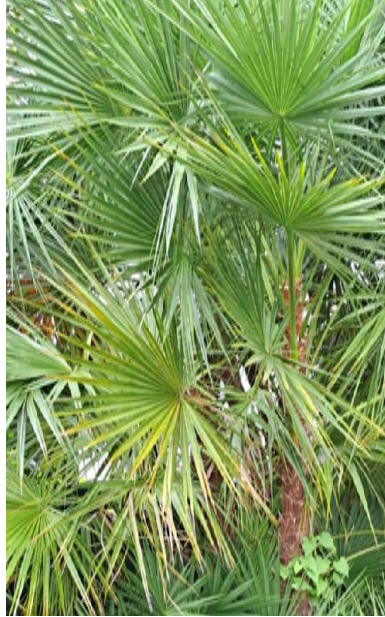
## Tree #3965

Tree #3965 is an Everglades Palm located on the east side of the property. It is multi-trunked and in good condition.

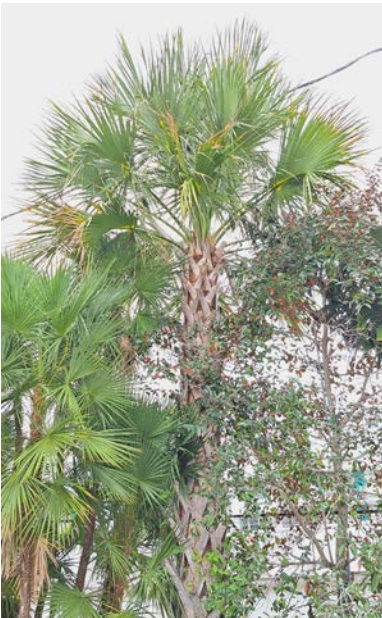
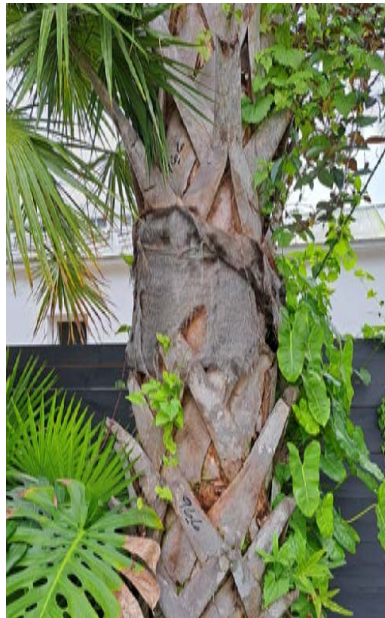
## Tree #3966

Tree #3966 is a Cabbage Palm located on the east side of the property. It is in fair condition.

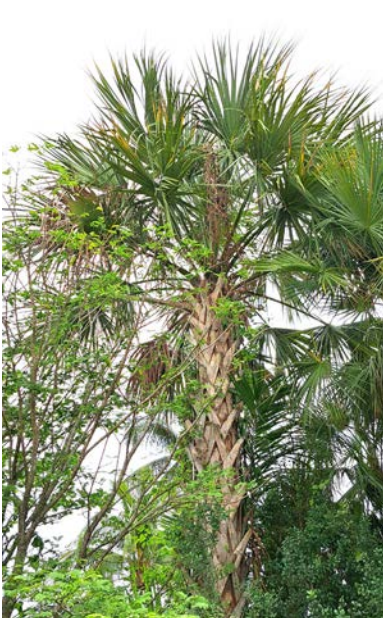
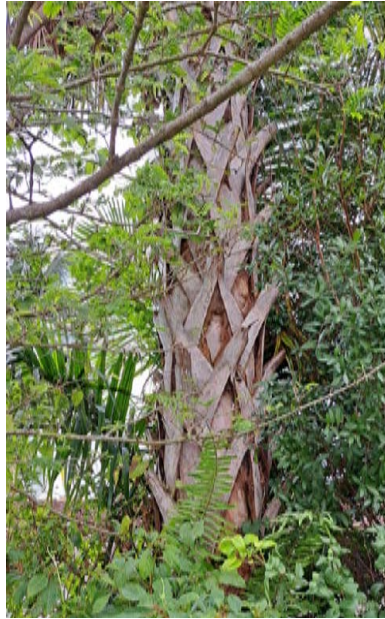
## Tree #3971

Tree #3971 is a Cabbage Palm located on the east side of the property. It is in fair condition.

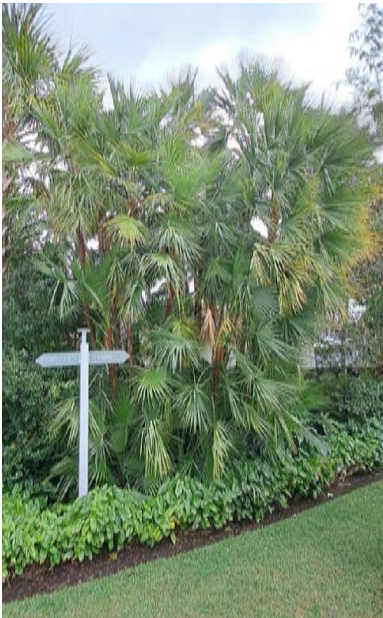
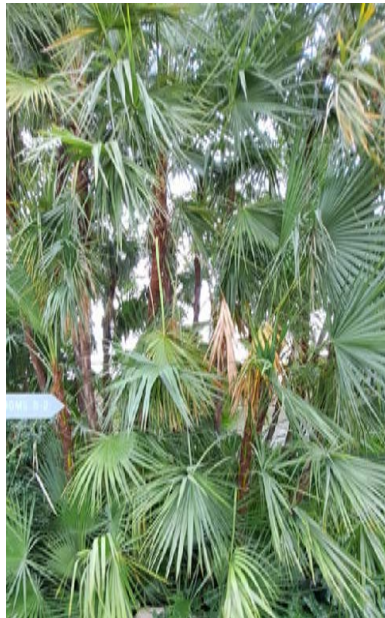
## Tree #3972

Tree #3972 is an Everglades Palm located on the east side of the property. It is multi-trunked and in fair condition with some yellowing fronds.

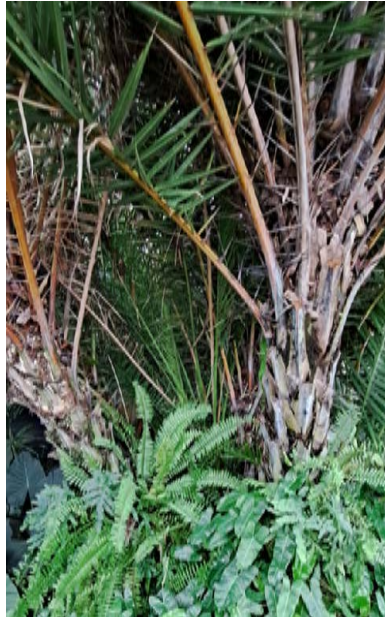
## Tree #3990

Tree #3990 is a triple-trunked Date Palm located on the east side of the property. It is in fair condition with some yellowing on the fronds.

**Disposition -** REMOVE

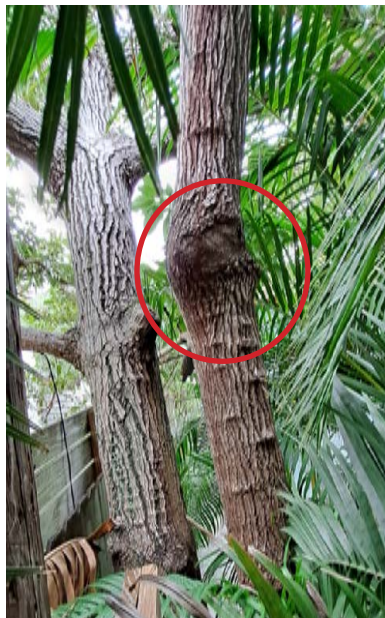
## Tree #4001

Tree #4001 is an Avocado Tree located on the east side of the property. It is located on the other side of the existing fence and the canopy spreads into the neighboring property. The tree is in fair condition. There are small cavities with decay and the tree has low vigor. There is a burl on one of the two main trunks (circled in red).

**Disposition -** REMOVE

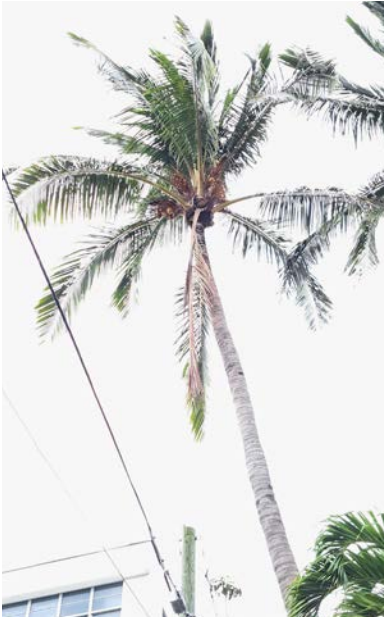
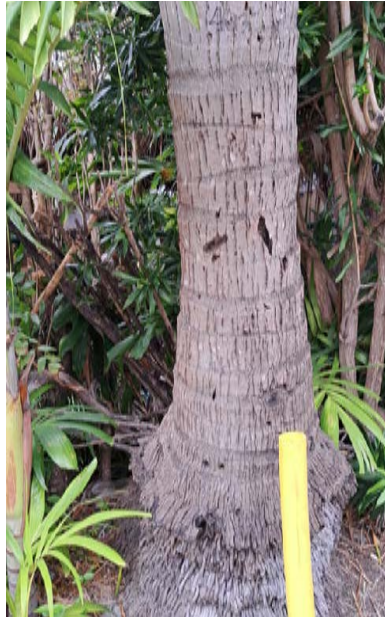
## Tree #4035

Tree #4035 is a Coconut Palm street tree located along Island Avenue. It is in fair condition with climbing spike injuries to the trunk. Continue to remove the coconut fruits.

**Disposition - REMOVE**
