# HPB24-0638

## 1210 Michigan Avenue

Certificate of Appropriateness  
for Demolition and Design

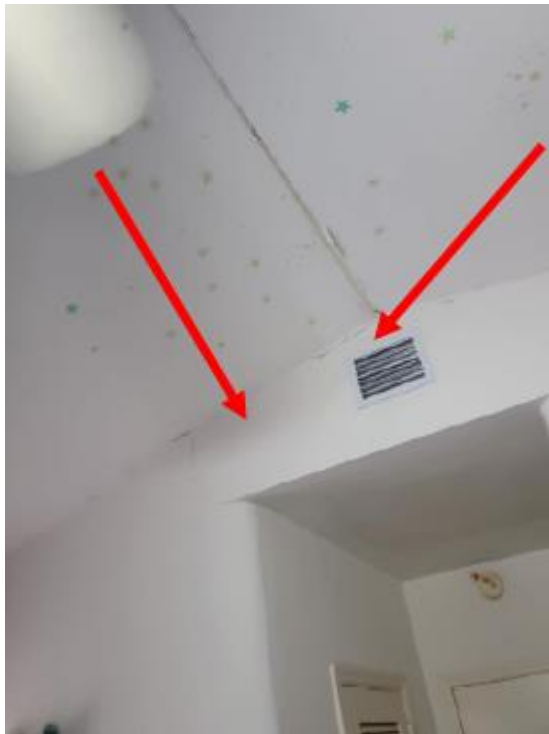
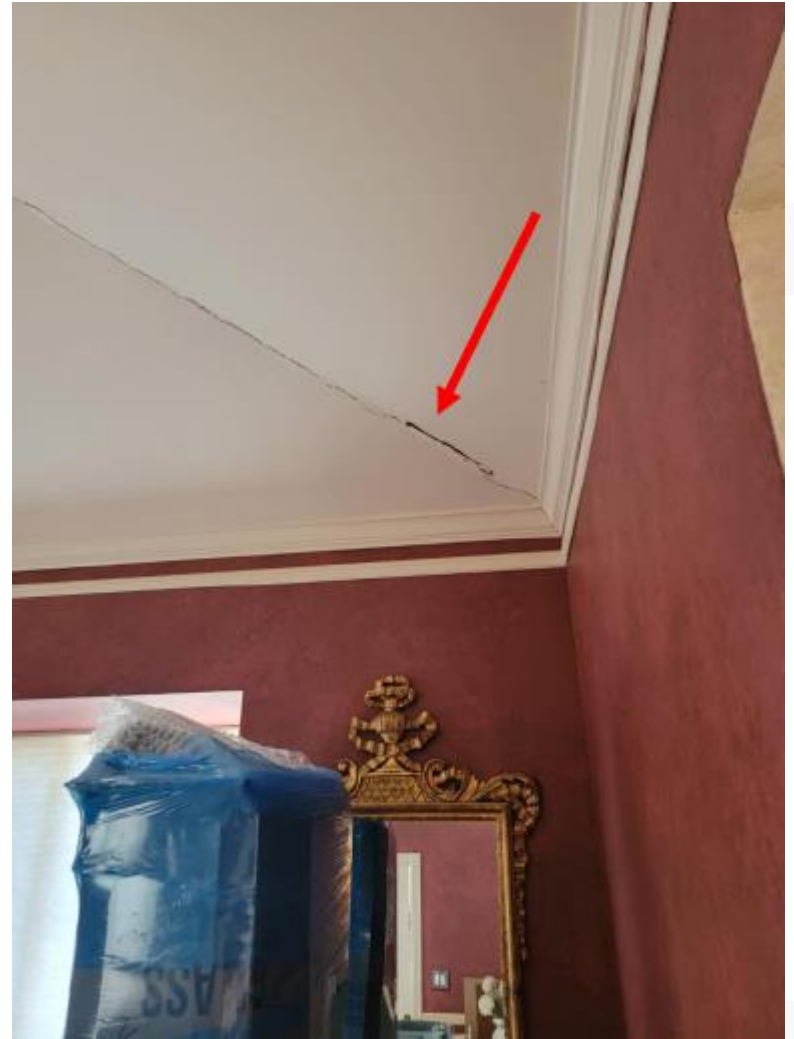
# Structural Integrity Issues With Roof

- The roof has failed in multiple locations
- Moisture intrusion has caused severe and extensive damage to all the wood members of the building

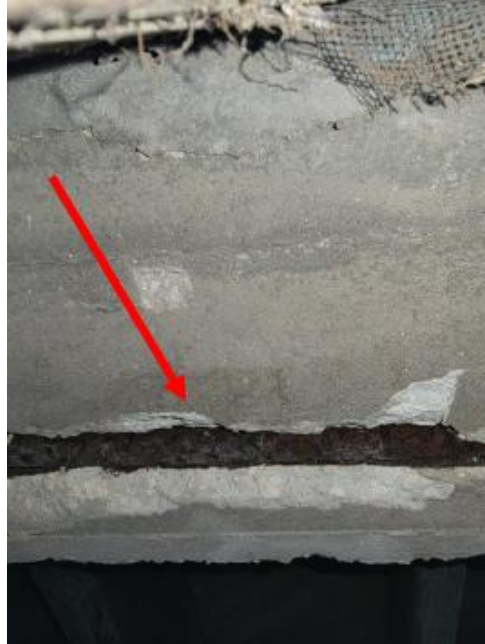
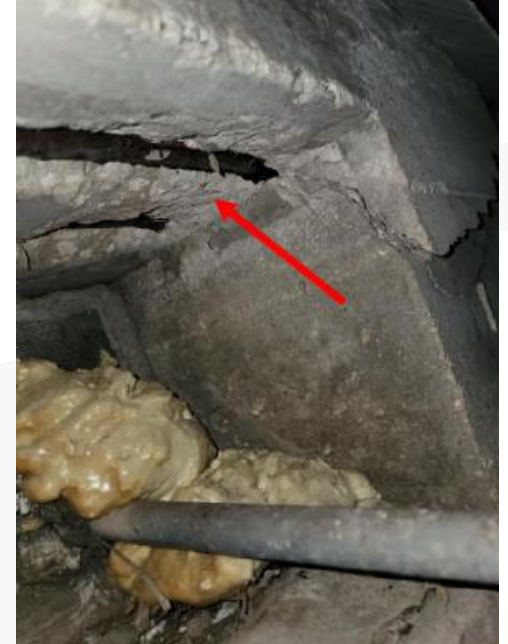
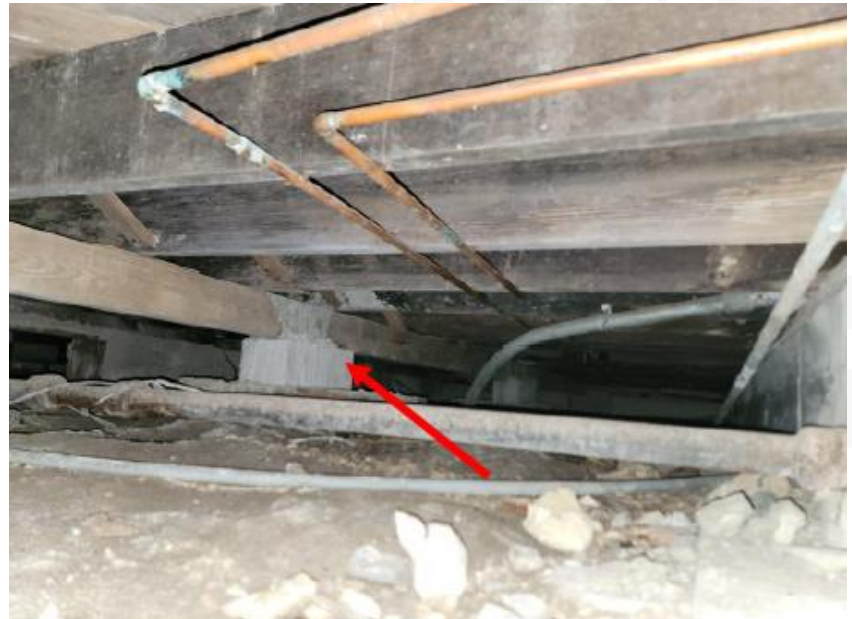
# Structural Integrity Issues With Foundations

- Foundations are severely deteriorated
- Reinforcing rebars are corroded
- Damage accelerated by continuous flooding
- Floor joists have been supported in a rudimentary fashion due to floor sagging and settlement

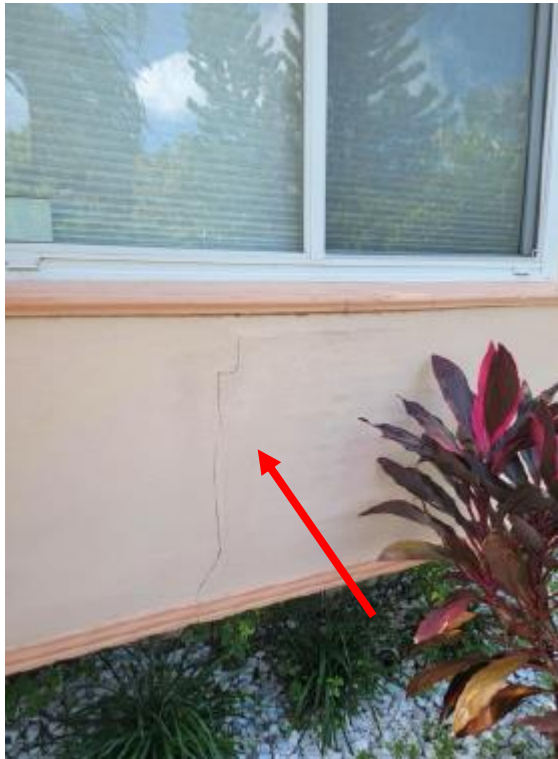
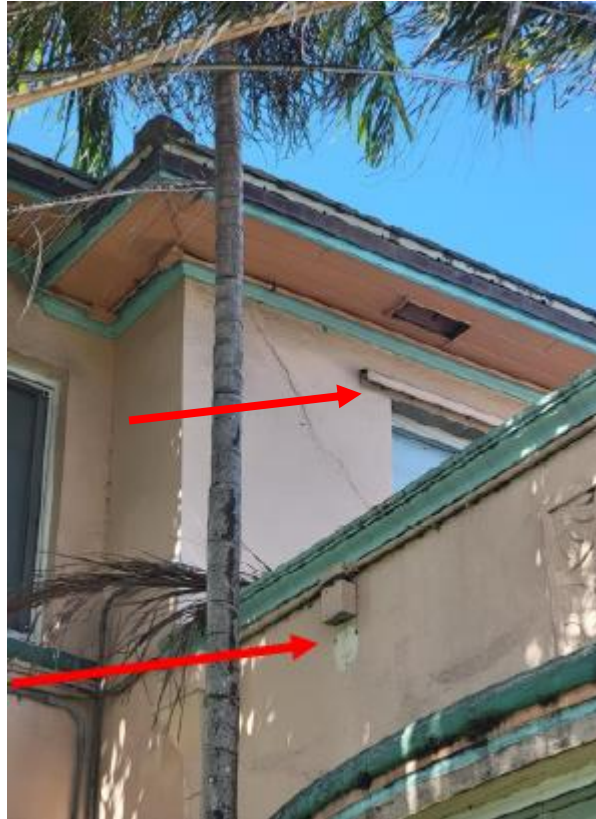
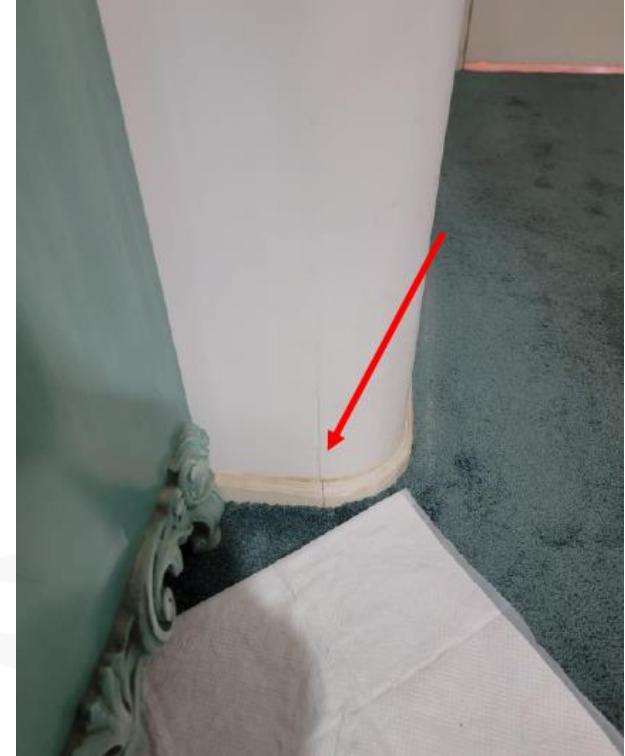
# Structural Integrity Issues With Foundations

- Floor joists have been supported in a rudimentary fashion due to floor sagging and settlement
- Distressed signs are cracking, spalling, water damage, decayed wood and termite damage

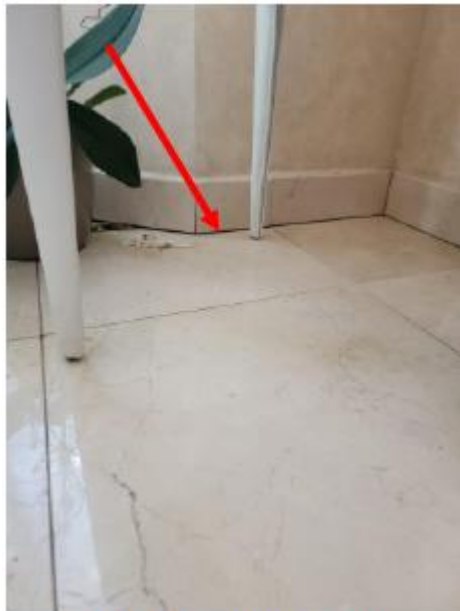
- Floor deflection caused by continuous flooding and weakening foundation of the house

Floor Deflection and sagging
