June 24<sup>th</sup>, 2024

Mr. Bryan Pravda, AIA/ NCARB/ WELL AP  
Pravda Architecture/Design, PLLC  
12906 154th Rd N  
Jupiter, FL 33478

### **Arboricultural Consulting Services at 8-10 Century Lane, Miami Beach, Florida**

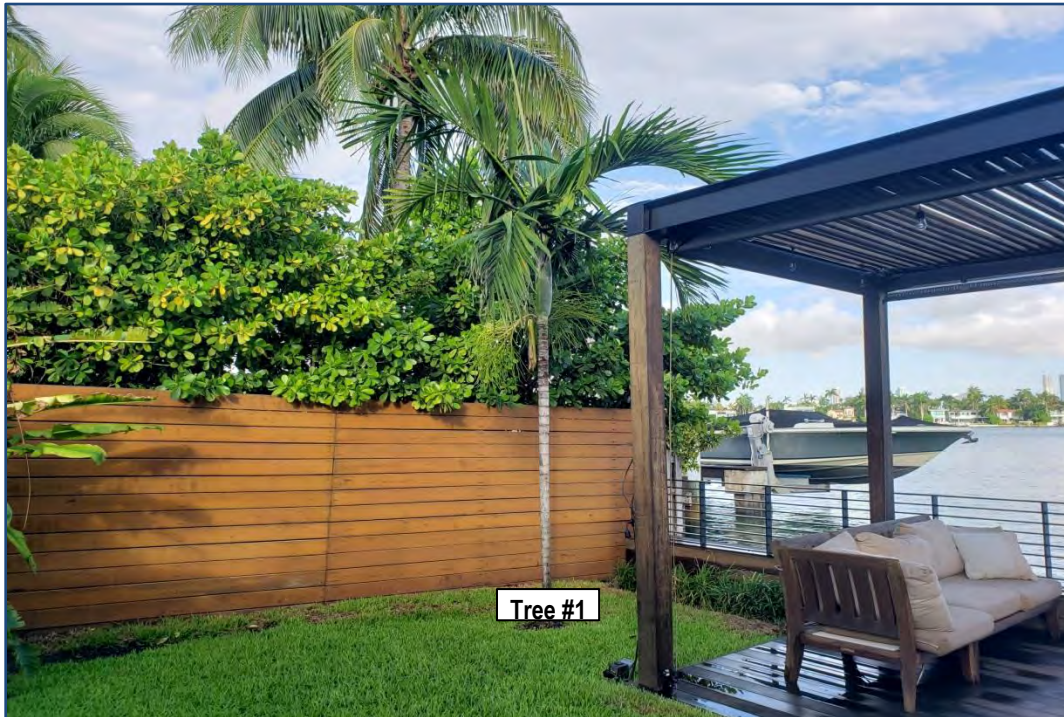
Looking northwest at Non-Regulated Tree No. 1.

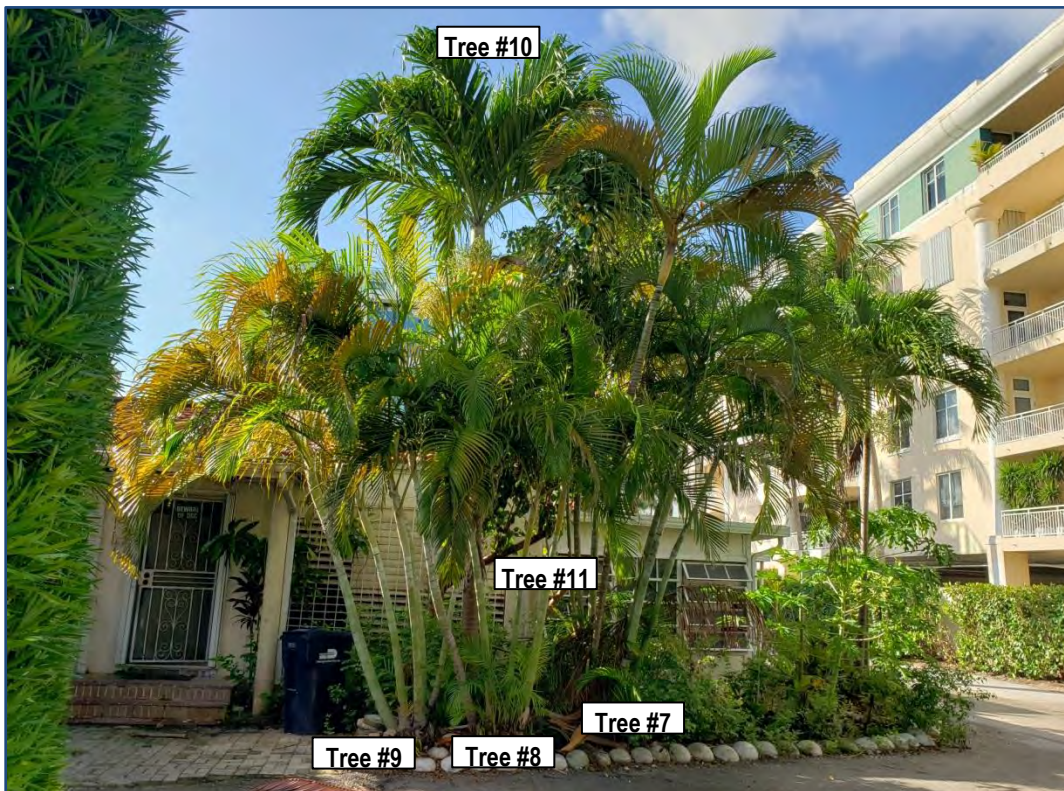
Looking southeast at Non-Regulated Tree Nos. 7, 8 and 9 and Regulated Tree Nos. 10 and 11.

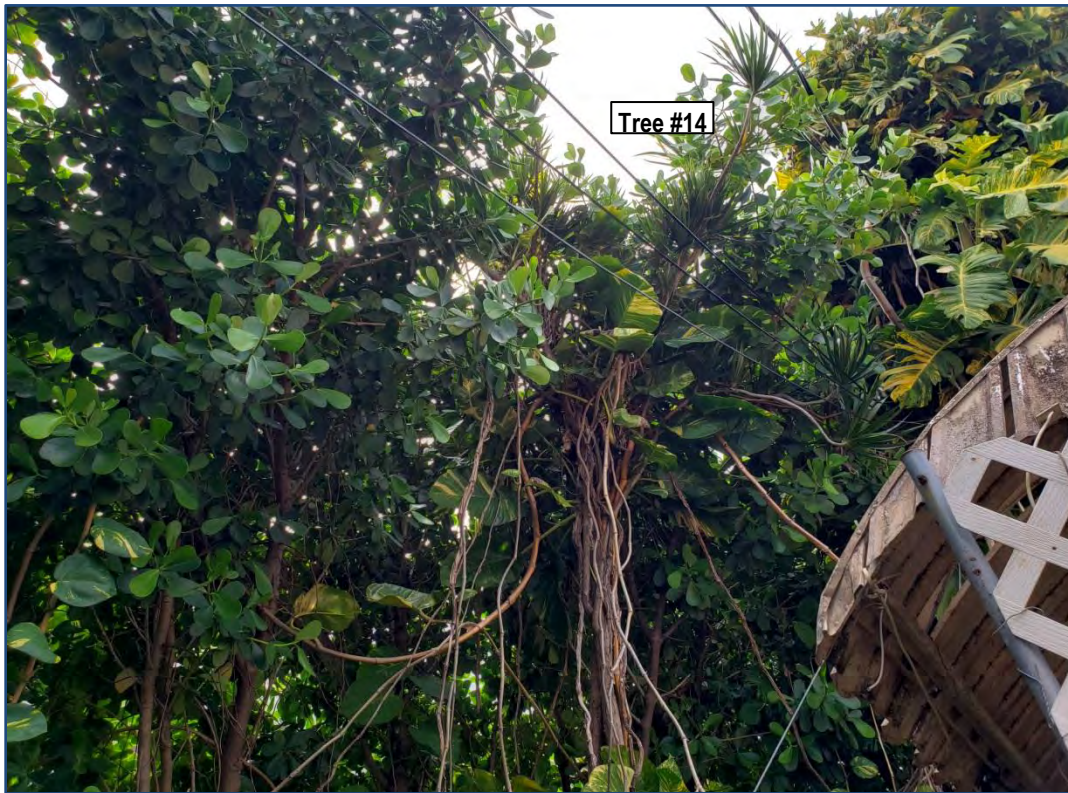
**Looking southeast at Non-Regulated Tree No. 14.**

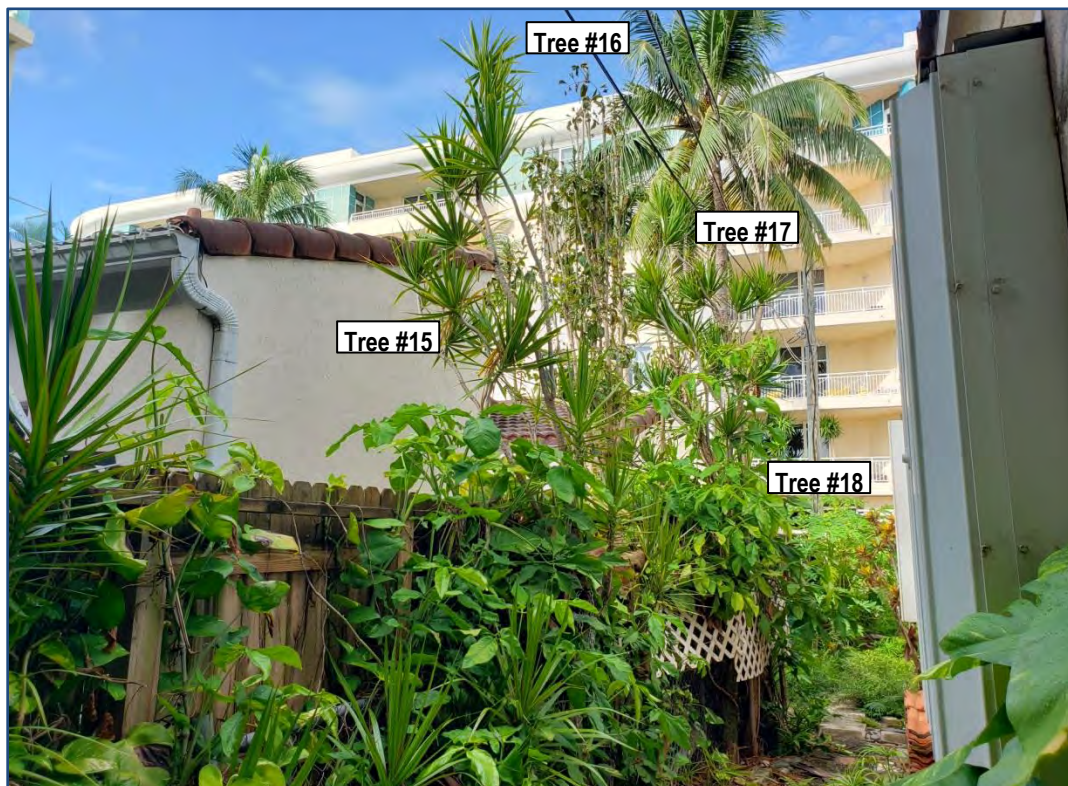
**Looking southwest at Non-Regulated Tree Nos. 15, 17 and 18 and Regulated Tree No. 16.**
