June 11, 2024

Reference: Flamingo Park  
1200 Meridian Ave.  
Miami Beach, Florida, 33139  
**Site Observation of Existing Structure**

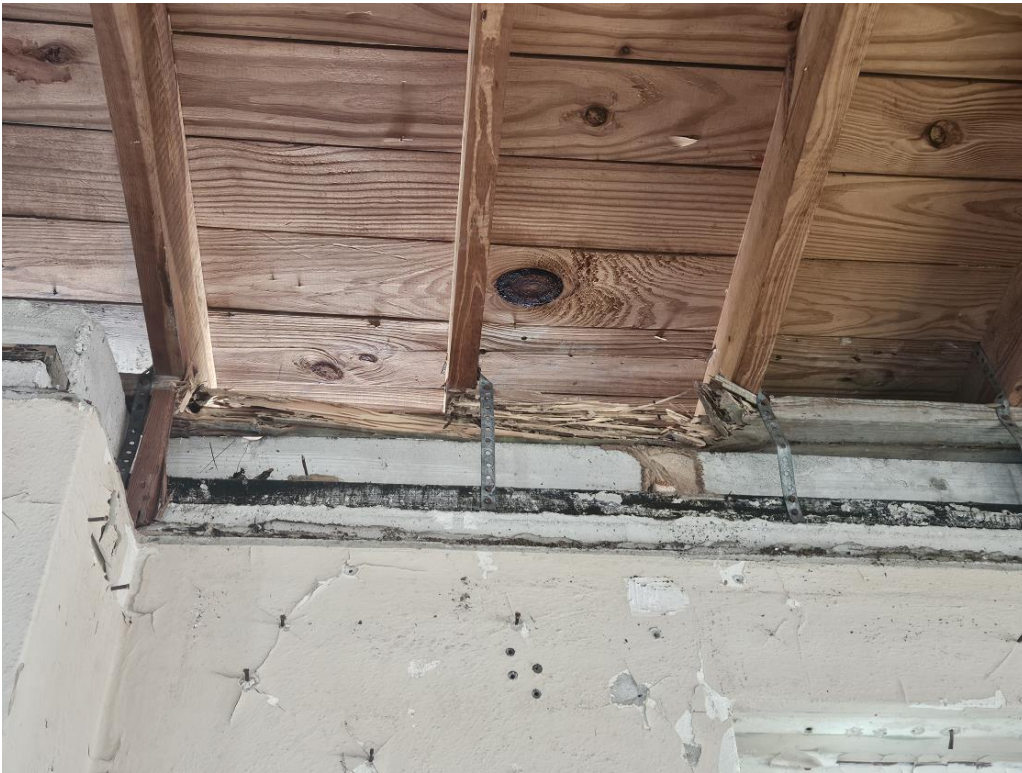
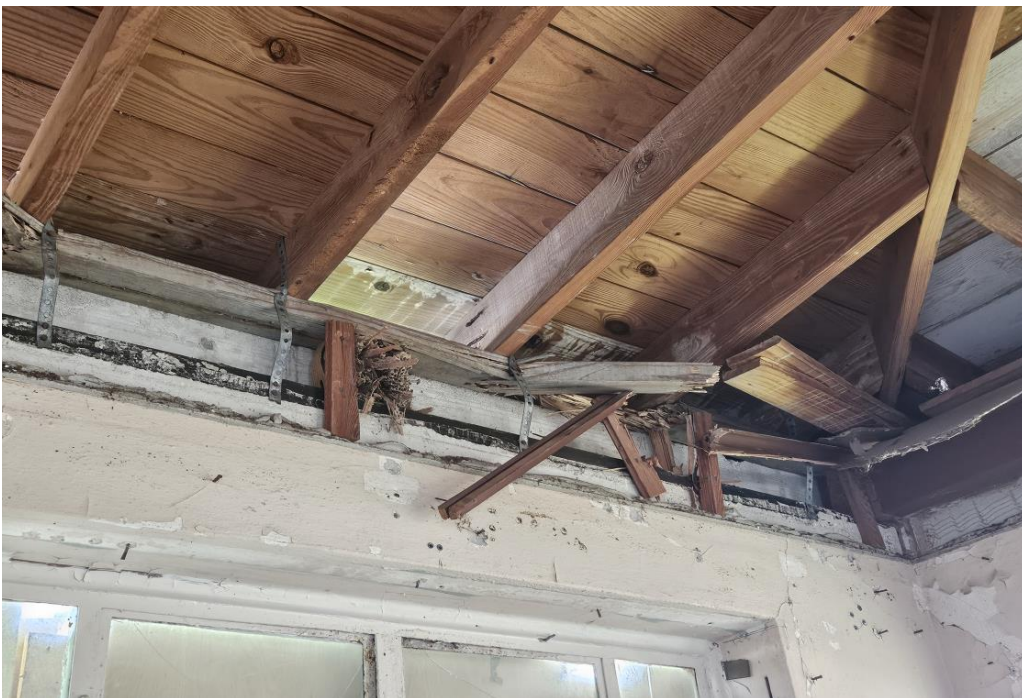
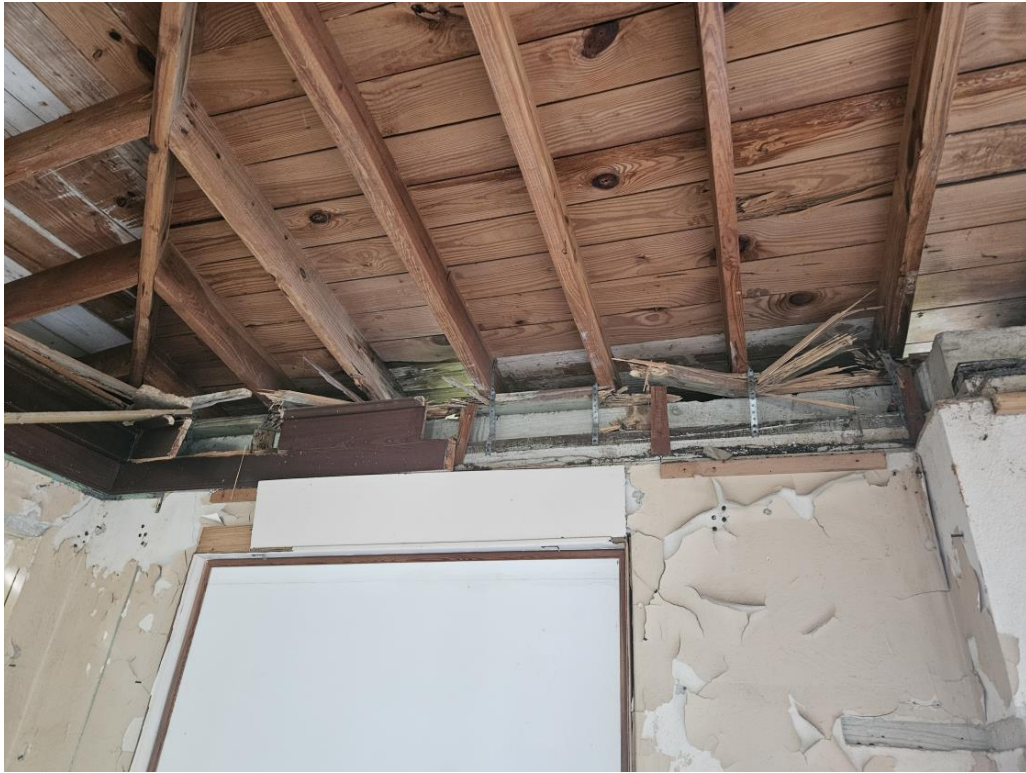
1. The bottom plate and strap connections of roof rafters' bearing ends are damaged. The strap connections are missing on many roof rafters. Refer Figures 1 to 3.
2. The roof planking is deteriorated and doesn't qualify as roof sheathing per Florida Building Code. Refer Figure 4.
3. The roof rafters are damaged. Refer Figures 5 and 6.
4. The roof rafter bearing supports/braces are discontinued or left unsupported due to removal of walls below. Refer Figures 7 to 9.
5. The floor system is severely damaged throughout. Refer Figures 10 and 11.
6. In several locations the existing 2x10 floor joists are supported on top of a flat 2x4 spanning between masonry piers. This is blatantly inadequate for the required floor loads. Refer Figure 12.
7. Further roof rafters on the west building are found substantially damaged. Refer Figures 13 and 14.

In summary, Deficiencies 1 thru 4, and 7 above are significant and widespread. BNI would recommend complete removal of the existing wood roof framing system and replace with prefabricated roof trusses, plywood sheathed roof and proper Simpson tie-downs.
