2025-33559
RESOLUTION NO.

A RESOLUTION OF THE MAYOR AND CITY COMMISSION OF THE CITY OF MIAMI BEACH, FLORIDA, ACCEPTING THE RECOMMENDATION OF THE LAND USE AND SUSTAINABILITY COMMITTEE AT ITS MEETING ON MARCH 11, 2025, AND APPROVING "OPERATION CLEAN WATER" TO URGENTLY ADDRESS STREET LEVEL POLLUTANTS IN THE NORTH BEACH WATERSHED ENTERING THE STORMWATER SYSTEM AND IMPACTING PARK VIEW CANAL WATER QUALITY, AS IDENTIFIED IN THE REPORT DATED FEBRUARY 24, 2025, ENTITLED "ASSESSMENT OF ENTEROCOCCI IN GROUNDWATER AND STORMWATER AT THE MIAMI BEACH PARK VIEW CANAL."

DATE: March 19, 2025
TITLE: A RESOLUTION OF THE MAYOR AND CITY COMMISSION OF THE CITY OF MIAMI BEACH, FLORIDA, ACCEPTING THE RECOMMENDATION OF THE LAND USE AND SUSTAINABILITY COMMITTEE AT ITS MEETING ON MARCH 11, 2025, AND APPROVING "OPERATION CLEAN WATER" TO URGENTLY ADDRESS STREET LEVEL POLLUTANTS IN THE NORTH BEACH WATERSHED ENTERING THE STORMWATER SYSTEM AND IMPACTING PARK VIEW CANAL WATER QUALITY, AS IDENTIFIED IN THE REPORT DATED FEBRUARY 24, 2025, ENTITLED "ASSESSMENT OF ENTEROCOCCI IN GROUNDWATER AND STORMWATER AT THE MIAMI BEACH PARK VIEW CANAL."

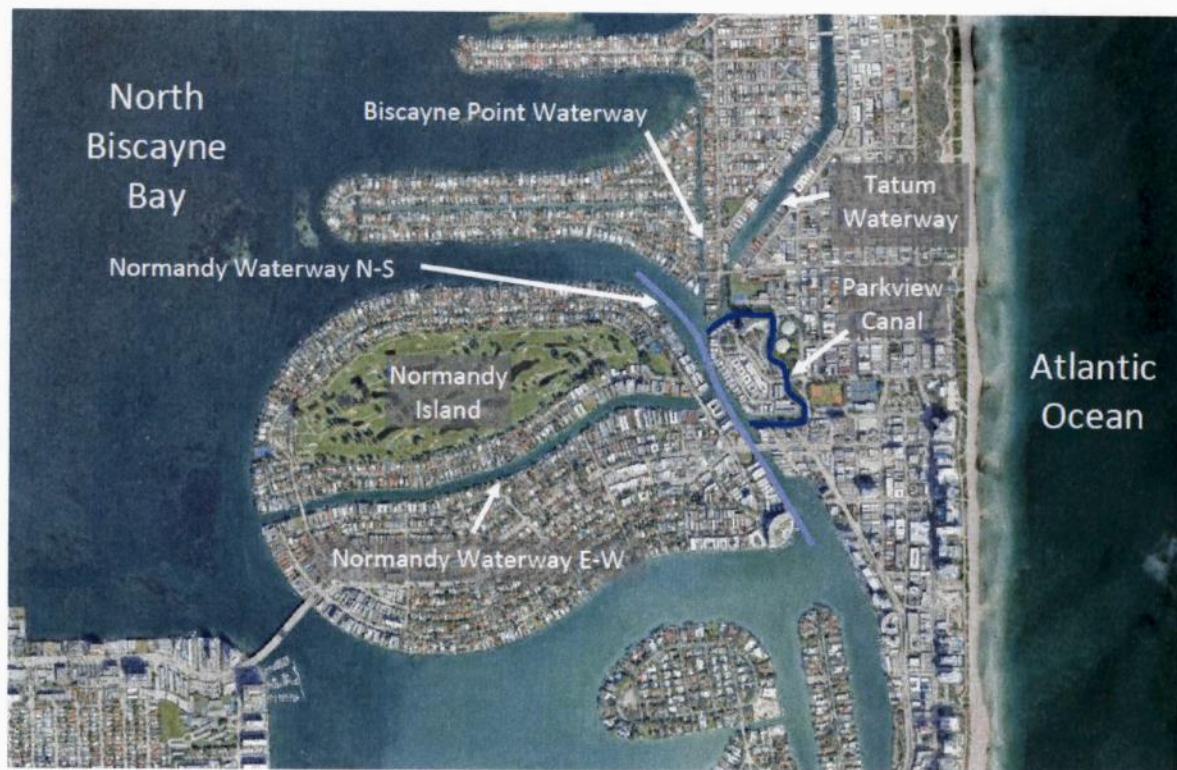
Figure I.4: Map showing locations of 1) Park View Canal, 2) Biscayne Point Waterway, 3) Tatum Waterways, 4) Normandy Waterway N-S, and 5) Normandy Waterway E-W.

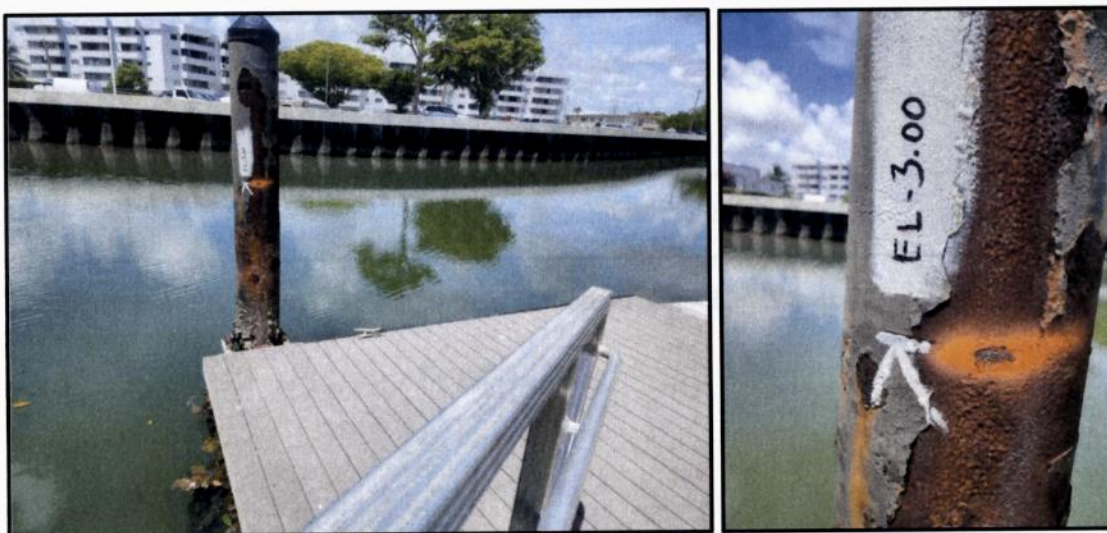
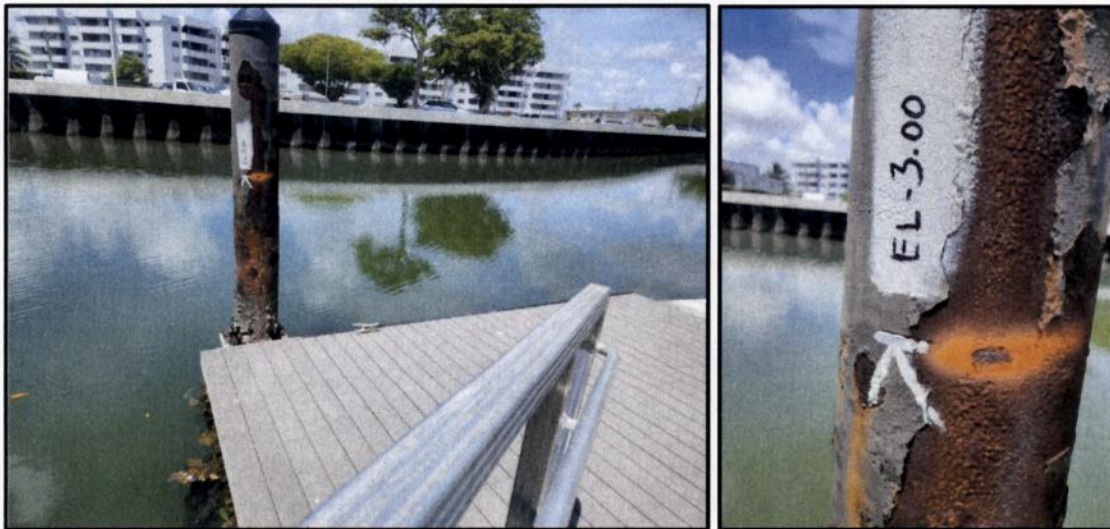
To establish a relationship between water surface elevation at the NOAA tidal station and the PVC, a benchmark was needed. This benchmark was installed by M.G. Vera and Associates (Mark Sowers) in collaboration with TYLin (Jeffrey Marcus) during the week of August 5, 2024. The benchmark is located on a piling (southwest corner) of the Kayak Launch (Figure III.1). The elevation of the benchmark is 3.00 feet referenced to the National American Vertical Datum of 1988 (NAVD88). This benchmark has since been used to measure the elevation of the PVC water surface by measuring the vertical distance from the benchmark to the water's surface. Measurements of PVC water surface elevation were taken hourly from 6:00 am to 5:00 pm on August 15, 2024. Additional spot checks were made on August 6, 2024, at 11:00 am, 1:00 pm and 3:15 pm and on September 19, 2024, at 2:45 pm and at 4:07 pm.

Figure III.1: Benchmark established at the Kayak Launch of the PVC showing the elevation as 3.00 feet NAVD88. Benchmark and photos courtesy of M.G. Vera and Associates and TYLin.

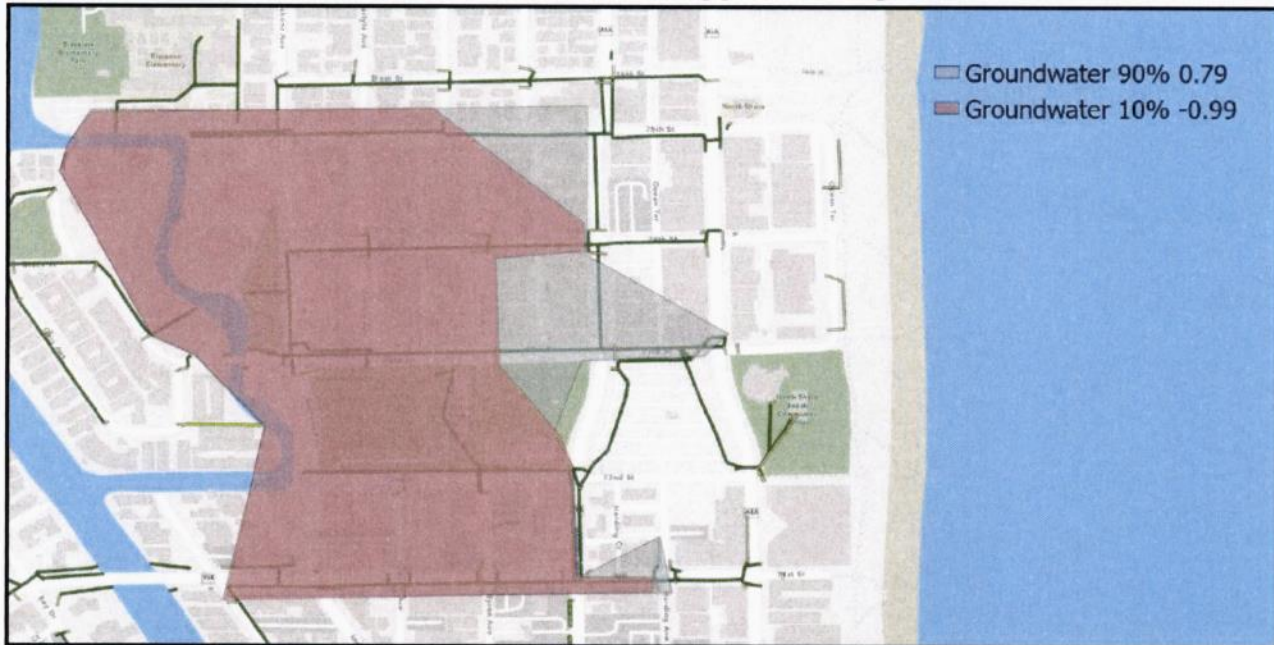
Figure III.5: Stormwater conveyance system with areas of groundwater inundation shown during the lowest 10% elevation (-0.99 ft NGVD) and the highest 90% elevation (0.79 ft NGVD).

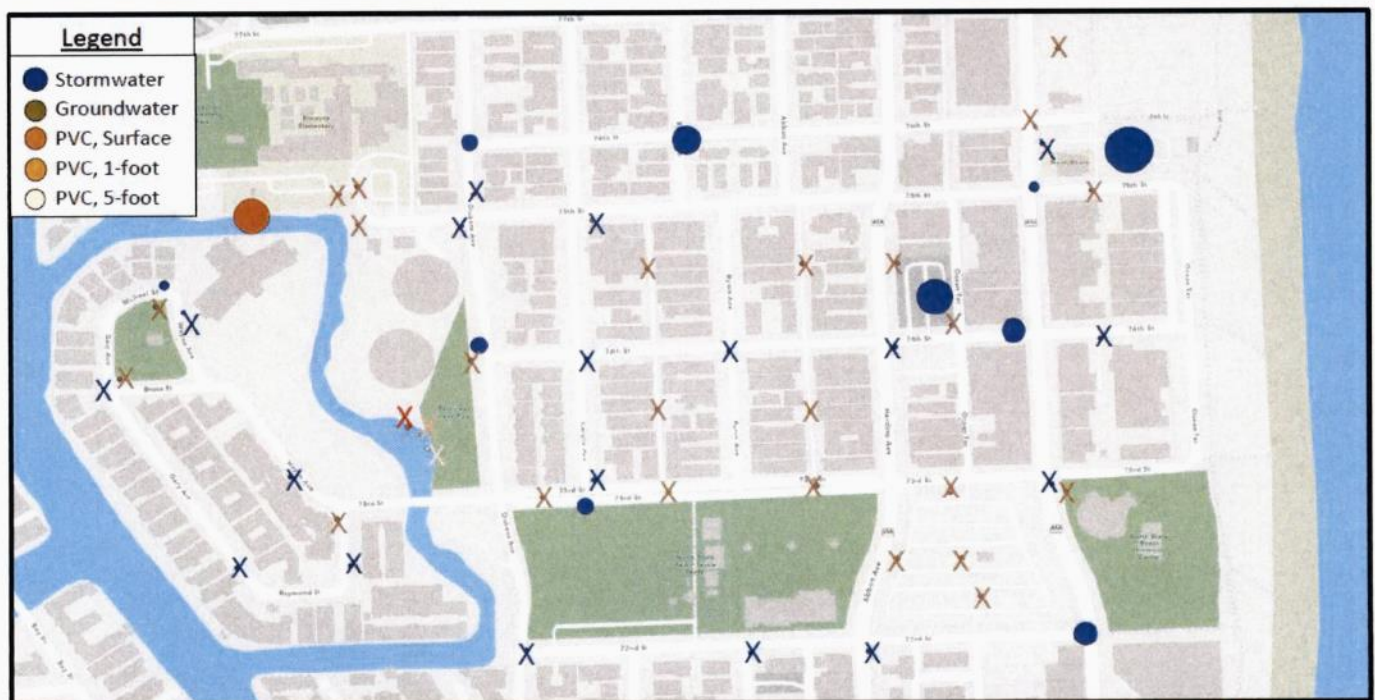
Figure V.5: Spatial distribution of dog MST marker. The “X” symbol represents samples below the detection limit.

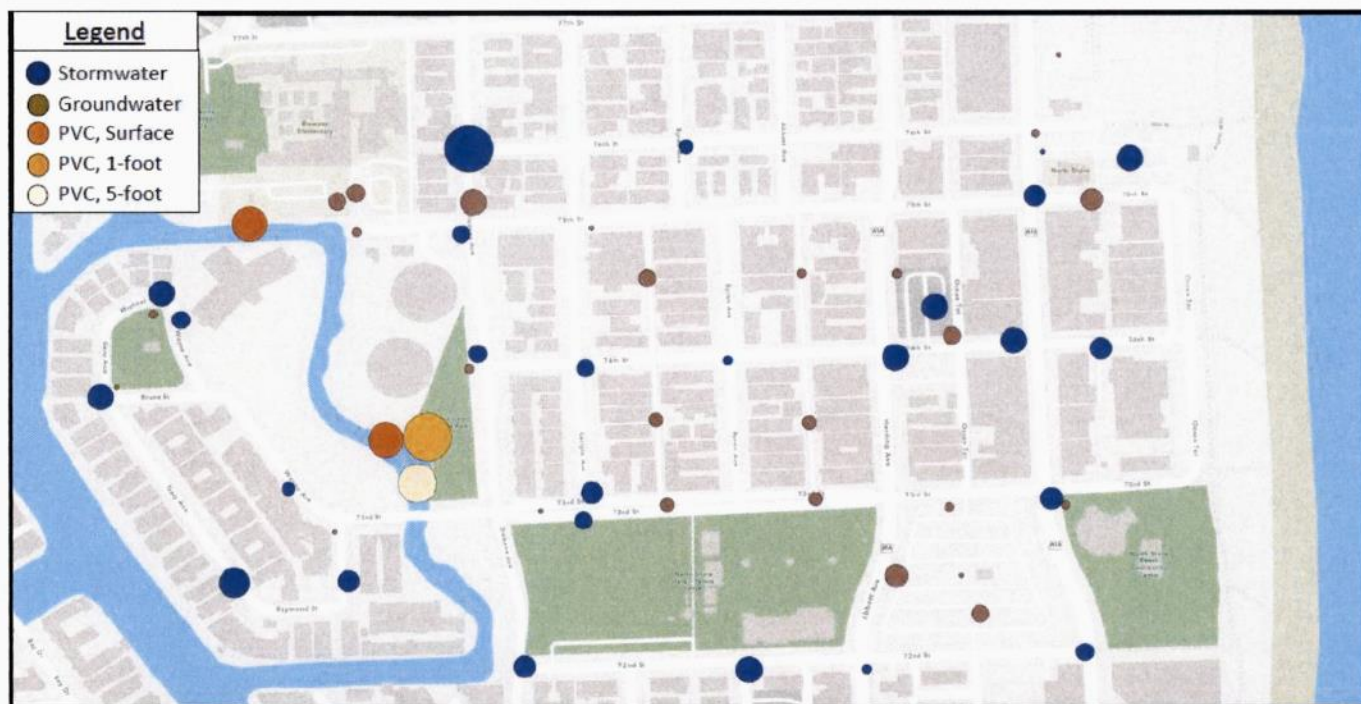
Figure V.6: Spatial distribution of general bird MST marker. The “X” symbol represents samples below the detection limit.

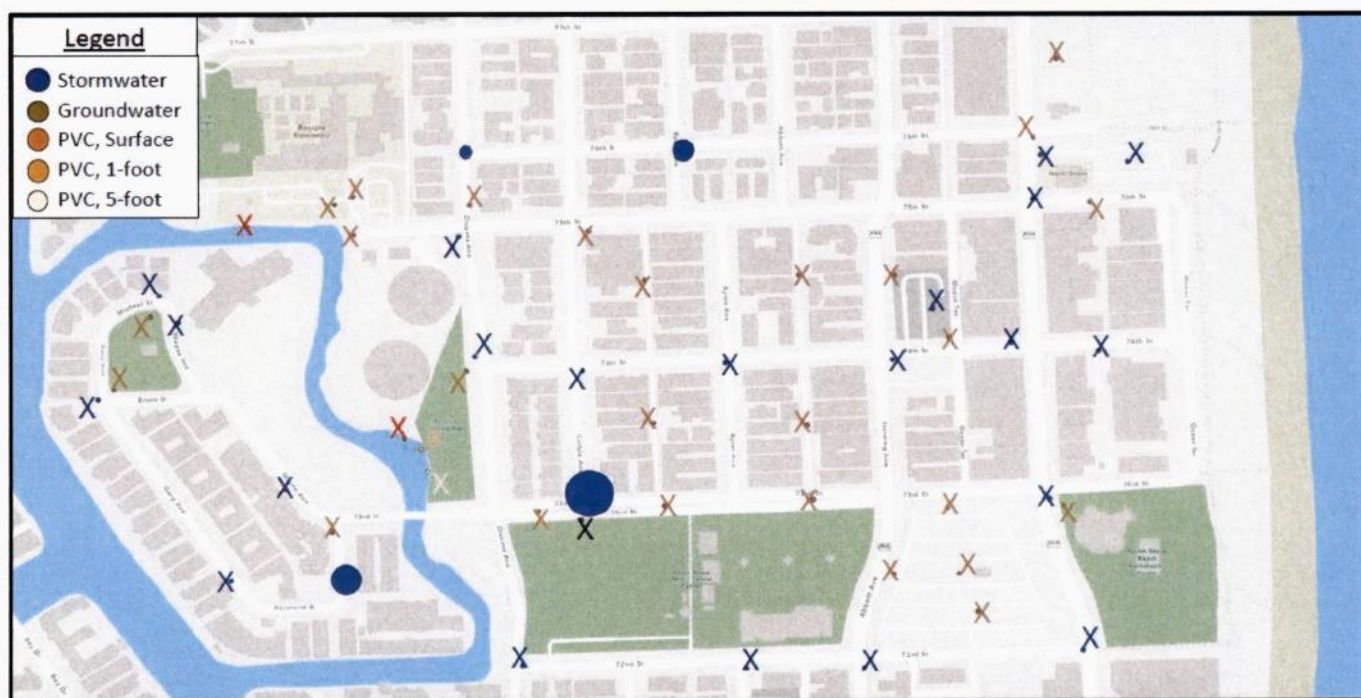
Figure V.7: Spatial distribution of gull MST marker. The “X” symbol represents samples below the detection limit.

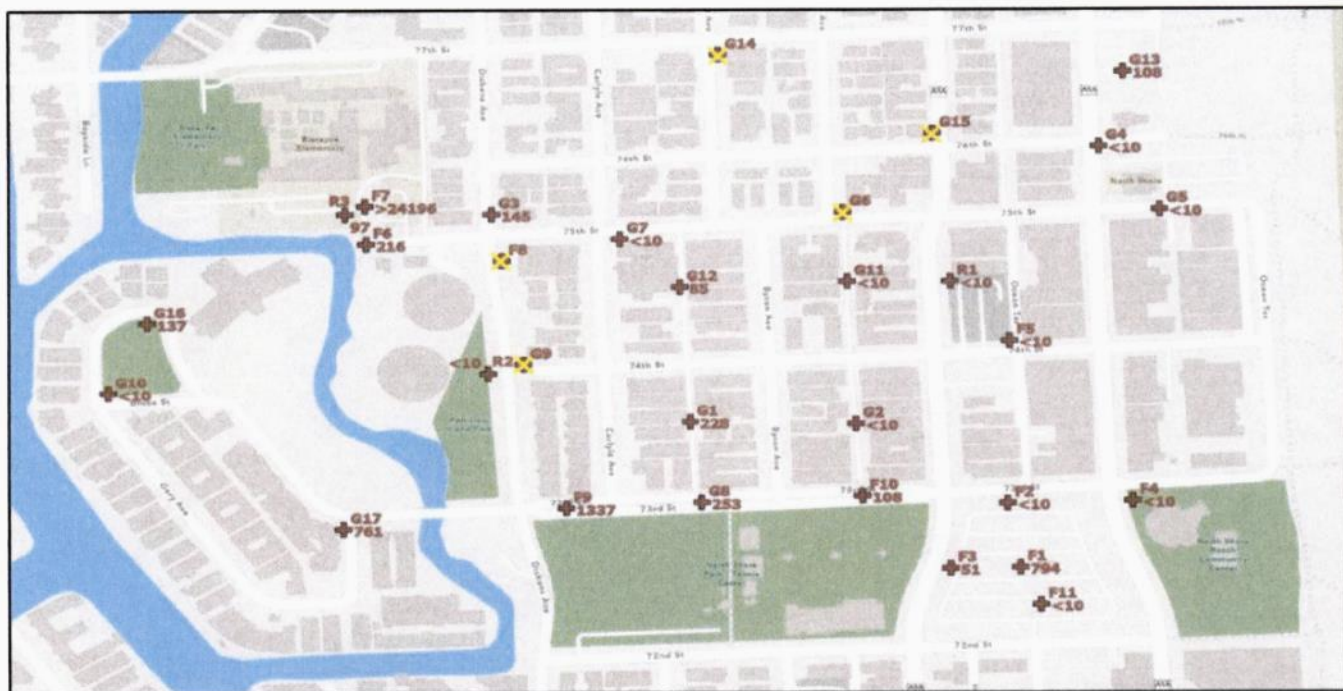
Figure C.1: Groundwater sampling sites. Sites with a yellow “X” were sites that were selected but were found to be non-viable to due excessive underground utilities and were therefore not drilled. The remaining 26 sites without the yellow “X” were sampled. The site ID is given by a “G”, “F”, or “R” (for proximity to gravity sewer, force main, and stormwater conveyance system, respectively) followed by a number. The number below the site ID corresponds to the enterococci concentration in the groundwater in units of MPN/100 mL.

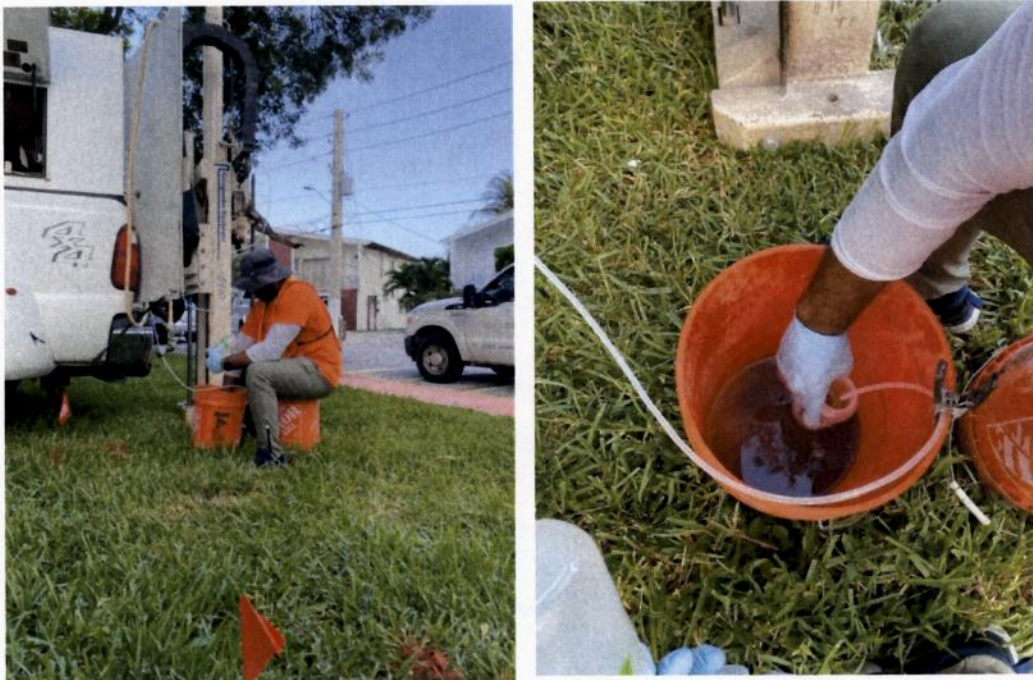
Figure C.14: Illustration of groundwater sample collection from behind the pickup truck mounted drill rig.

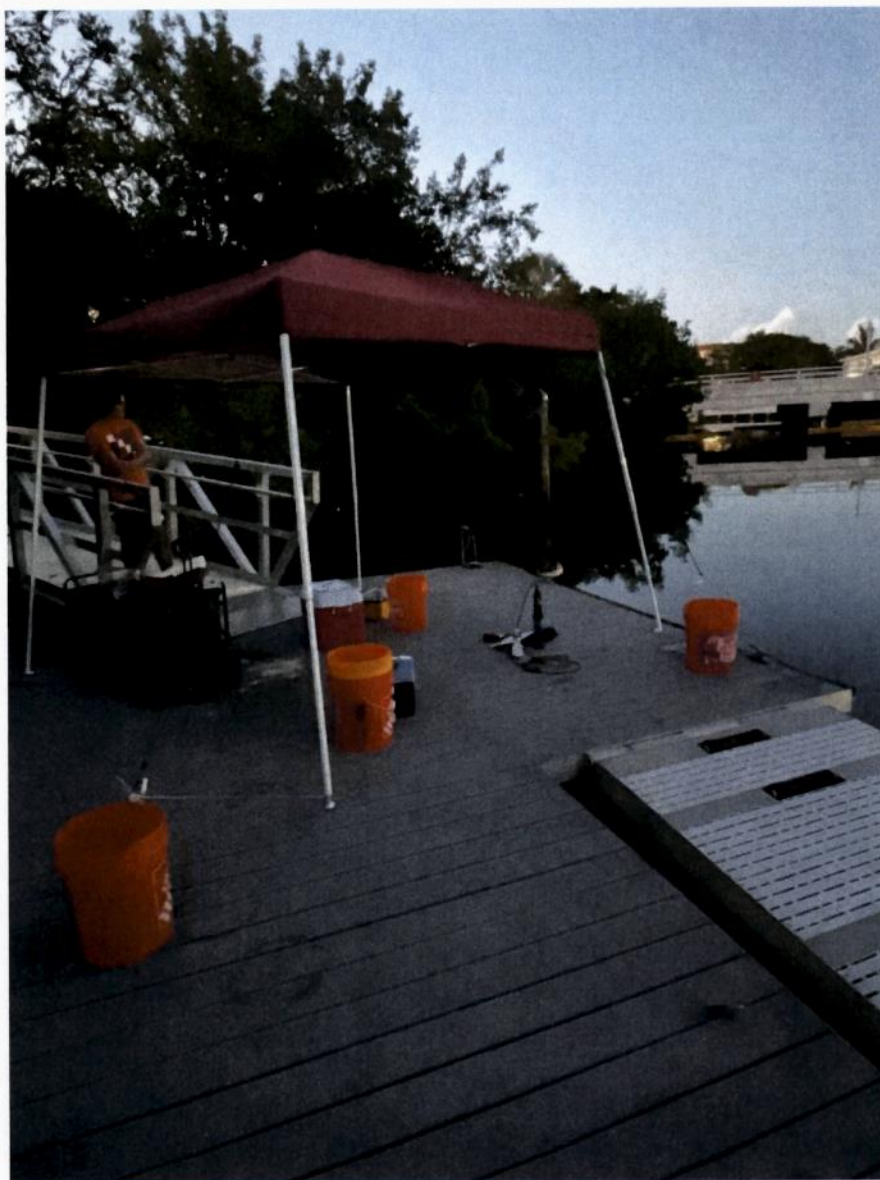
Figure C.16: Photo of sample collection set up at the Kayak Launch towards the beginning of the 12-hour sampling event.

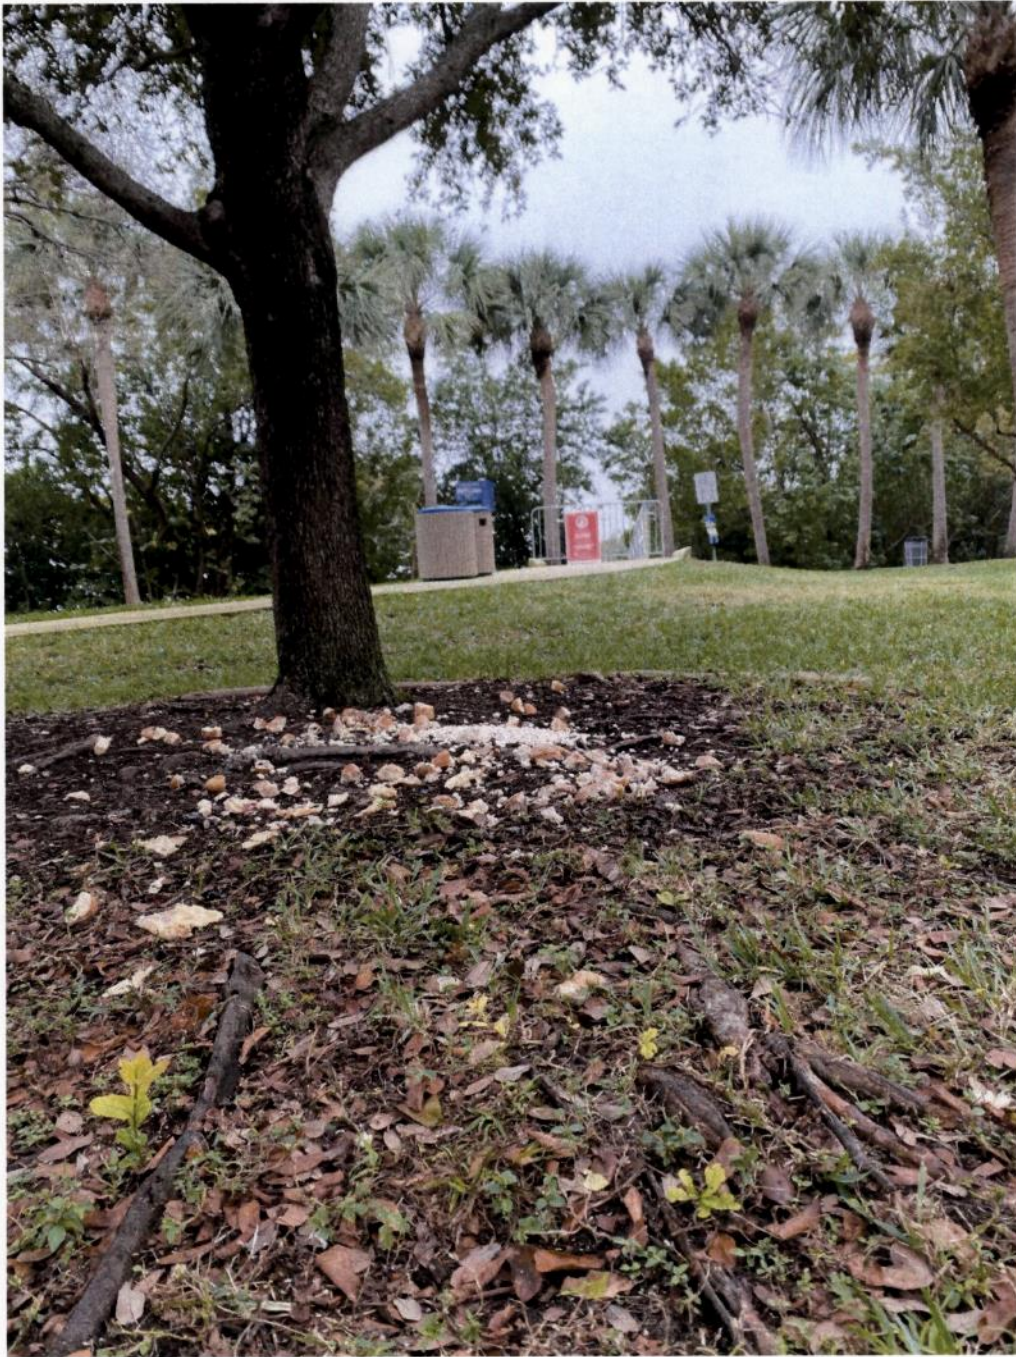
Figure C.18: Photo of animal feeding station of bread and donuts taken on January 31, 2025, near the entrance to the Kayak Launch. Prior to taking the photo, a flock of birds were seen at the station. These birds flew away once the station was approached to take this photo.
