Assessment of Enterococci in Groundwater and Stormwater at the Miami Beach Park View Canal

March 11, 2025

University of Miami Team: Ayaaz (Johann) Amirali, Cristina Fayad Martinez, Aarohi Talati, Diego Lopez Oranday, Larissa Montas, Isabela Puente, Rivka Reiner, Matthew Roca,
Helena Solo-Gabriele

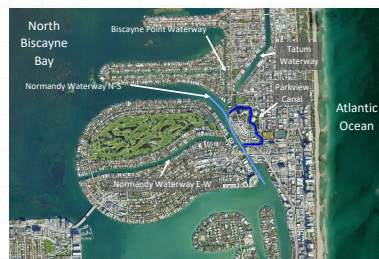
PVC has Limited Natural Flushing within an Impaired Bay

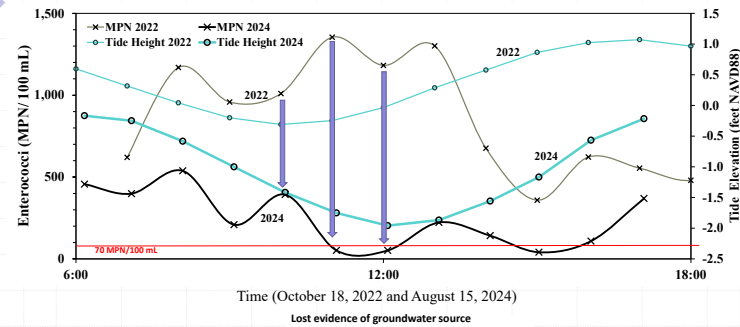
Enterococci values dropped significantly b/w storm events, suggesting ARVs and pipe lining have had a positive impact

- Enterococci levels lower between storm events (lost earlier signal of possible sewer leaks).
- Sanitary sewer pipe-lining and repair of air release valves appears to have improved water quality between storms
- **Main water type contributing to enterococci in the PVC is stormwater**
- Source to stormwater comes from birds, humans, and dogs from street runoff
- Additional load from birds within the PVC
- BBE outfall contributes enterococci to the PVC

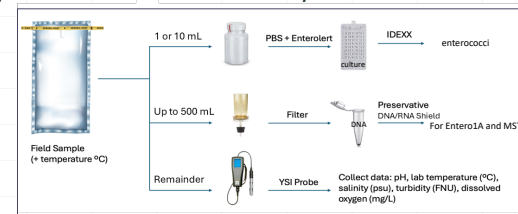
Measurements by Culture and Genomic Analysis

- Groundwater
- Stormwater
- PVC water
 - Surface
 - 1-foot
 - 5-foot

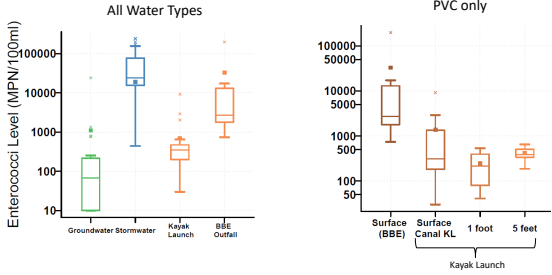
Charts below compare the different samples by water type and depth within PVC

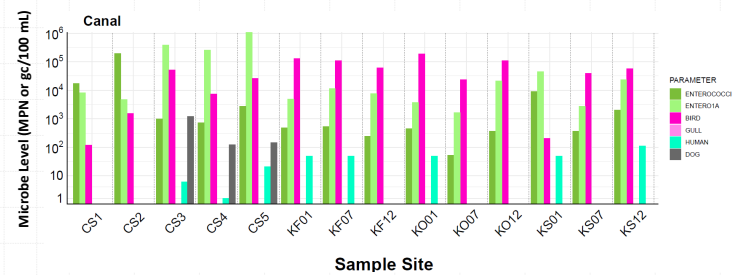
PVC water shows evidence of bird (a lot), some dog and some human

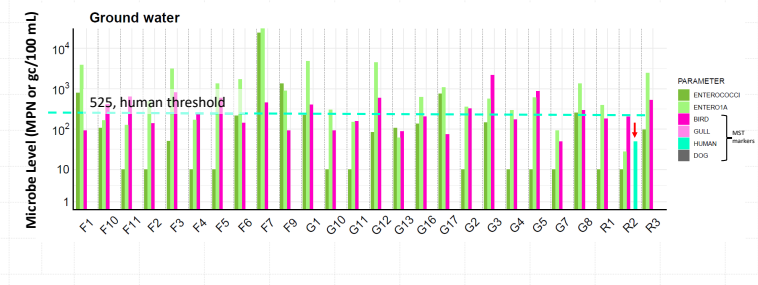
Groundwater shows evidence of bird (due to stormwater and PVC mixing) but no dog and one with very low human
