RESOLUTION NO. 2025-33559

A RESOLUTION OF THE MAYOR AND CITY COMMISSION OF THE CITY OF MIAMI BEACH, FLORIDA, ACCEPTING THE RECOMMENDATION OF THE LAND USE AND SUSTAINABILITY COMMITTEE AT ITS MEETING ON MARCH 11, 2025, AND APPROVING "OPERATION CLEAN WATER" TO URGENTLY ADDRESS STREET LEVEL POLLUTANTS IN THE NORTH BEACH WATERSHED ENTERING THE STORMWATER SYSTEM AND IMPACTING PARK VIEW CANAL WATER QUALITY, AS IDENTIFIED IN THE REPORT DATED FEBRUARY 24, 2025, ENTITLED "ASSESSMENT OF ENTEROCOCCI IN GROUNDWATER AND STORMWATER AT THE MIAMI BEACH PARK VIEW CANAL."

The Administration recommends the City Commission accept the selected recommendations of the North Beach Water Quality and Park View Canal report entitled "Assessment of Enterococci in Groundwater and Stormwater at the Miami Beach Park View Canal" and adopt the "Operation Clean Water" Resolution to urgently address the specific outfalls and street level pollutants entering the stormwater system and impacting the Park View Canal water quality.

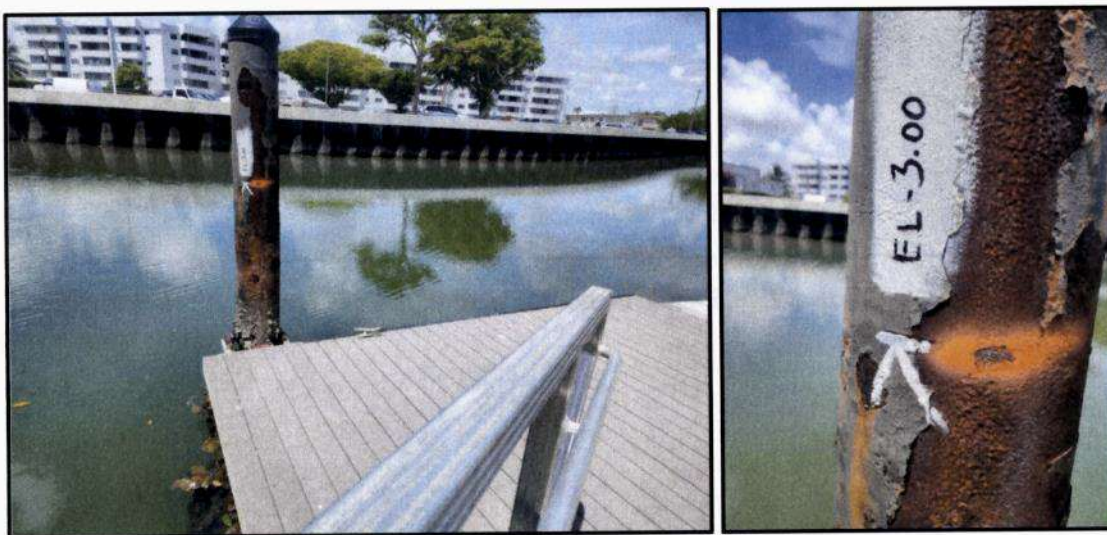
To establish a relationship between water surface elevation at the NOAA tidal station and the PVC, a benchmark was needed. This benchmark was installed by M.G. Vera and Associates (Mark Sowers) in collaboration with TYLin (Jeffrey Marcus) during the week of August 5, 2024. The benchmark is located on a piling (southwest corner) of the Kayak Launch (Figure III.1). The elevation of the benchmark is 3.00 feet referenced to the National American Vertical Datum of 1988 (NAVD88). This benchmark has since been used to measure the elevation of the PVC water surface by measuring the vertical distance from the benchmark to the water's surface. Measurements of PVC water surface elevation were taken hourly from 6:00 am to 5:00 pm on August 15, 2024. Additional spot checks were made on August 6, 2024, at 11:00 am, 1:00 pm and 3:15 pm and on September 19, 2024, at 2:45 pm and at 4:07 pm.

Figure III.1: Benchmark established at the Kayak Launch of the PVC showing the elevation as 3.00 feet NAVD88. Benchmark and photos courtesy of M.G. Vera and Associates and TYLin.

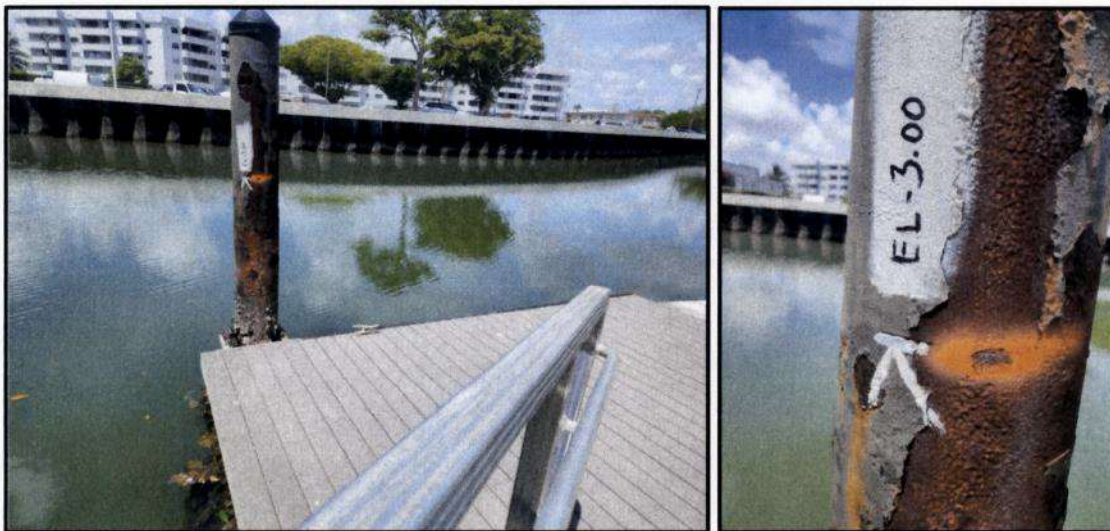
To establish a relationship between water surface elevation at the NOAA tidal station and the PVC, a benchmark was needed. This benchmark was installed by M.G. Vera and Associates (Mark Sowers) in collaboration with TYLin (Jeffrey Marcus) during the week of August 5, 2024. The benchmark is located on a piling (southwest corner) of the Kayak Launch (Figure III.1). The elevation of the benchmark is 3.00 feet referenced to the National American Vertical Datum of 1988 (NAVD88). This benchmark has since been used to measure the elevation of the PVC water surface by measuring the vertical distance from the benchmark to the water's surface. Measurements of PVC water surface elevation were taken hourly from 6:00 am to 5:00 pm on August 15, 2024. Additional spot checks were made on August 6, 2024, at 11:00 am, 1:00 pm and 3:15 pm and on September 19, 2024, at 2:45 pm and at 4:07 pm.

Figure III.1: Benchmark established at the Kayak Launch of the PVC showing the elevation as 3.00 feet NAVD88. Benchmark and photos courtesy of M.G. Vera and Associates and TYLin.

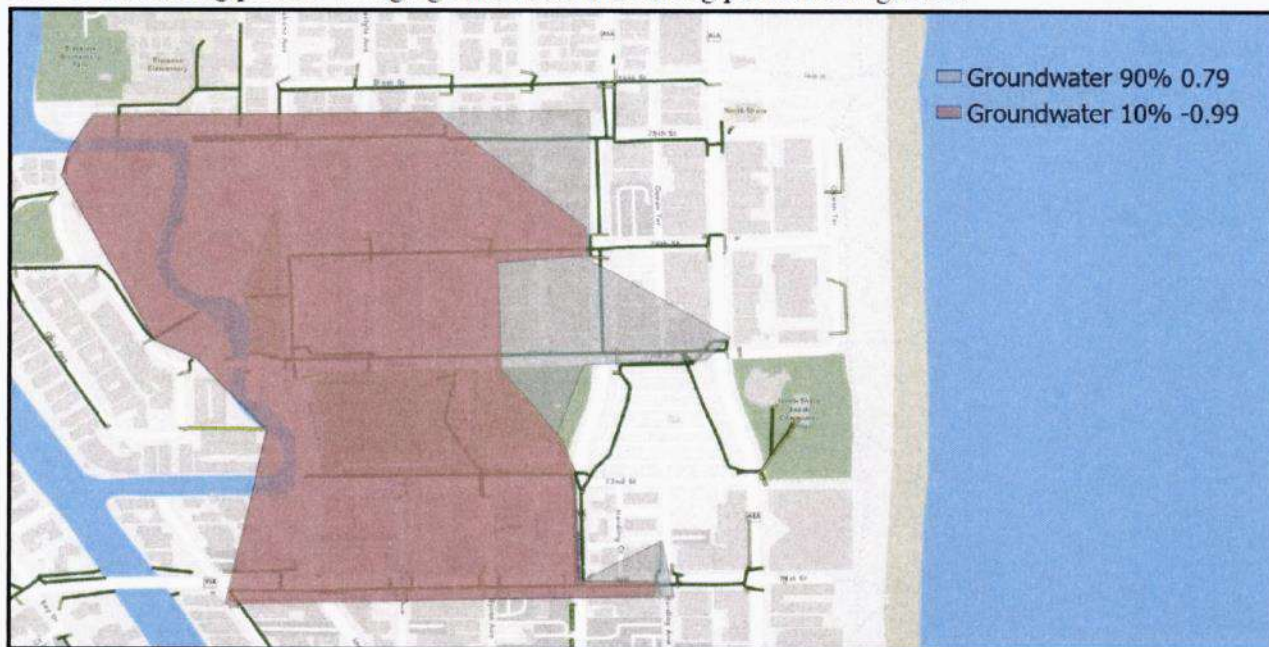
Figure III.5: Stormwater conveyance system with areas of groundwater inundation shown during the lowest 10% elevation (-0.99 ft NGVD) and the highest 90% elevation (0.79 ft NGVD).

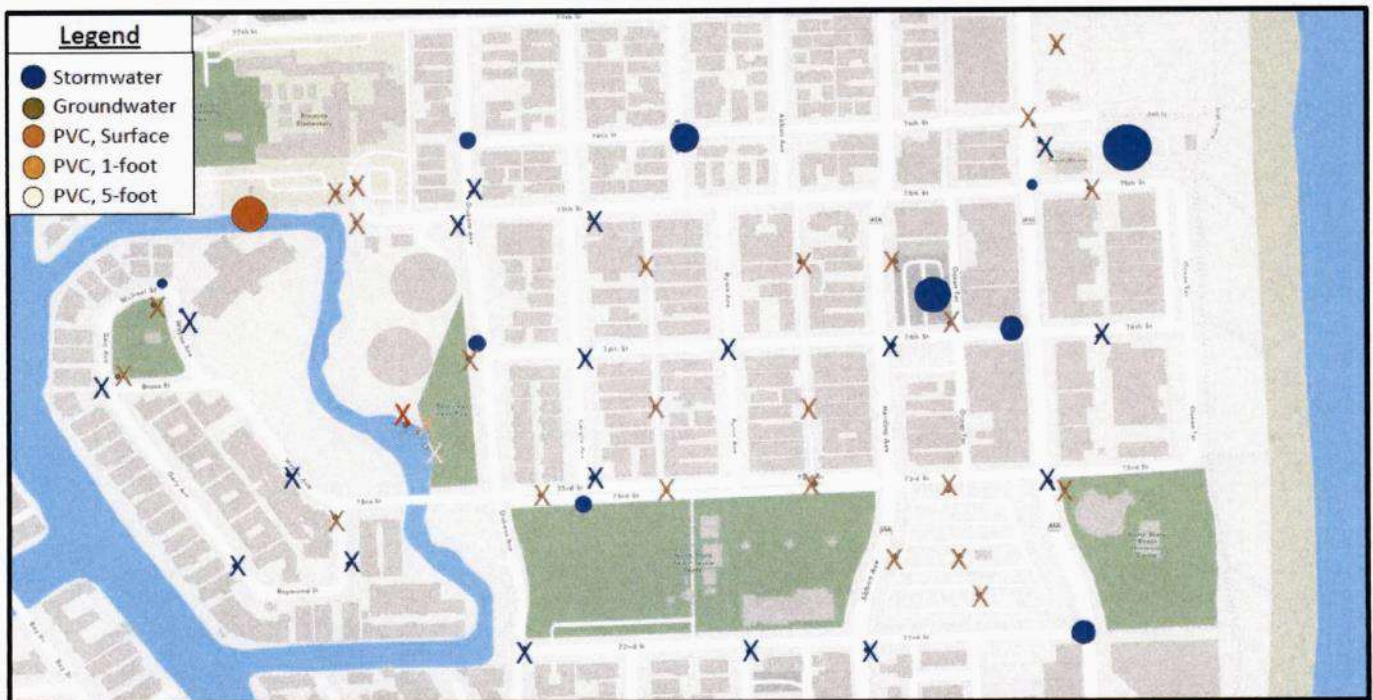
Figure V.5: Spatial distribution of dog MST marker. The “X” symbol represents samples below the detection limit.

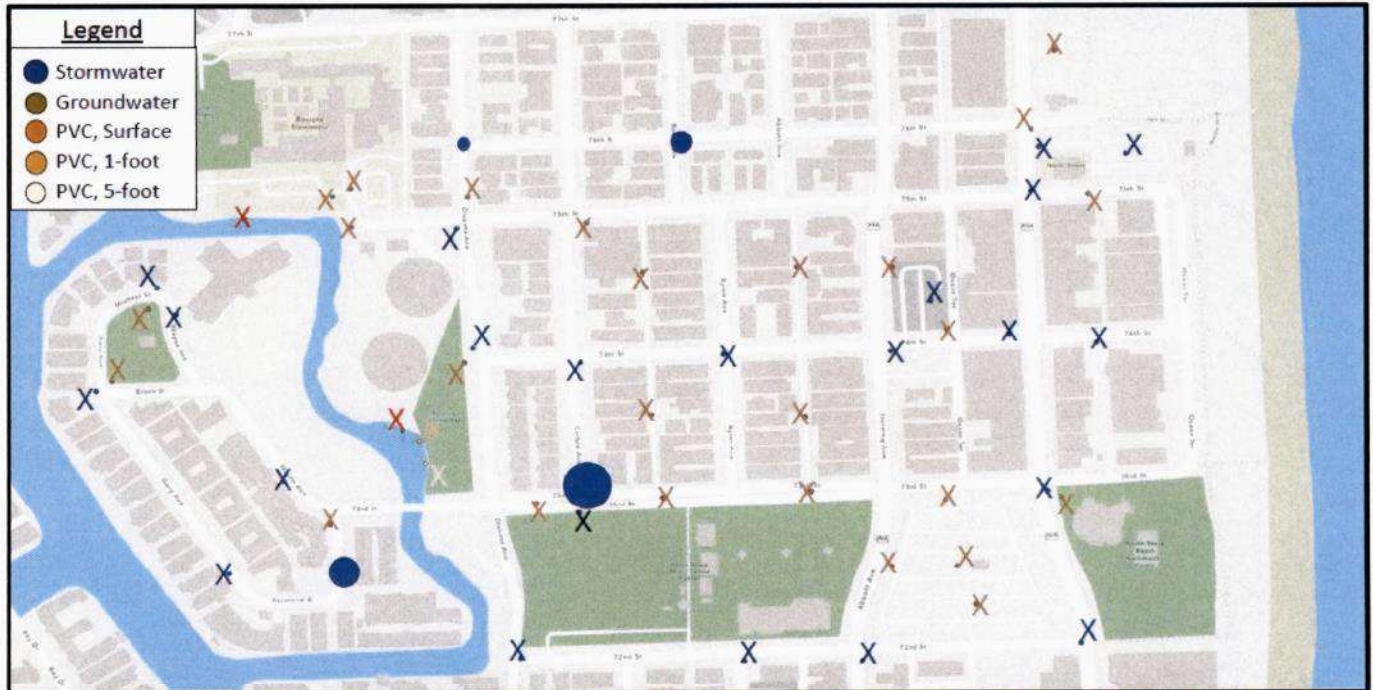
Figure V.7: Spatial distribution of gull MST marker. The “X” symbol represents samples below the detection limit.

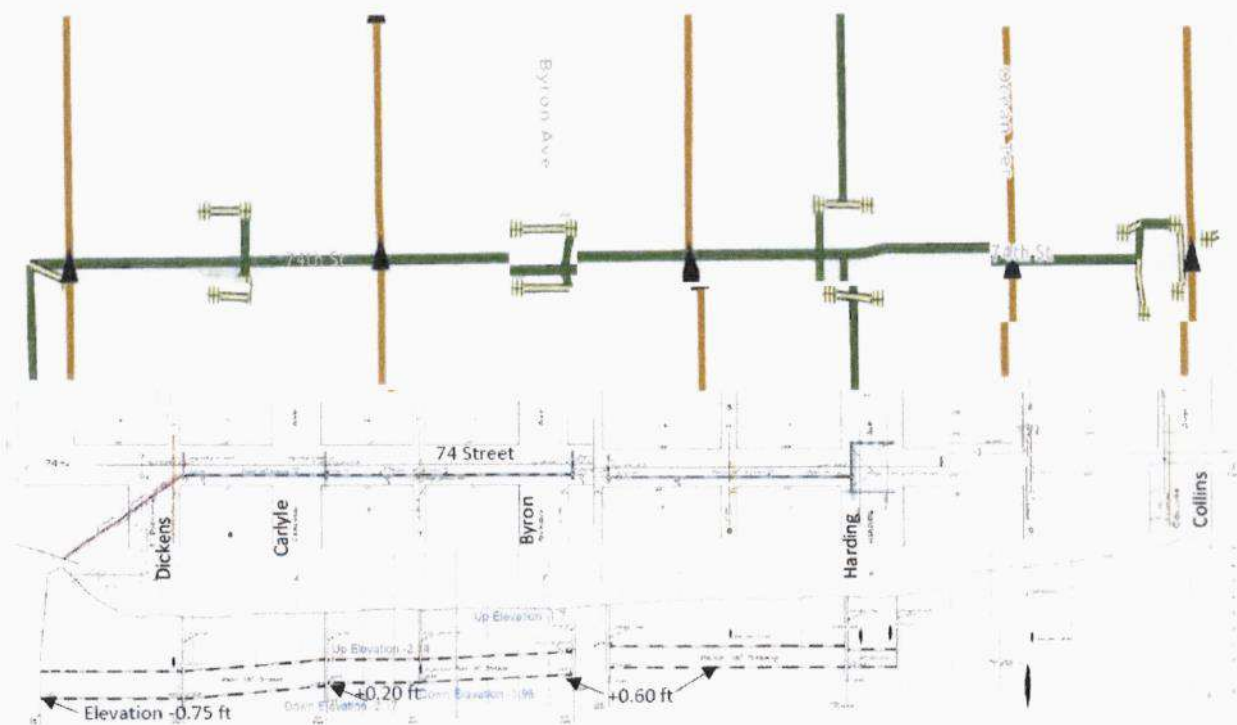
Figure B.3: Storm Conveyance Construction Drawings at 74 Street.

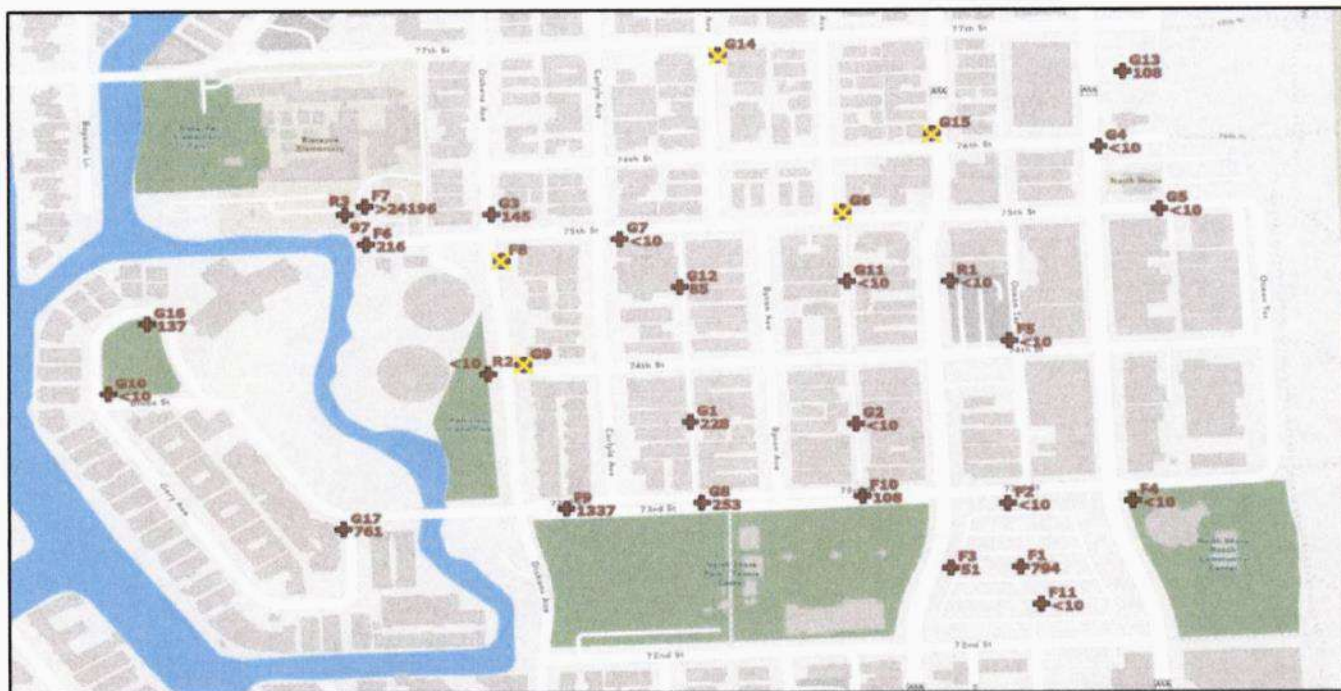
Figure C.1: Groundwater sampling sites. Sites with a yellow "X" were sites that were selected but were found to be non-viable to due excessive underground utilities and were therefore not drilled. The remaining 26 sites without the yellow "X" were sampled. The site ID is given by a "G", "F", or "R" (for proximity to gravity sewer, force main, and stormwater conveyance system, respectively) followed by a number. The number below the site ID corresponds to the enterococci concentration in the groundwater in units of MPN/100 mL.

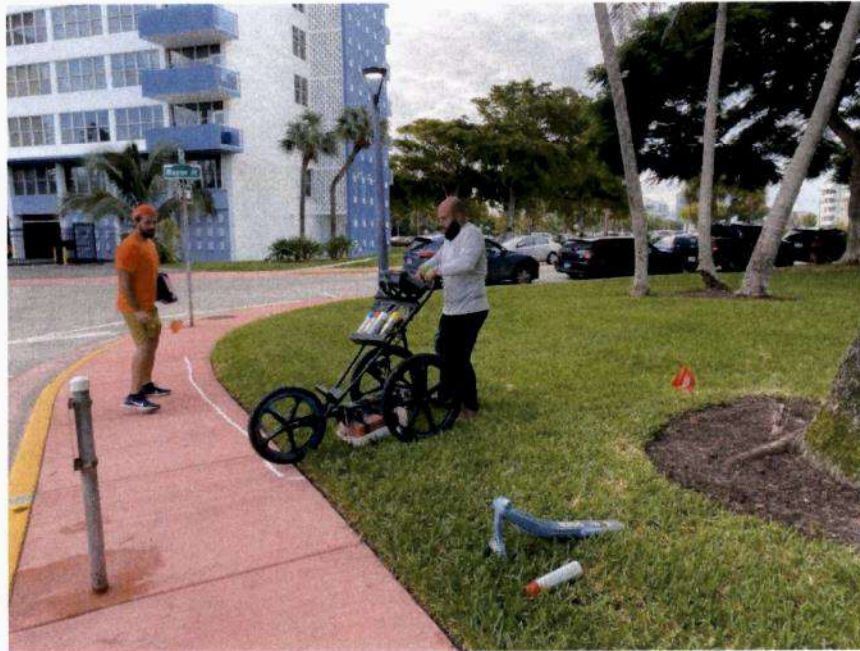
Figure C.13: Illustration of process used to identify underground utilities using ground penetrating radar. The roller device is used to obtain an overall mapping of the utilities and the handheld device (in the foreground on the grass) is used to obtain finer resolution of the underground utilities.

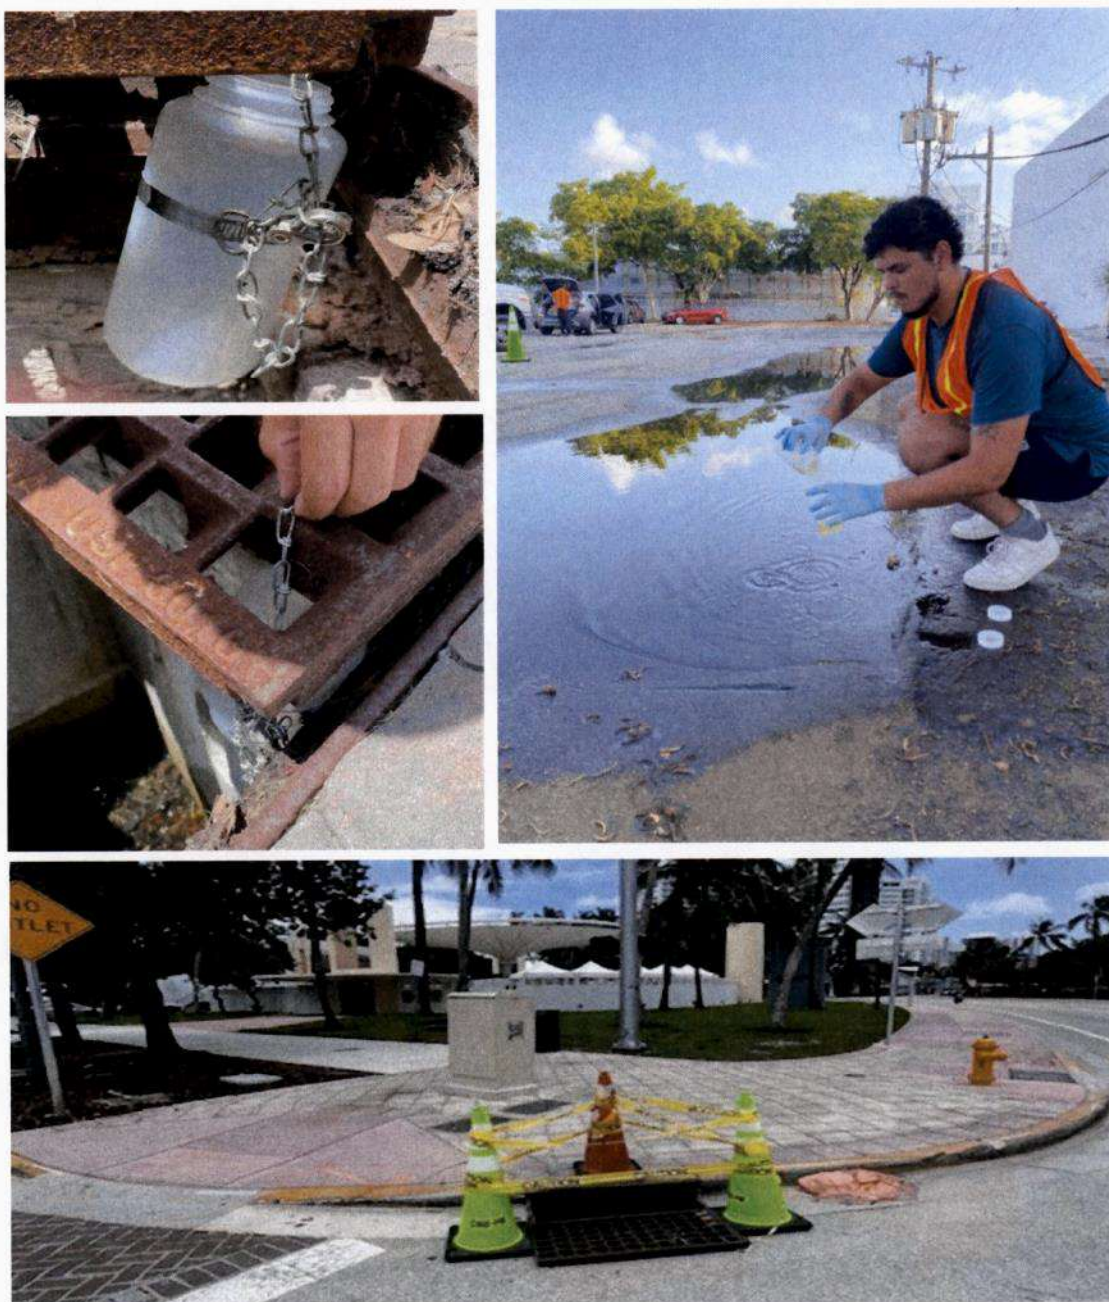
Figure C.15: Illustration of stormwater sampling. Top two square photos illustrate the field-staged bottle sample set up hanging immediately below the catch basin grate. Top right photo illustrates puddle sampling. The bottom photo illustrates the set up for in-person runoff sampling requiring the removal of the top grate or manhole cover for manual placement of a bottle to collect water as it falls into the catch basin.
