## **FINAL SCOPING REPORT**

SR A1A/COLLINS AVENUE FROM SR 907/W 63RD STREET TO 75TH STREET  
(87060000 - MP 8.640 - 9.782)  
MIAMI-DADE COUNTY, FLORIDA

FPID 250759-3-22-04

March 2024

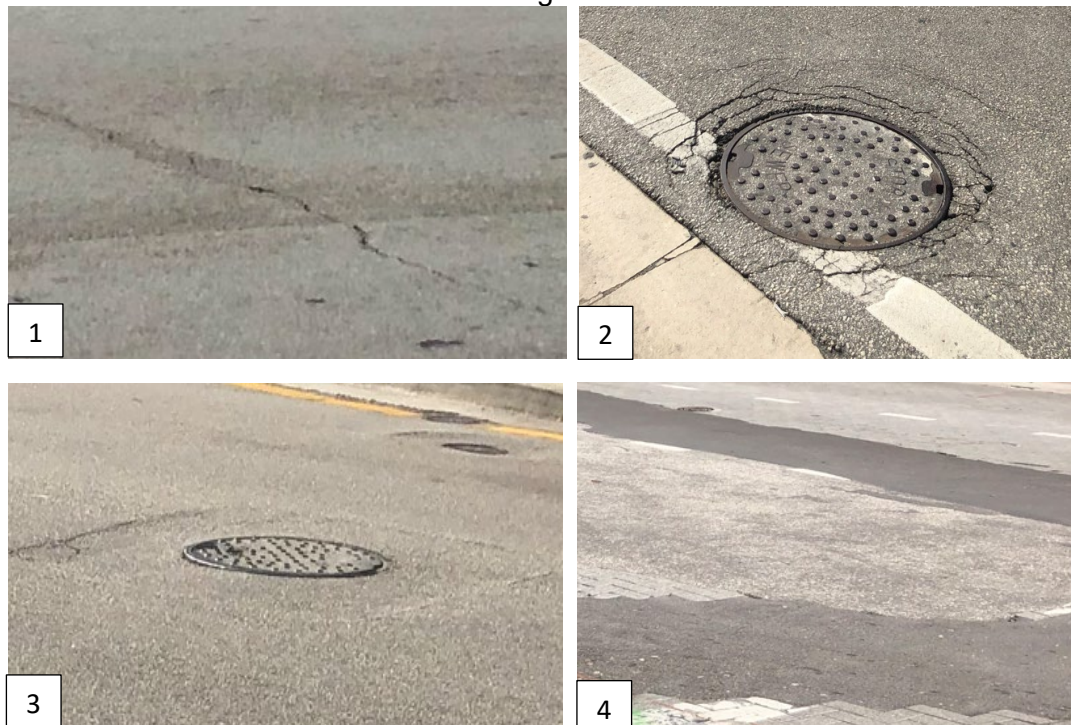
**Figure 2-1 EXISTING PAVEMENT CONDITION**  
(1-2. CRACKING, 3. DEPRESSION, 4. UTILITY CUT)

After conducting a field review on the pavement condition (PC), surface deteriorations were encountered, such as minor cracking, utility cuts, and pavement depression around manholes and valves. The pavement condition was reviewed in the Pavement Condition Survey (PCS) Ratings by State Materials Office (SMO) 2022. According to the PCS, the survey resulted in a ride evaluation of 4.6 with no projection. The cracking evaluation resulted in 6.5 with no projection. The rutting evaluation resulted in 8.0 with no project. The existing pavement will be 15 years by 2027. Refer to Appendix D-1. Figure 2-1 illustrates samples of the surface deteriorations encountered during the field review.

Assume milling and resurfacing 2.5 inches for the purpose of this scoping report. Milling recommendation is to be provided by the FDOT State Materials Office.
