2025-33559
RESOLUTION NO.

A RESOLUTION OF THE MAYOR AND CITY COMMISSION OF THE CITY OF MIAMI BEACH, FLORIDA, ACCEPTING THE RECOMMENDATION OF THE LAND USE AND SUSTAINABILITY COMMITTEE AT ITS MEETING ON MARCH 11, 2025, AND APPROVING "OPERATION CLEAN WATER" TO URGENTLY ADDRESS STREET LEVEL POLLUTANTS IN THE NORTH BEACH WATERSHED ENTERING THE STORMWATER SYSTEM AND IMPACTING PARK VIEW CANAL WATER QUALITY, AS IDENTIFIED IN THE REPORT DATED FEBRUARY 24, 2025, ENTITLED "ASSESSMENT OF ENTEROCOCCI IN GROUNDWATER AND STORMWATER AT THE MIAMI BEACH PARK VIEW CANAL."

The Administration recommends the City Commission accept the selected recommendations of the North Beach Water Quality and Park View Canal report entitled "Assessment of Enterococci in Groundwater and Stormwater at the Miami Beach Park View Canal" and adopt the "Operation Clean Water" Resolution to urgently address the specific outfalls and street level pollutants entering the stormwater system and impacting the Park View Canal water quality.

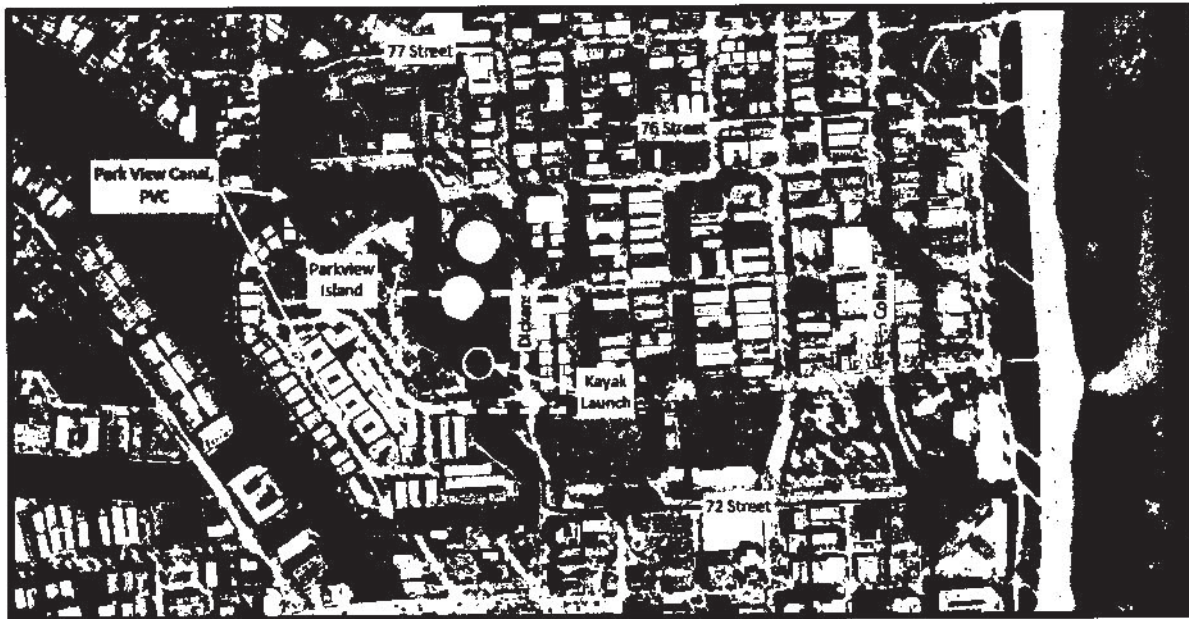
Figure I.1: Park View Canal (dark blue) and Park View Watershed (cyan blue). The areas outlined in cyan blue contribute stormwater towards the PVC. Close up of kayak launch area (yellow square) shown in Figure I.2. Base image from Google Earth (January 2023).

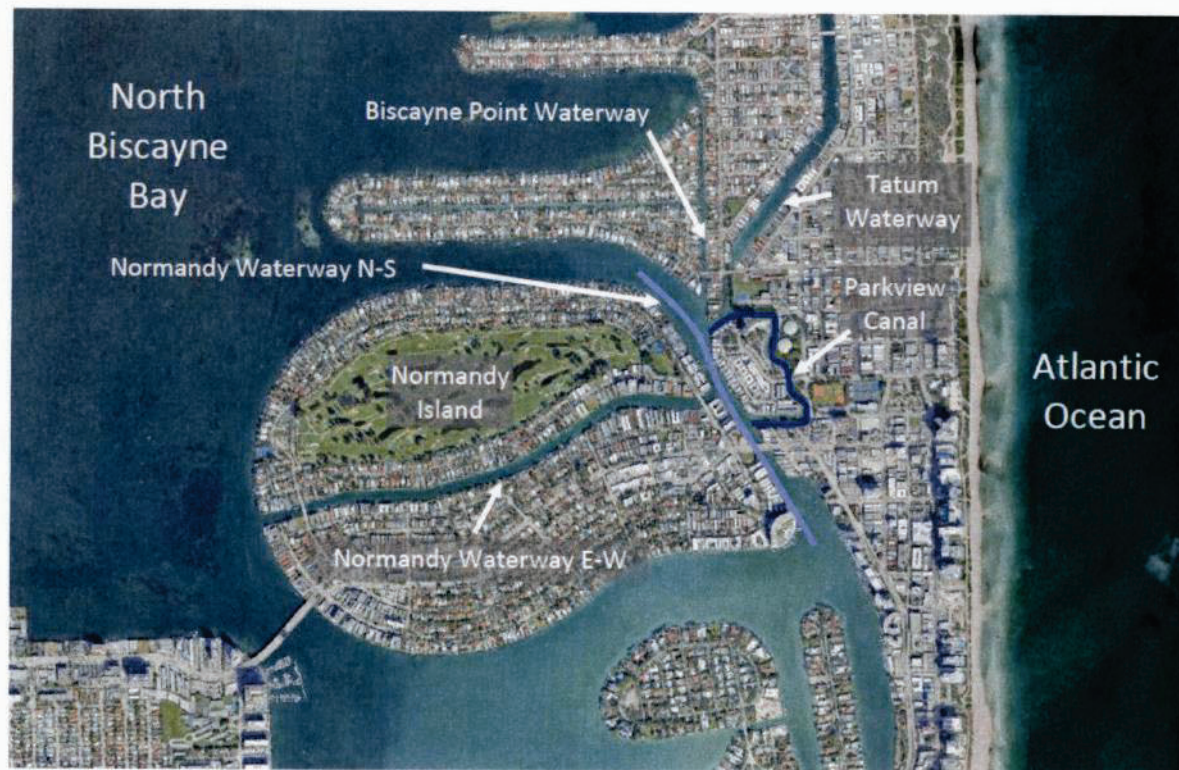
Figure I.4: Map showing locations of 1) Park View Canal, 2) Biscayne Point Waterway, 3) Tatum Waterways, 4) Normandy Waterway N-S, and 5) Normandy Waterway E-W.

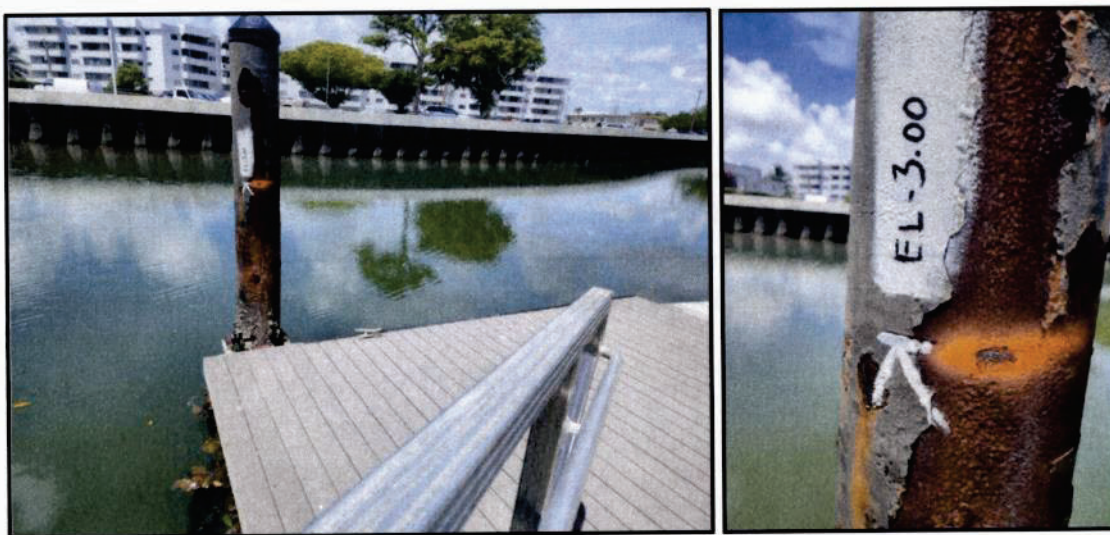
Figure III.1: Benchmark established at the Kayak Launch of the PVC showing the elevation as 3.00 feet NAVD88. Benchmark and photos courtesy of M.G. Vera and Associates and TYLin.

To establish a relationship between water surface elevation at the NOAA tidal station and the PVC, a benchmark was needed. This benchmark was installed by M.G. Vera and Associates (Mark Sowers) in collaboration with TYLin (Jeffrey Marcus) during the week of August 5, 2024. The benchmark is located on a piling (southwest corner) of the Kayak Launch (Figure III.1). The elevation of the benchmark is 3.00 feet referenced to the National American Vertical Datum of 1988 (NAVD88). This benchmark has since been used to measure the elevation of the PVC water surface by measuring the vertical distance from the benchmark to the water's surface. Measurements of PVC water surface elevation were taken hourly from 6:00 am to 5:00 pm on August 15, 2024. Additional spot checks were made on August 6, 2024, at 11:00 am, 1:00 pm and 3:15 pm and on September 19, 2024, at 2:45 pm and at 4:07 pm.

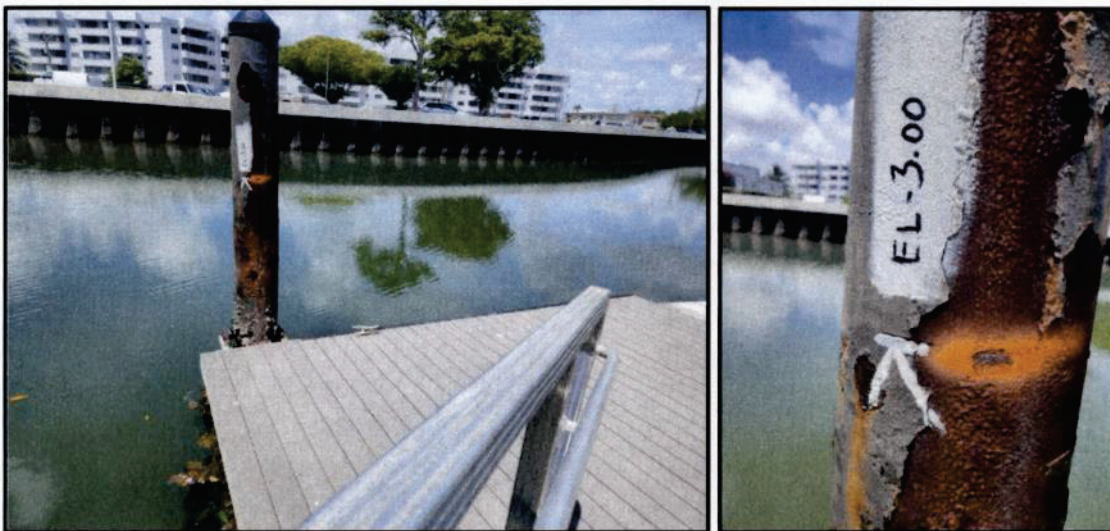
Figure III.1: Benchmark established at the Kayak Launch of the PVC showing the elevation as 3.00 feet NAVD88. Benchmark and photos courtesy of M.G. Vera and Associates and TYLin.

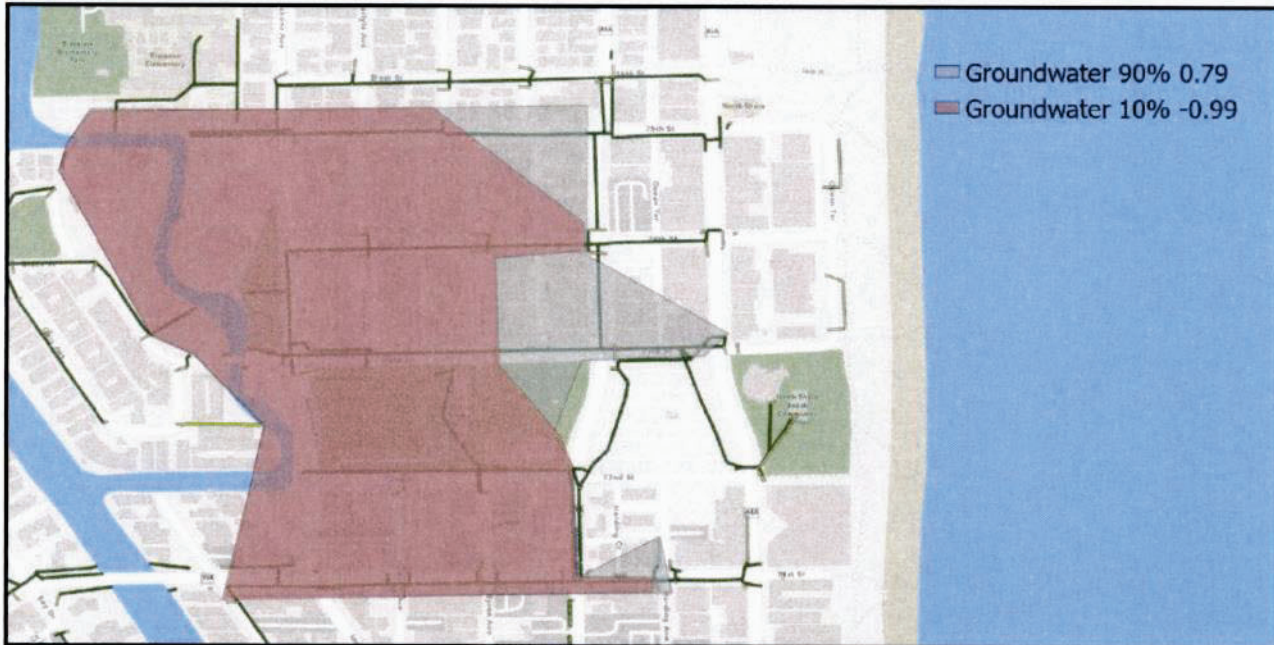
Figure III.5: Stormwater conveyance system with areas of groundwater inundation shown during the lowest 10% elevation (-0.99 ft NGVD) and the highest 90% elevation (0.79 ft NGVD).

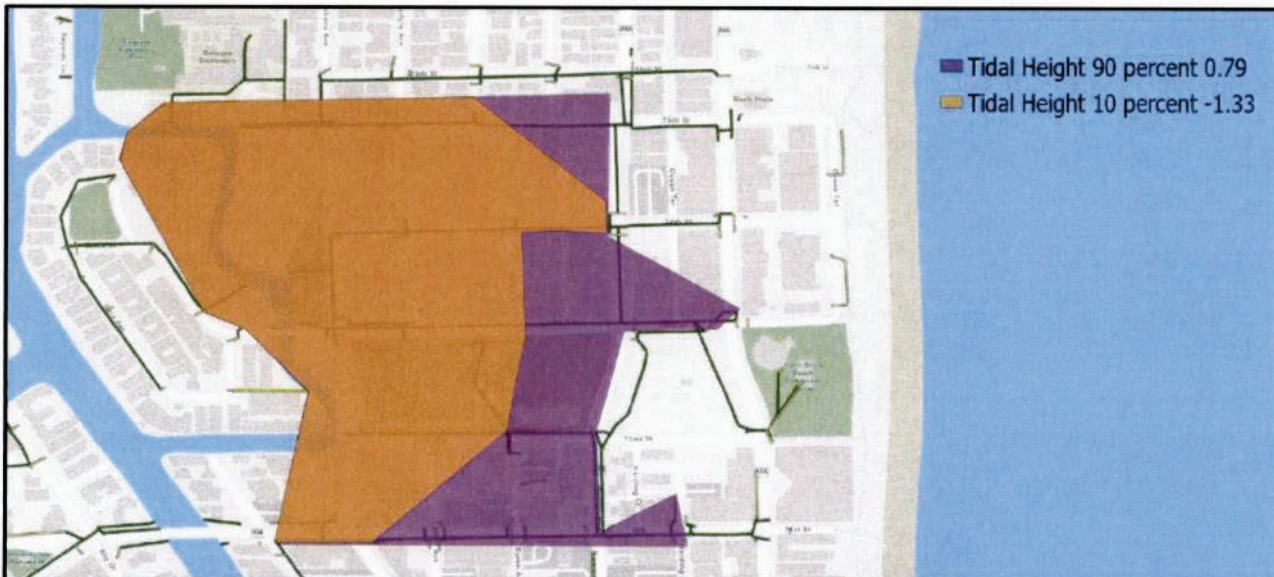
Figure III.6: Stormwater conveyance system with areas of tidal inundation shown during the lowest 10% elevation (-1.33 ft NGVD) and the highest 90% elevation (0.79 ft NGVD). The reference for the tidal data is the NOAA station located on Virginia Key at Bear Cut.

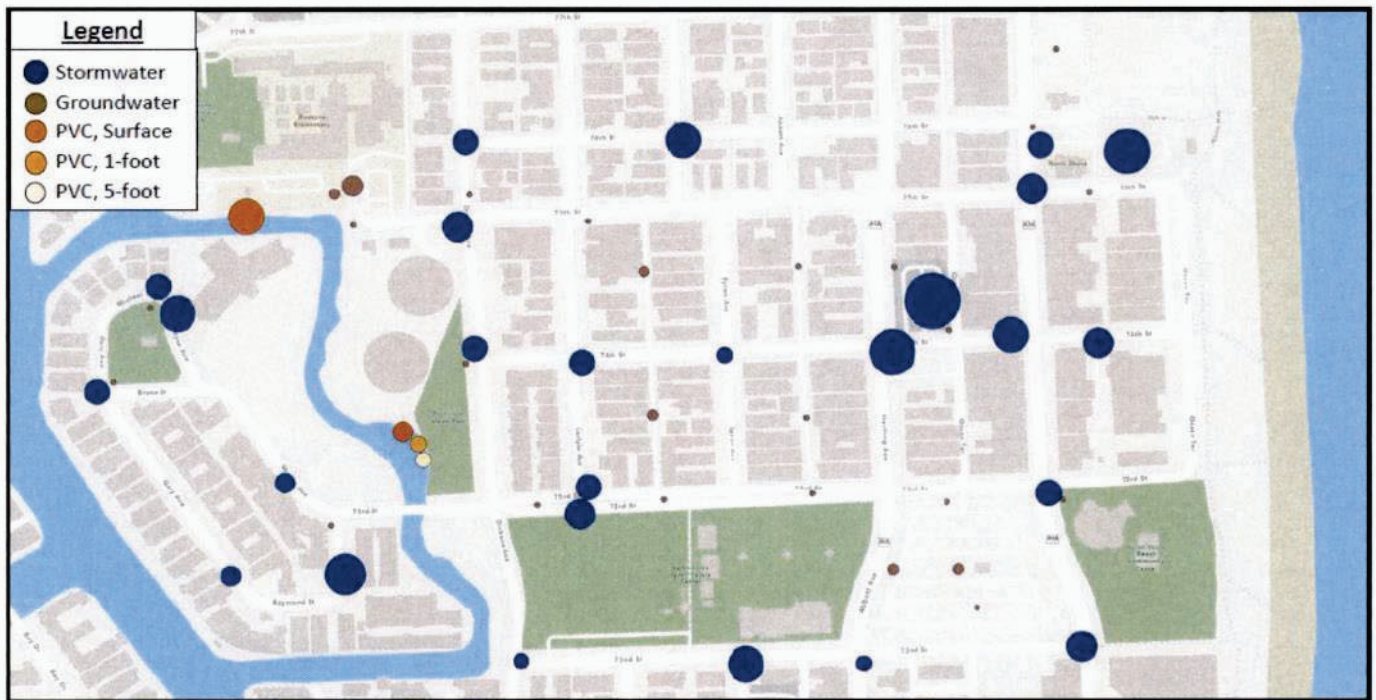
Figure V.3: Spatial distribution of enterococci (Entero-1A) as measured by qPCR.

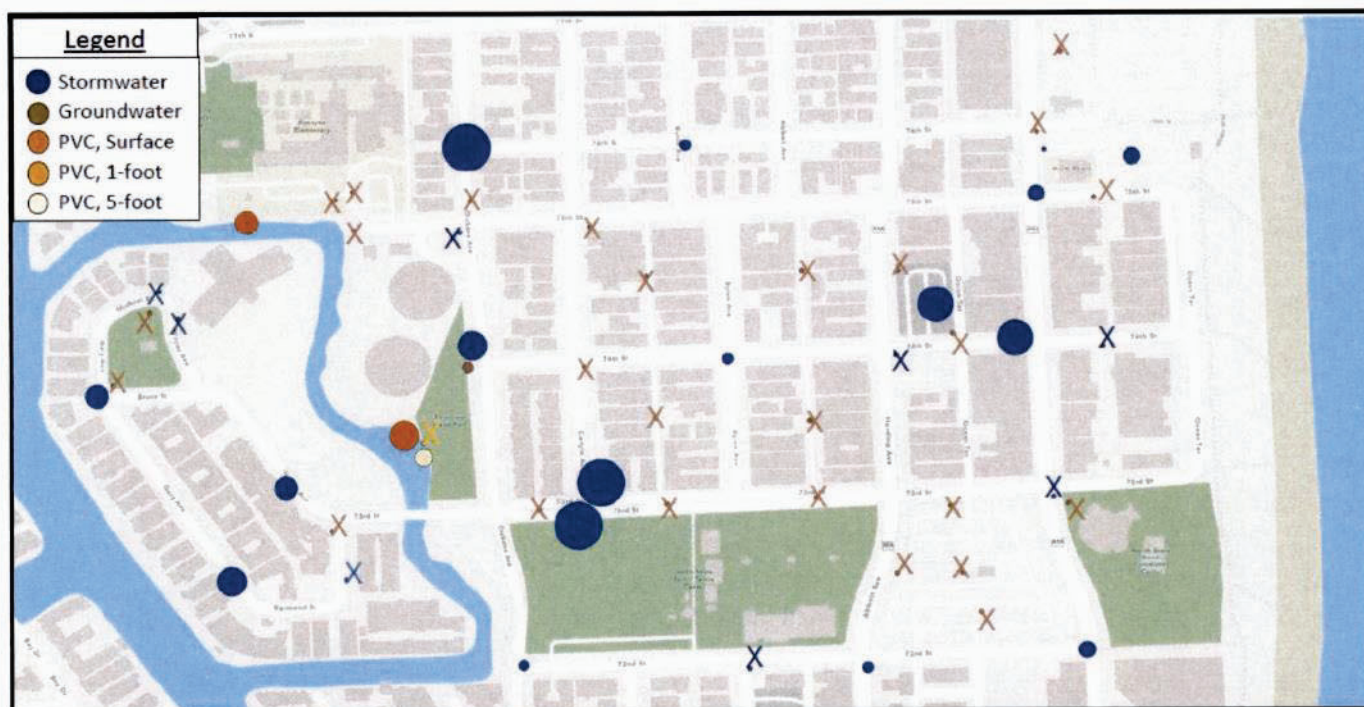
Figure V.4: Spatial distribution of human MST marker. The “X” symbol represents samples below the detection limit.

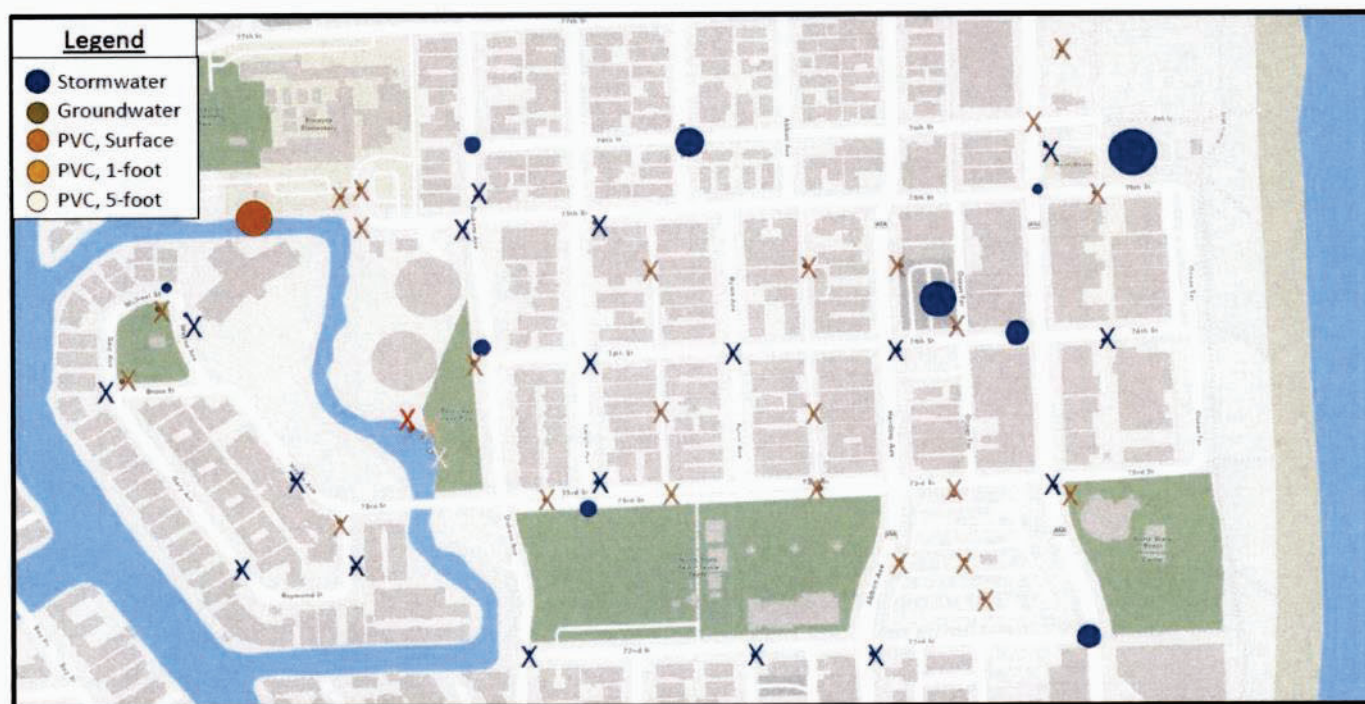
Figure V.5: Spatial distribution of dog MST marker. The “X” symbol represents samples below the detection limit.

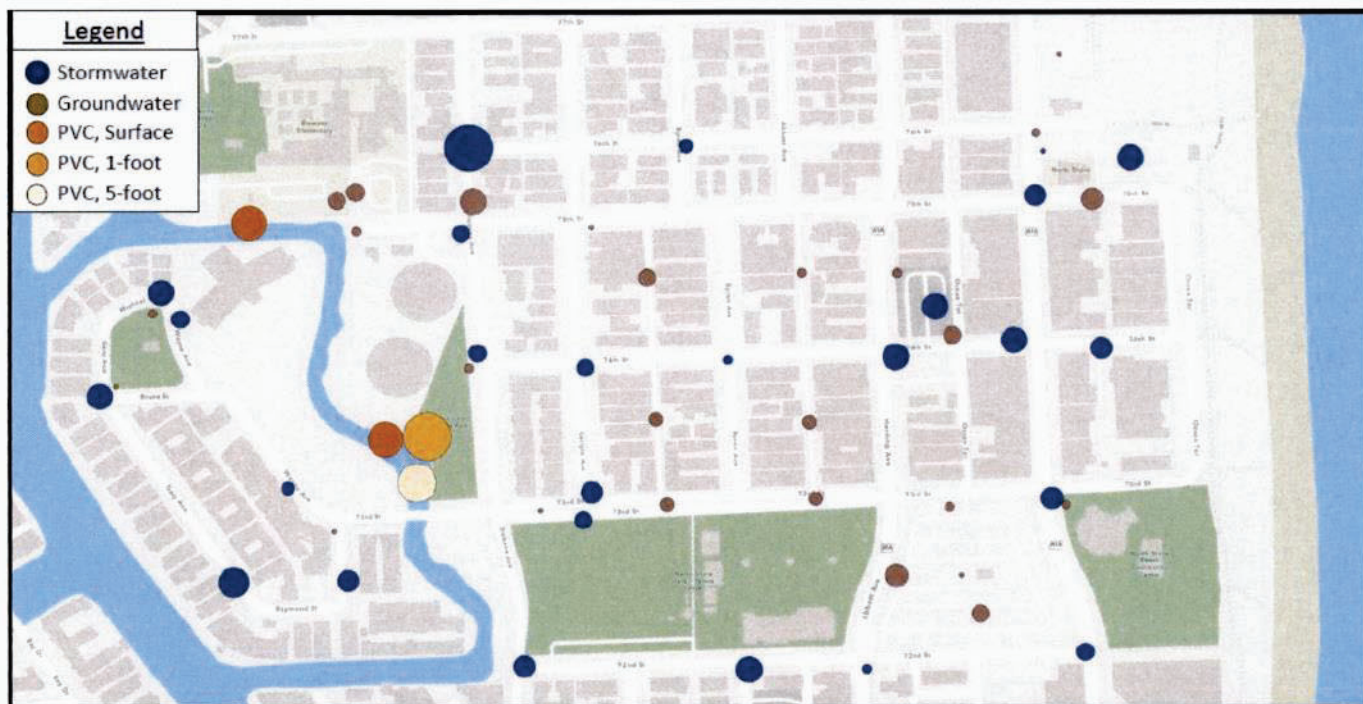
Figure V.6: Spatial distribution of general bird MST marker. The “X” symbol represents samples below the detection limit.

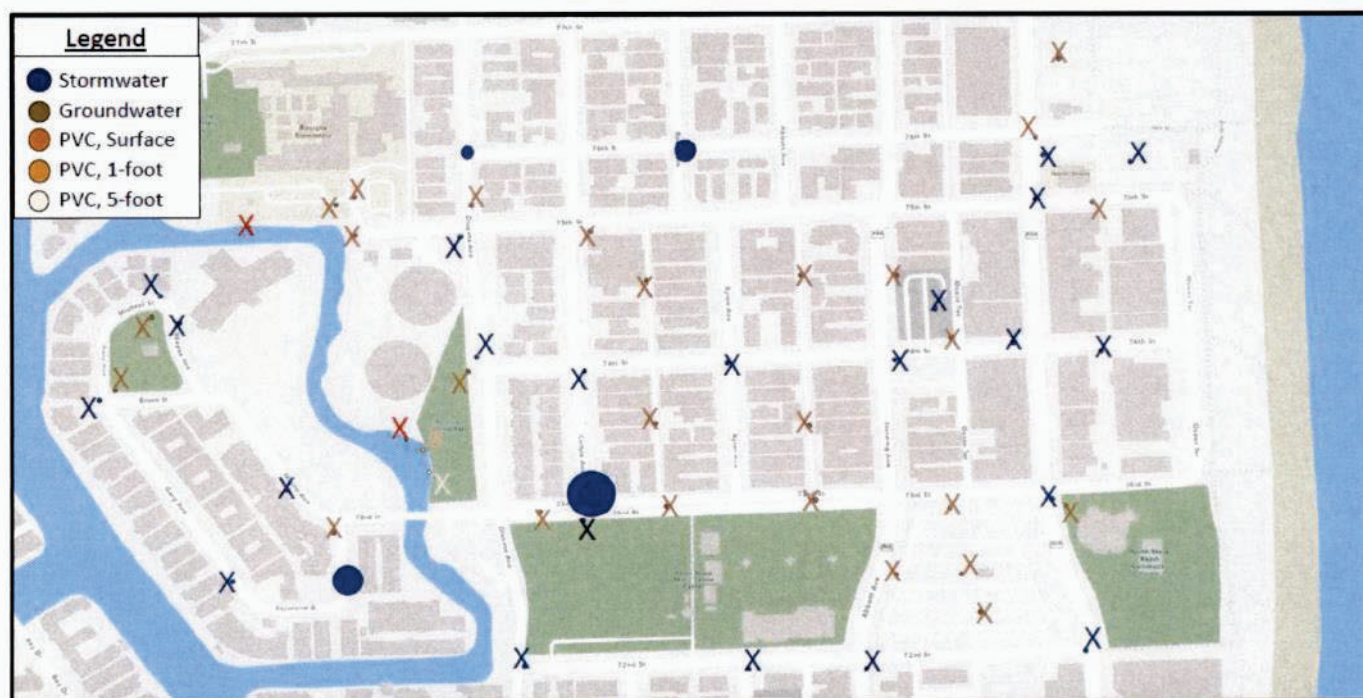
Figure V.7: Spatial distribution of gull MST marker. The “X” symbol represents samples below the detection limit.

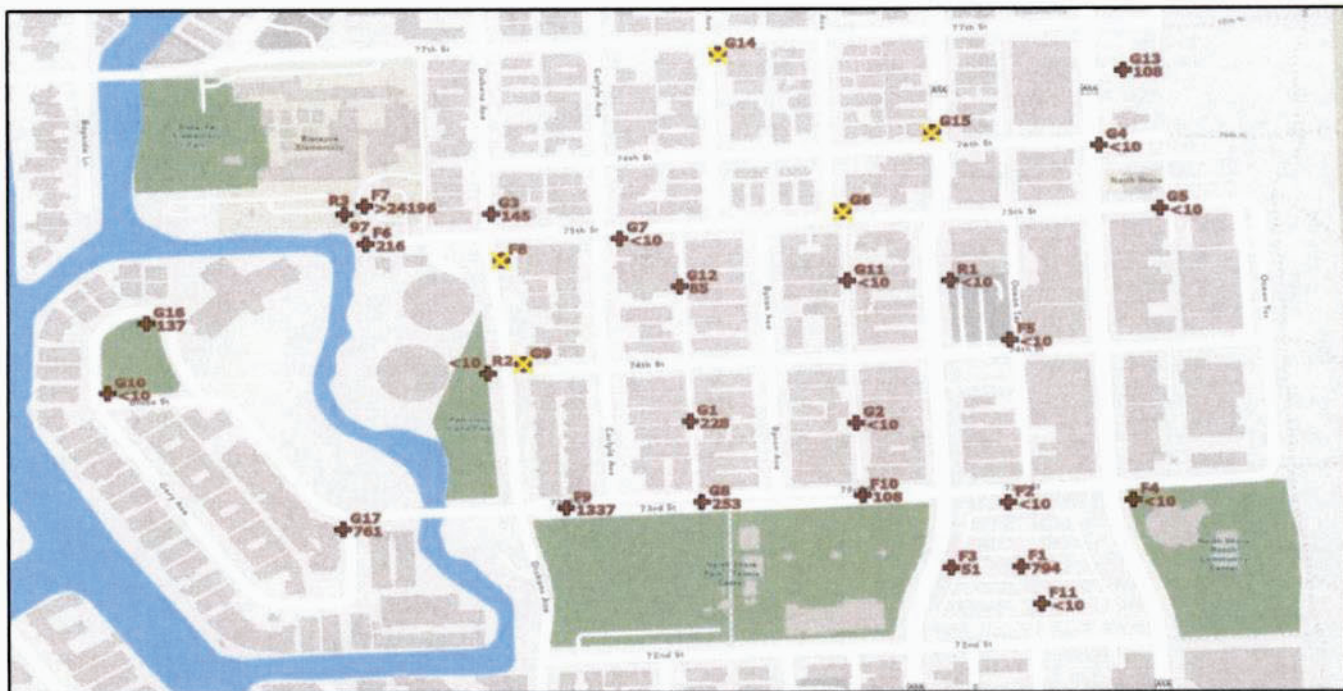
Figure C.1: Groundwater sampling sites. Sites with a yellow “X” were sites that were selected but were found to be non-viable due to excessive underground utilities and were therefore not drilled. The remaining 26 sites without the yellow “X” were sampled. The site ID is given by a “G”, “F”, or “R” (for proximity to gravity sewer, force main, and stormwater conveyance system, respectively) followed by a number. The number below the site ID corresponds to the enterococci concentration in the groundwater in units of MPN/100 mL.

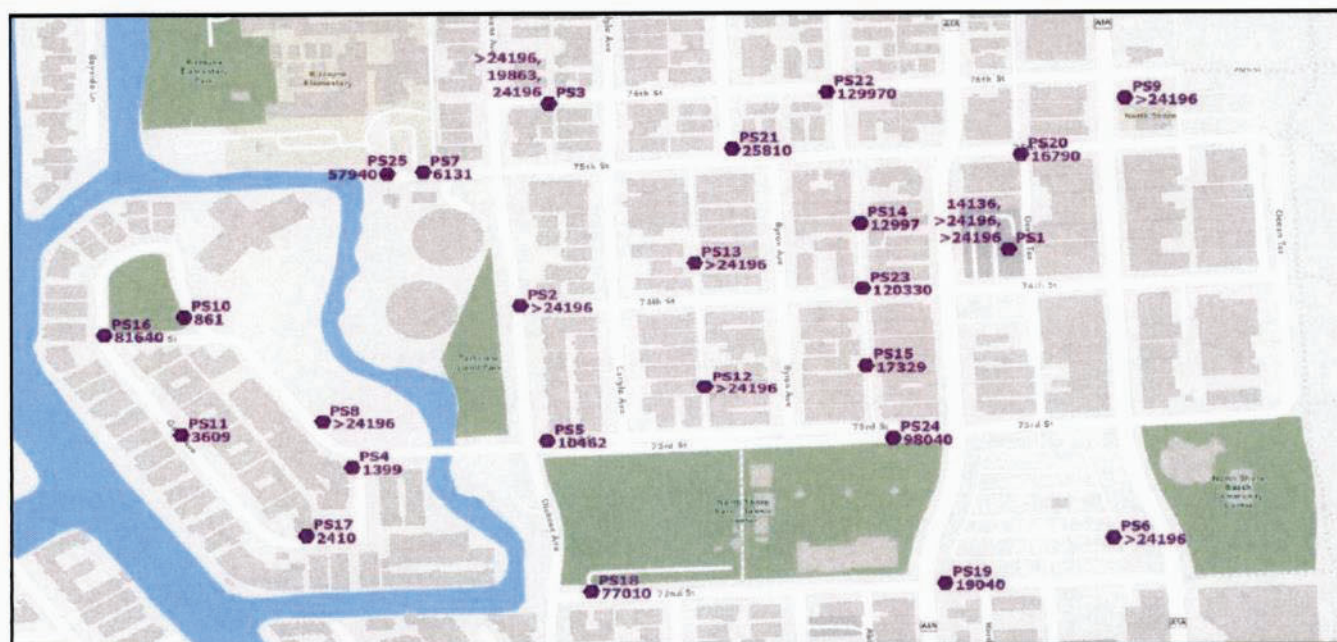
Figure C.2: Puddle sampling sites. The site ID is given by “PS” followed by a number. The number below the site ID corresponds to the enterococci concentration in the puddle water in units of MPN/100 mL.

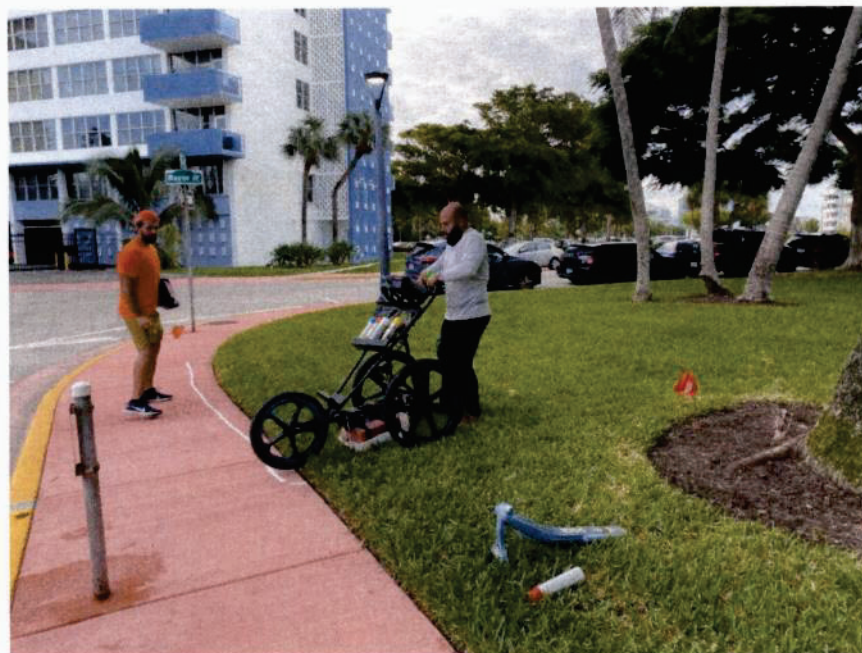
Figure C.13: Illustration of process used to identify underground utilities using ground penetrating radar. The roller device is used to obtain an overall mapping of the utilities and the handheld device (in the foreground on the grass) is used to obtain finer resolution of the underground utilities.

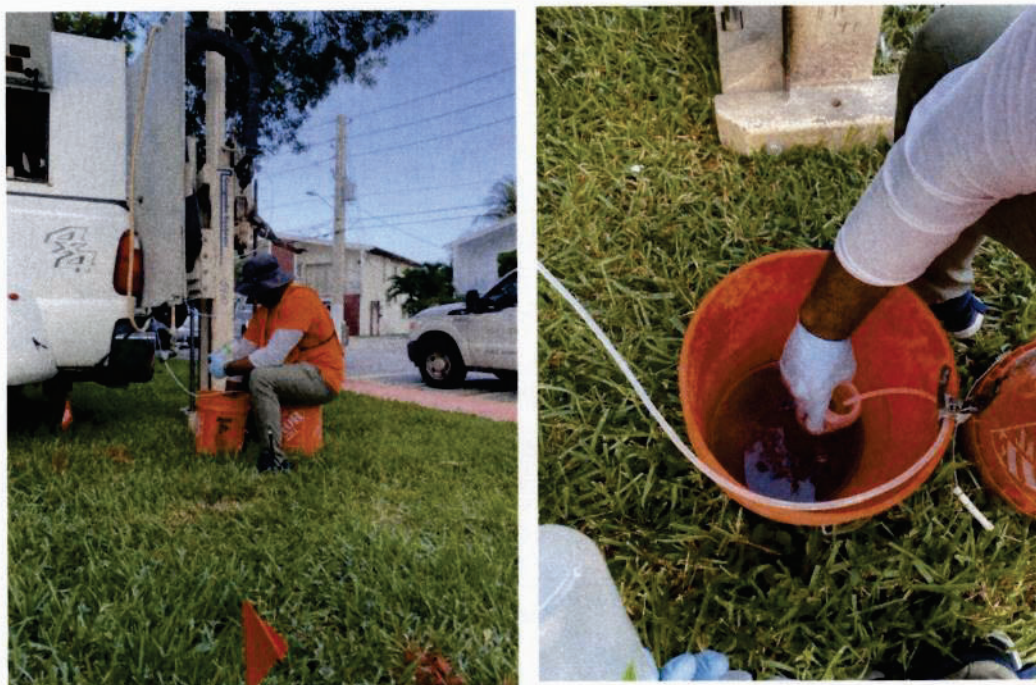
Figure C.14: Illustration of groundwater sample collection from behind the pickup truck mounted drill rig.

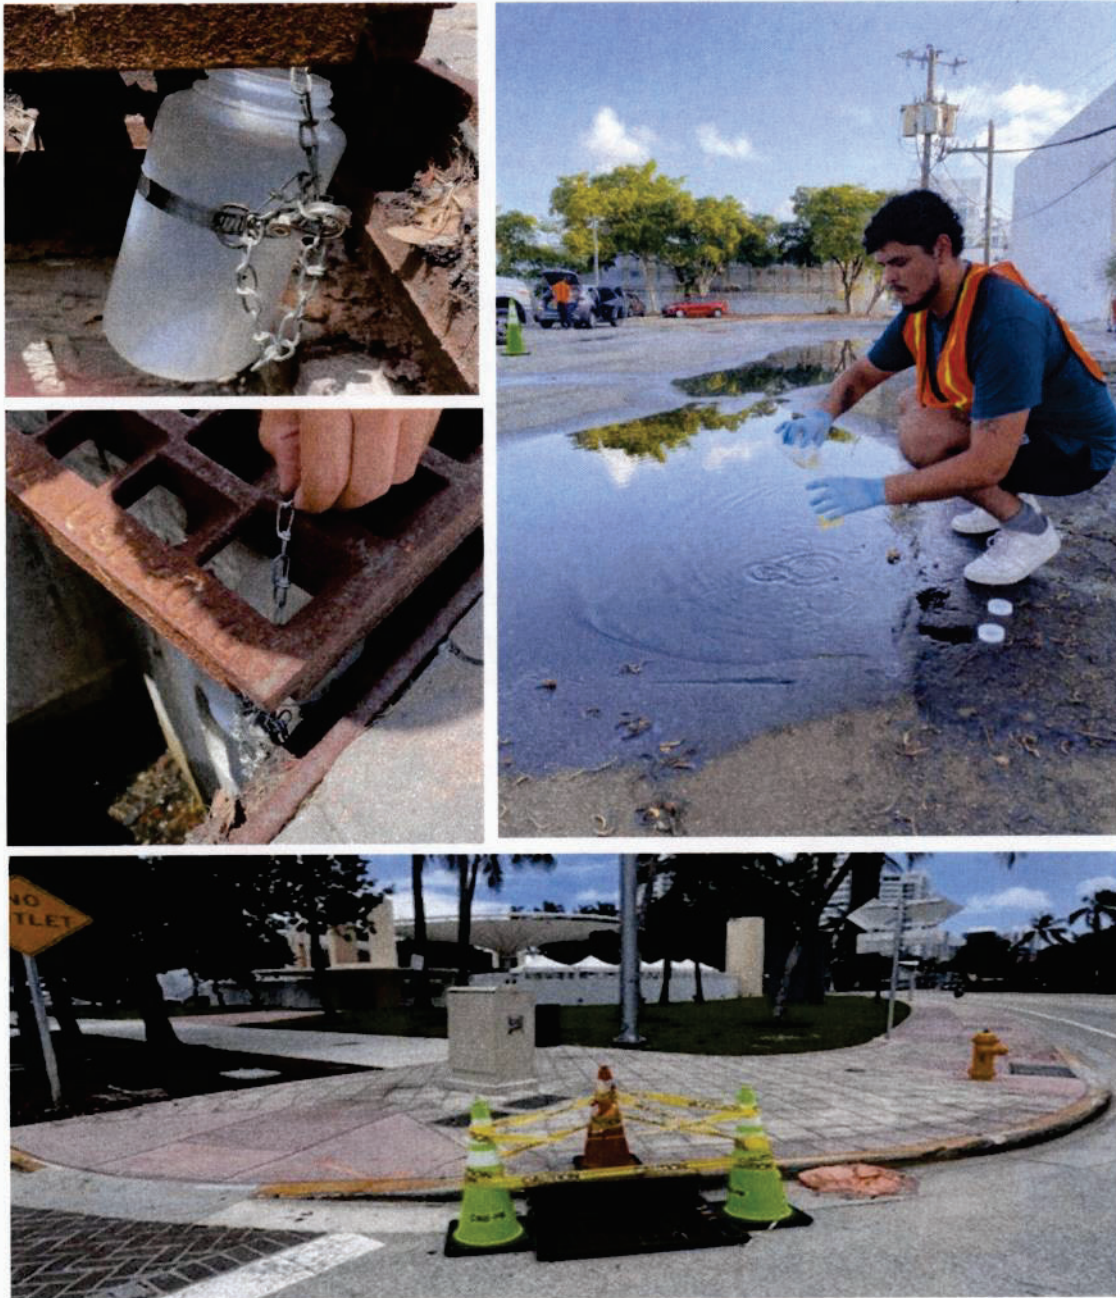
Figure C.15: Illustration of stormwater sampling. Top two square photos illustrate the field-staged bottle sample set up hanging immediately below the catch basin grate. Top right photo illustrates puddle sampling. The bottom photo illustrates the set up for in-person runoff sampling requiring the removal of the top grate or manhole cover for manual placement of a bottle to collect water as it falls into the catch basin.

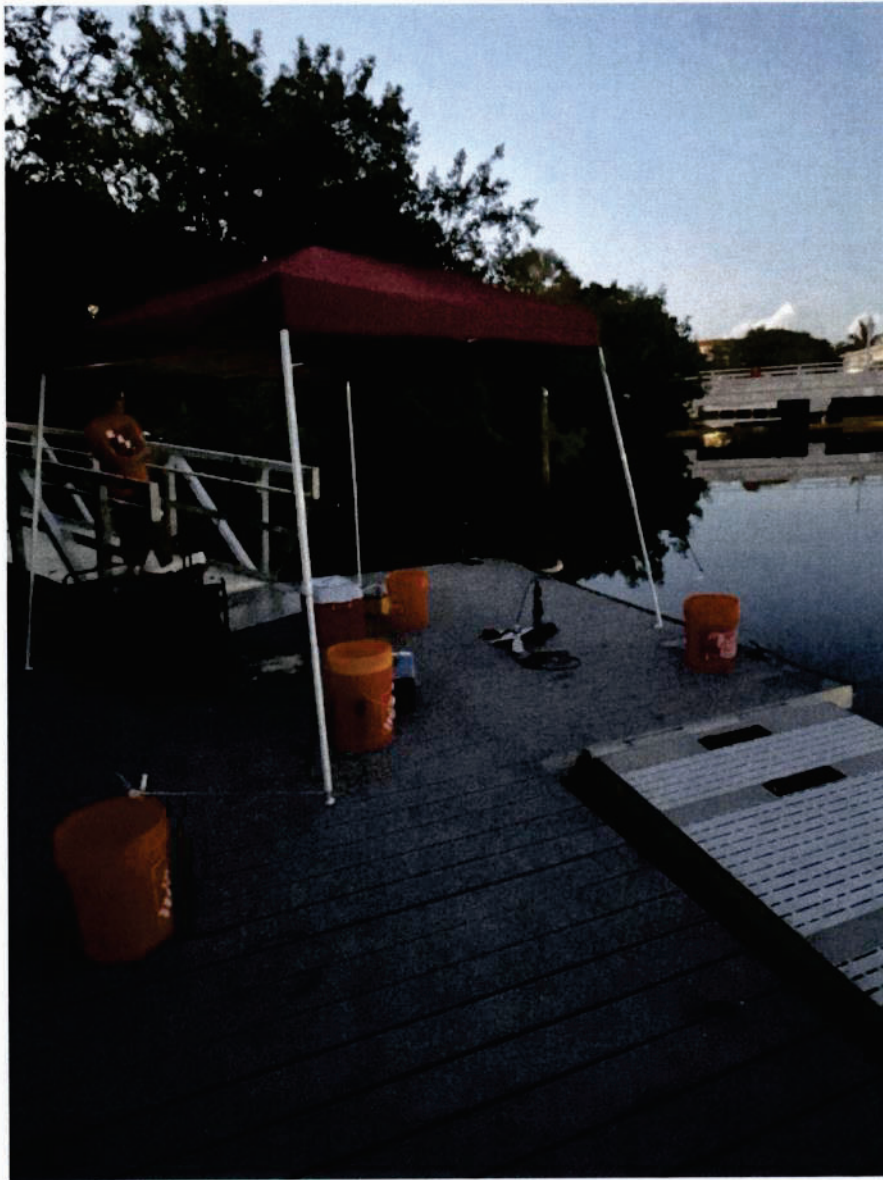
Figure C.16: Photo of sample collection set up at the Kayak Launch towards the beginning of the 12-hour sampling event.

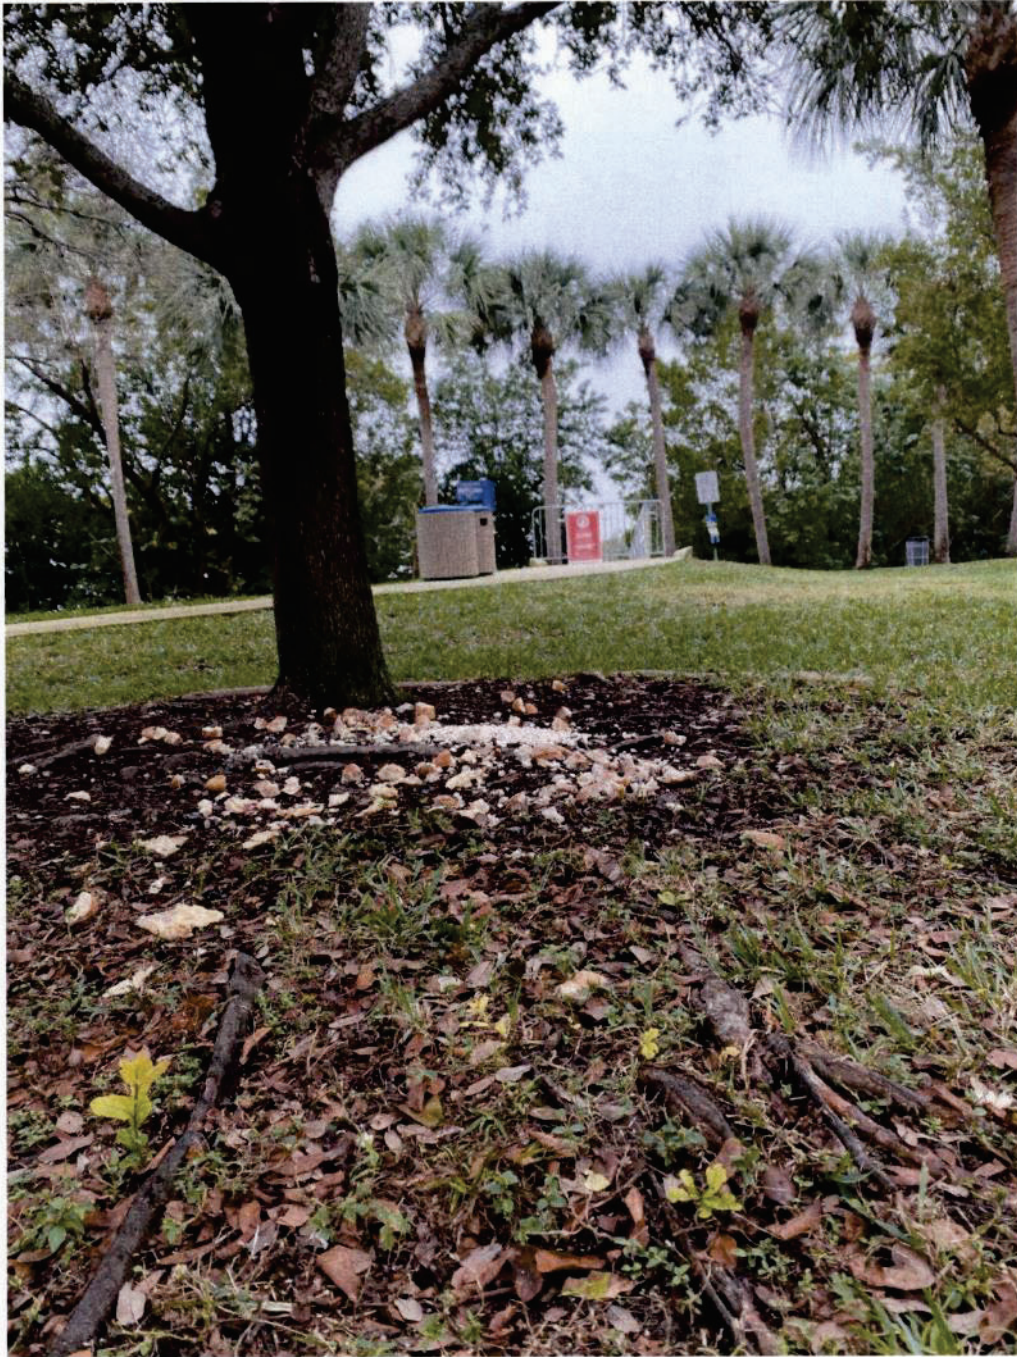
Figure C.18: Photo of animal feeding station of bread and donuts taken on January 31, 2025, near the entrance to the Kayak Launch. Prior to taking the photo, a flock of birds were seen at the station. These birds flew away once the station was approached to take this photo.
