Assessment of Enterococci in Groundwater and Stormwater at the Miami Beach Park View Canal

DRAFT REPORT

Ayaaz (Johann) Amirali M.S., Cristina Fayad Martinez M.S., Aarohe Talati,
Diego Lopez Oranday, Larissa Montas Ph.D., Isabela Puente, Rivka Reiner, Matthew Roca,
Helena Solo-Gabriele, Ph.D., P.E.

University of Miami, Coral Gables, FL
Department of Chemical, Environmental, and Materials Engineering

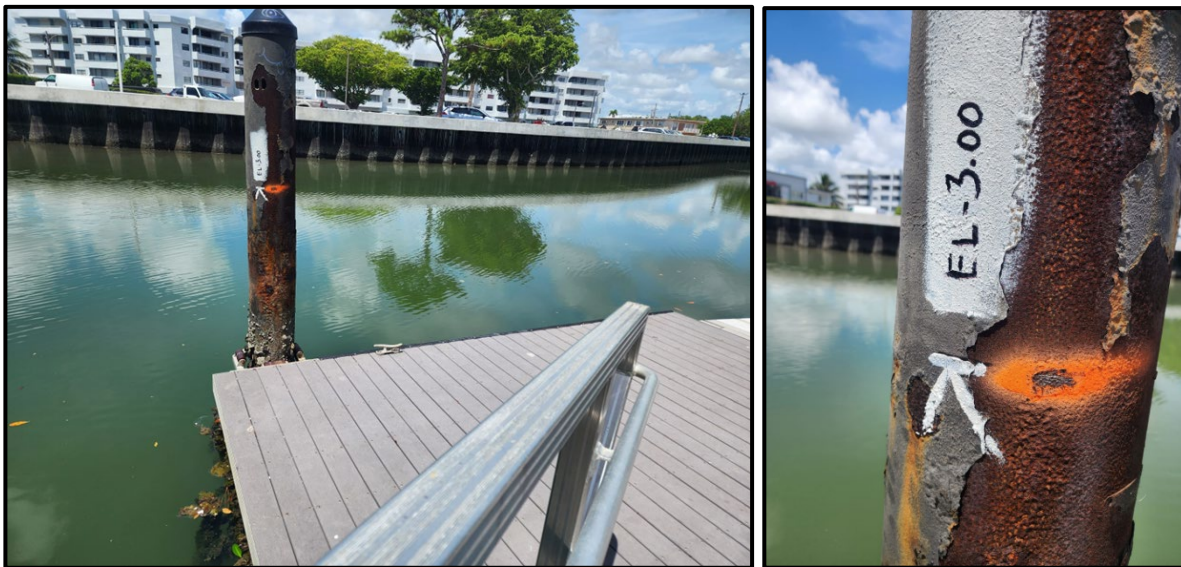
Figure III.1: Benchmark established at the Kayak Launch of the PVC showing the elevation as 3.00 feet NAVD88. Benchmark and photos courtesy of M.G. Vera and Associates and TYLin.

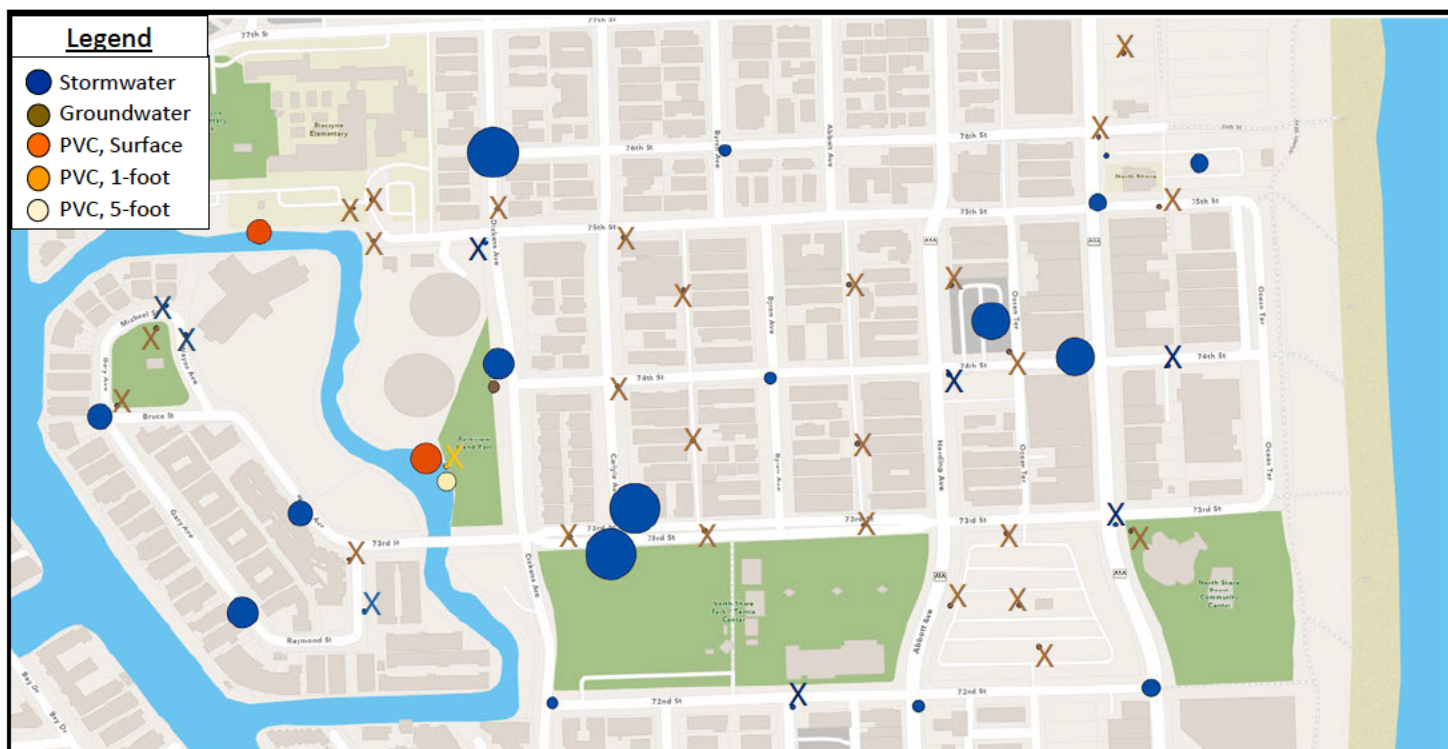
Figure V.4: Spatial distribution of human MST marker. The “X” symbol represents samples below the detection limit.

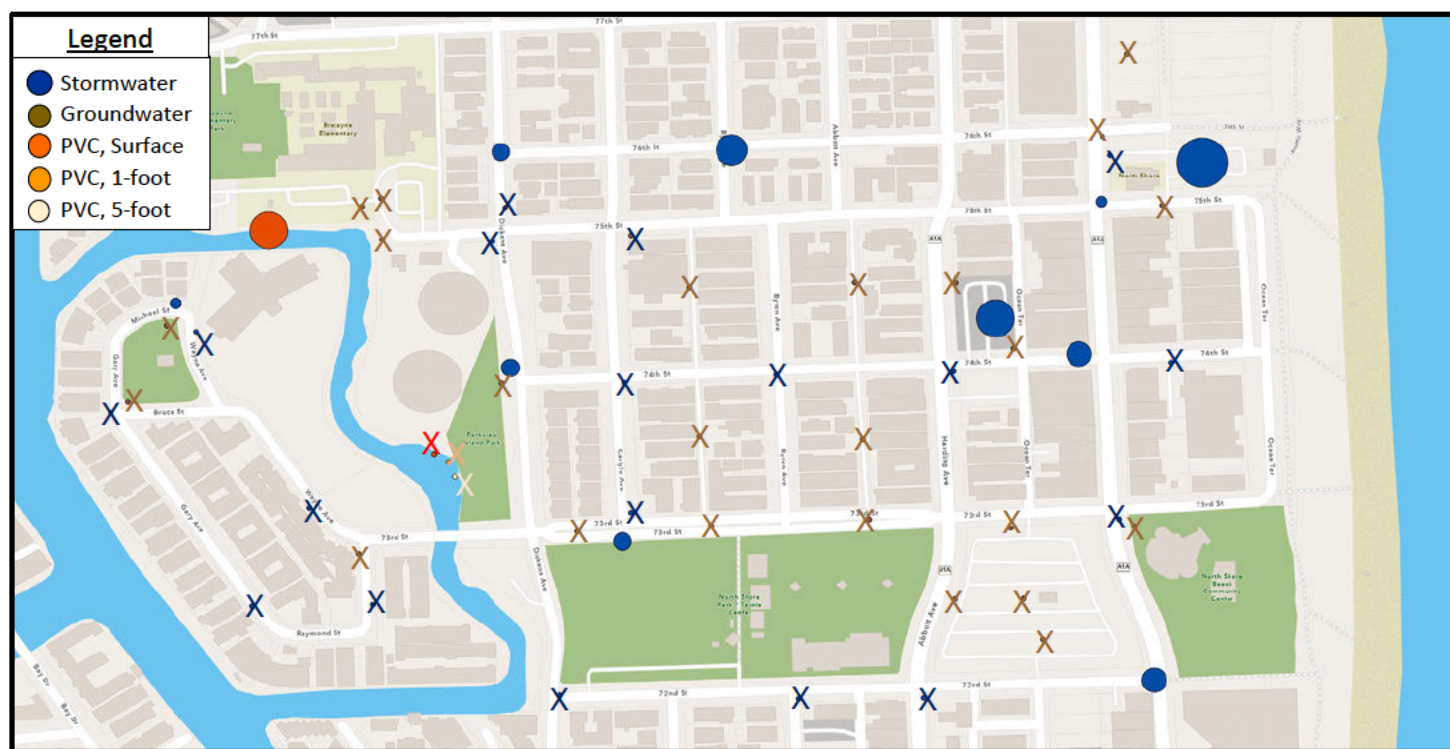
Figure V.5: Spatial distribution of dog MST marker. The “X” symbol represents samples below the detection limit.

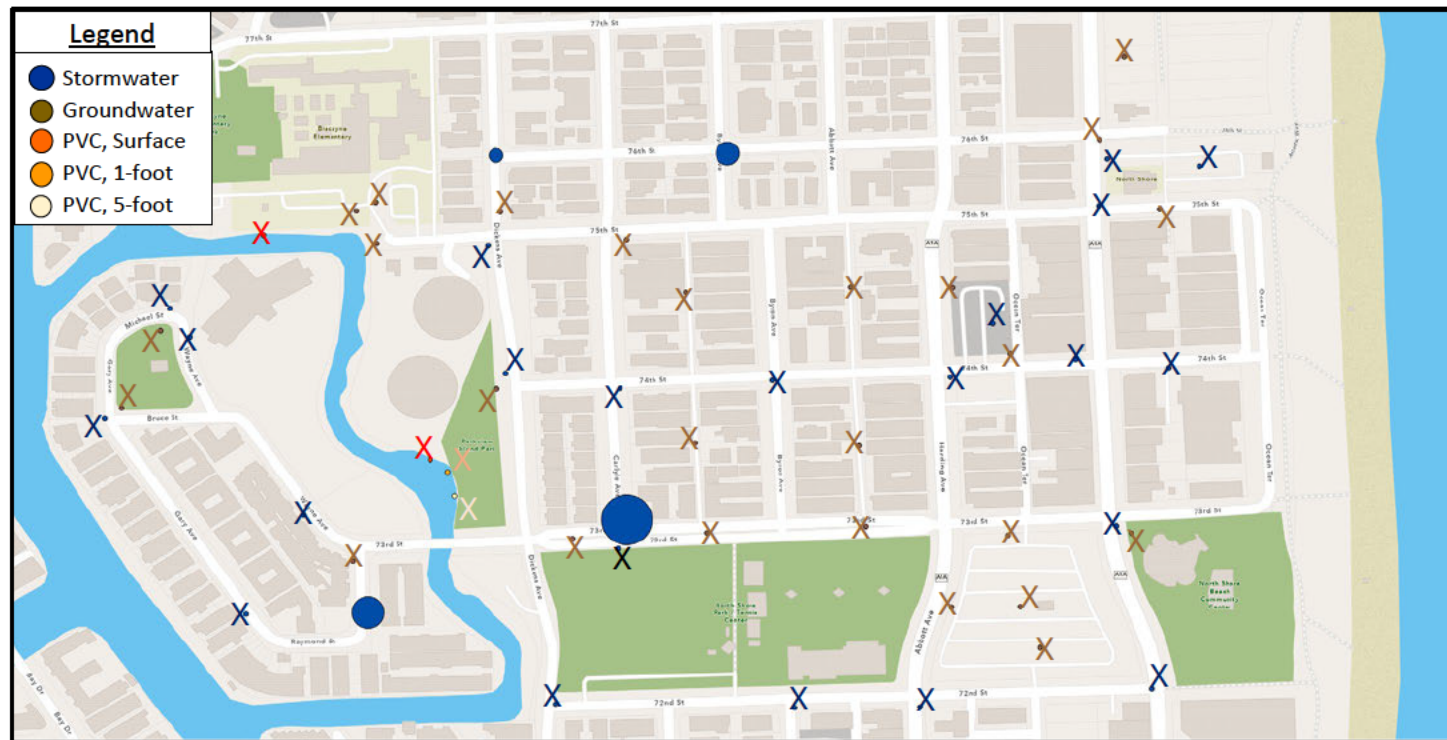
Figure V.7: Spatial distribution of gull MST marker. The “X” symbol represents samples below the detection limit.

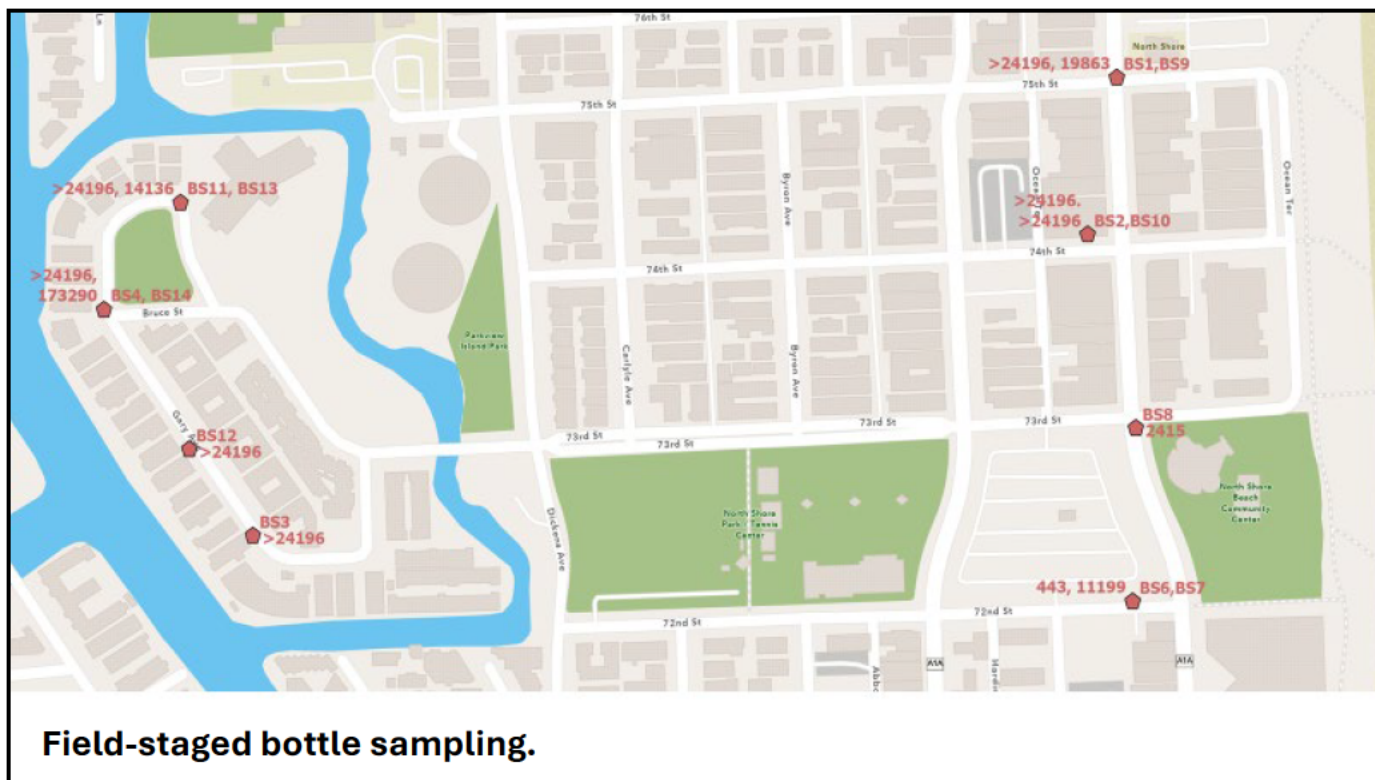
Figure C.3: Field-staged sampling sites. The site ID is given by “BS” followed by a number. The number below the site ID corresponds to the enterococci concentration in the field-staged bottle sample in units of MPN/100 mL.

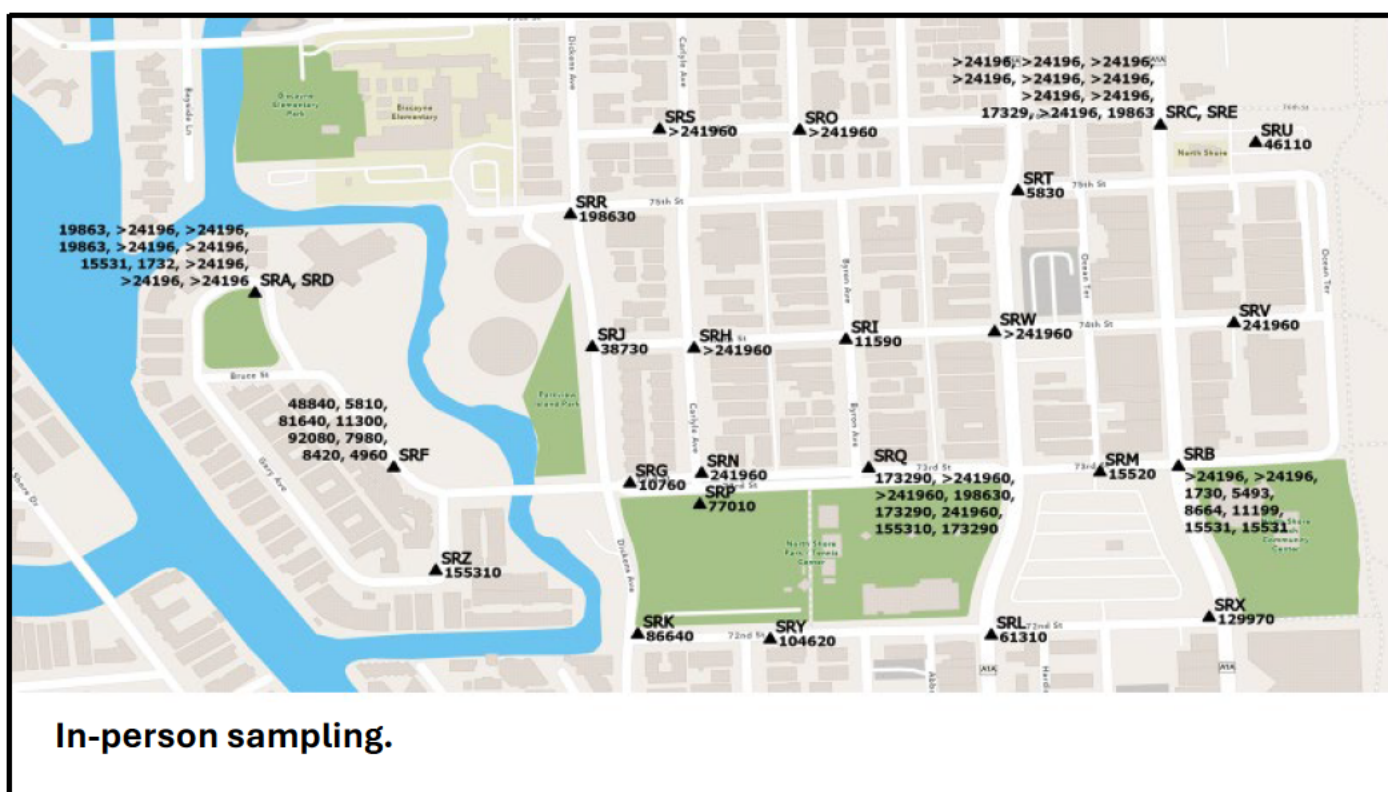
Figure C.4: In-person runoff sampling sites. The site ID is given by “SR” followed by a letter. The number below the site ID corresponds to the enterococci concentration in the in-person runoff samples in units of MPN/100 mL.

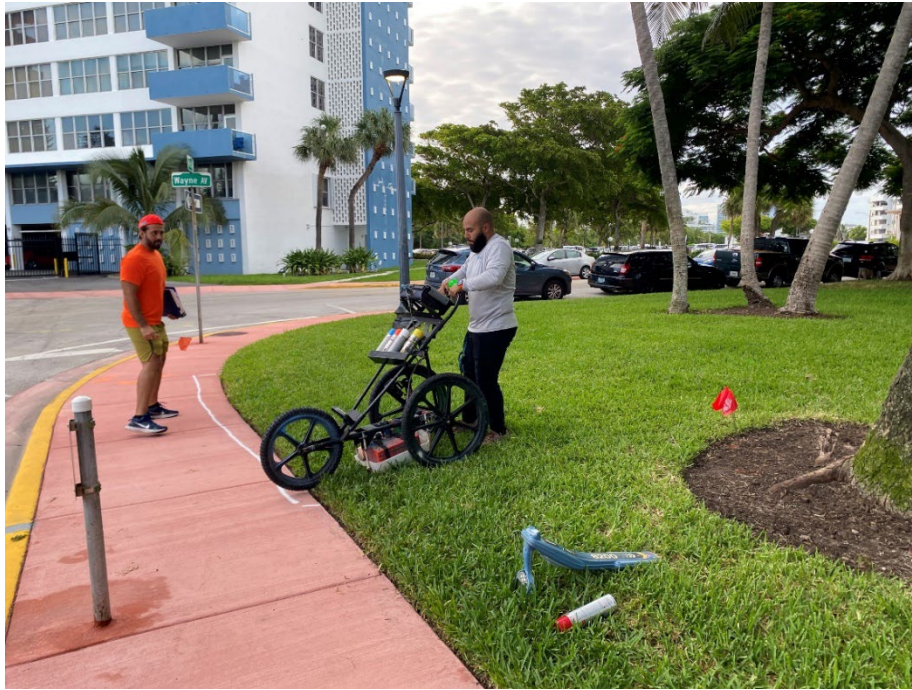
Figure C.13: Illustration of process used to identify underground utilities using ground penetrating radar. The roller device is used to obtain an overall mapping of the utilities and the handheld device (in the foreground on the grass) is used to obtain finer resolution of the underground utilities.

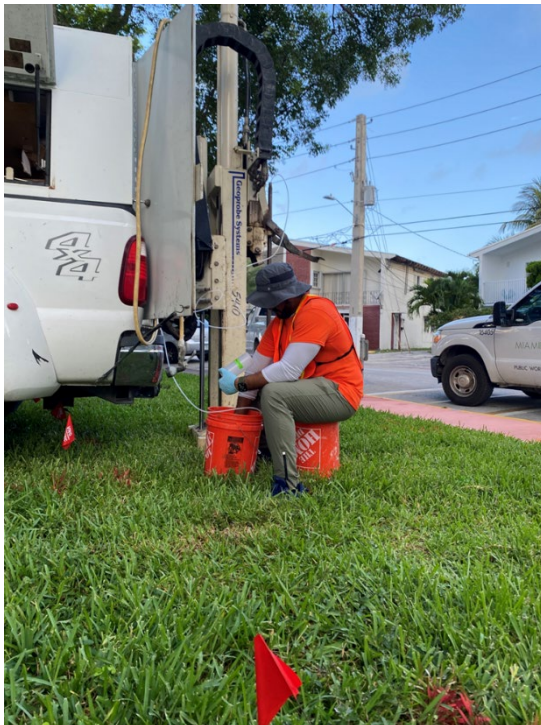
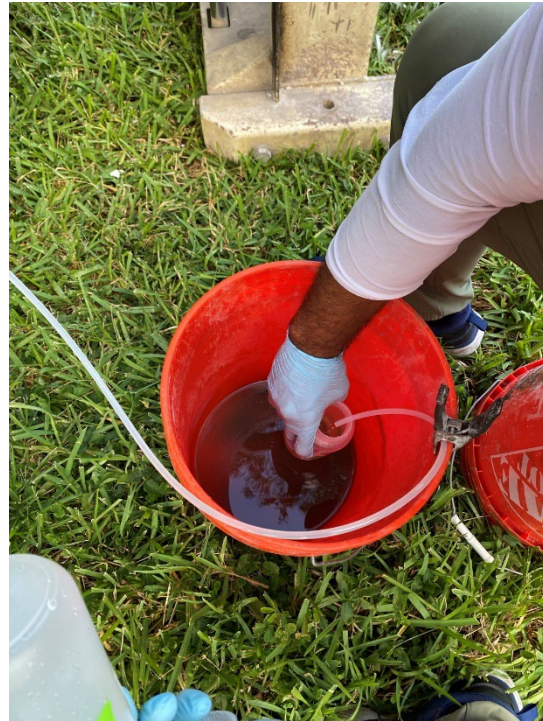
Figure C.14: Illustration of groundwater sample collection from behind the pickup truck mounted drill rig.

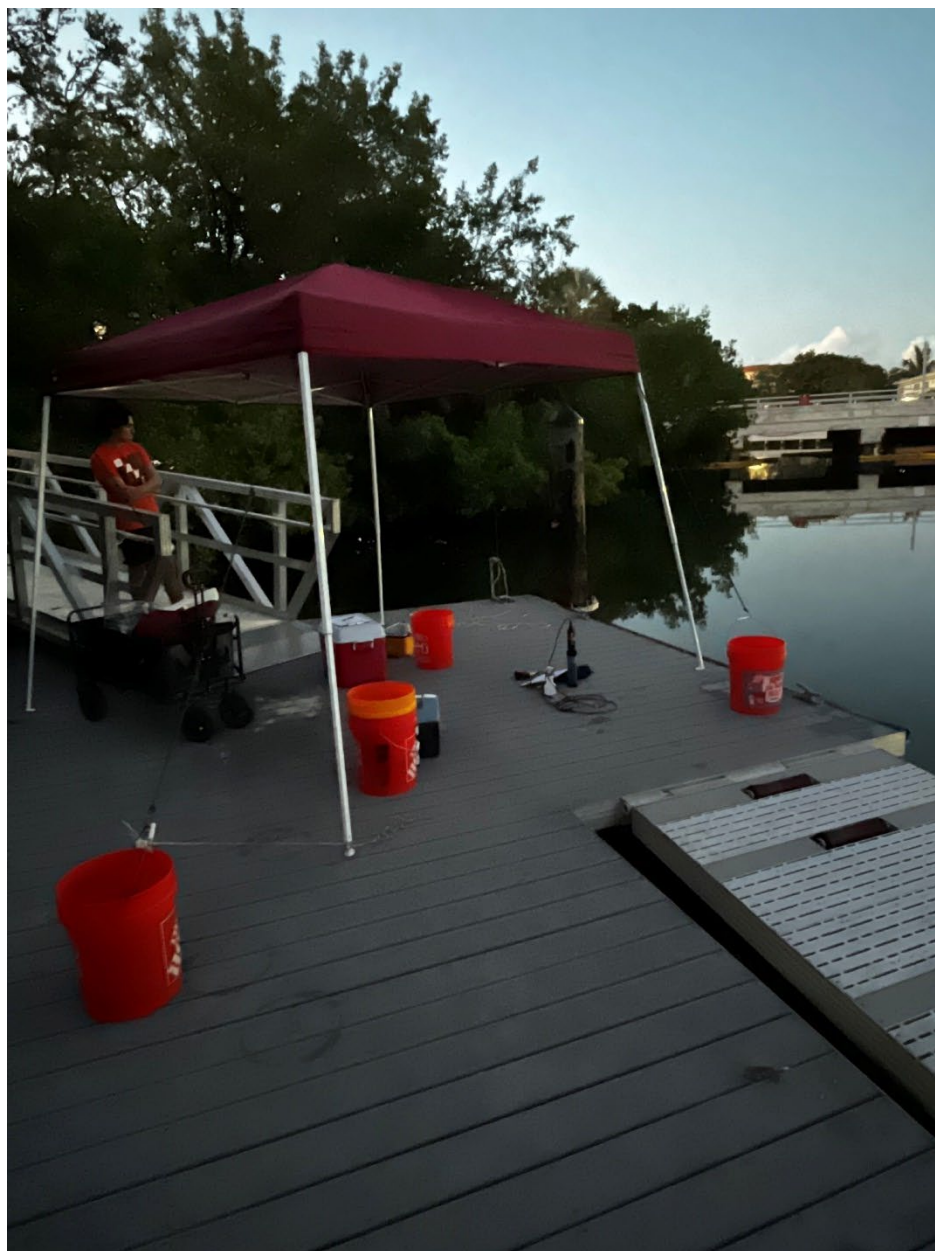
Figure C.16: Photo of sample collection set up at the Kayak Launch towards the beginning of the 12-hour sampling event.
