COMMISSION MEMORANDUM

SUBJECT: REFERRAL TO THE PUBLIC SAFETY AND NEIGHBORHOOD QUALITY OF LIFE COMMITTEE TO DISCUSS THE POTENTIAL IMPLEMENTATION OF A BICYCLE LANE ON THE WEST SIDE OF COLLINS AVENUE AS PART OF AN UPCOMING FLORIDA DEPARTMENT OF TRANSPORTATION ("FDOT") RESURFACING, RESTORATION, AND REHABILITATION ("RRR") PROJECT ON STATE ROAD ("SR") A1A/COLLINS AVENUE FROM SR 907/W 63 STREET TO 75 STREET.

1	<i>Introduction</i>	5
	1.1 Project Intent	5
	1.2 Project Description	5
	1.3 Project Type Determination	7
	1.4 Adjacent Projects	7
	1.5 Project Location Map	8
	1.6 Field Review	8
	1.7 Office Review	8
2	<i>Existing Conditions</i>	9
	2.1 Design Criteria	9
	2.1.1 Existing Pavement	9
	2.1.2 Design Control	10
	2.1.3 Lane Width	11
	2.1.4 Median and Traffic Separators – N/A	12
	2.1.5 Channelization Islands – N/A	12
	2.1.6 Refuge Islands – N/A	12
	2.1.7 Shoulders – N/A	12
	2.1.8 Curbed Roadways	12
	2.1.9 Roadside Slopes – N/A	12
	2.1.10 Roadway Cross Slope	12
	2.1.11 Border Width	12
	2.1.12 Horizontal Alignment	13
	2.1.13 Superelevation	13
	2.1.14 Vertical Alignment	14
	2.1.15 Intersections	14
	2.1.16 Lane Tapers and Deceleration Length	14
	2.1.17 Lateral Offset and Control Zone	15

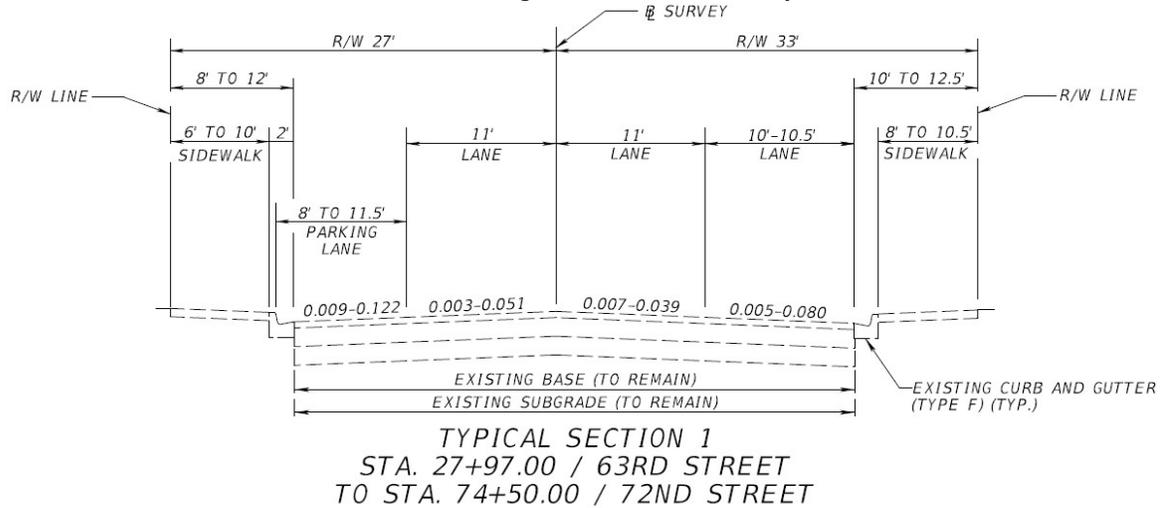
FIGURE 1-1 EXISTING TYPICAL SECTION 1

Existing Typical Section 1 (from W 63rd Street to 73rd Street): This segment is a three-lane roadway with one 8-11.5-foot parking lane to face of curb, two 11-foot inside lanes, one 10-10.5-foot outside lane, type F curb and gutter, 6-10-foot concrete sidewalk on the left side, and 8-10.5-foot concrete sidewalk on the right side of the roadway.

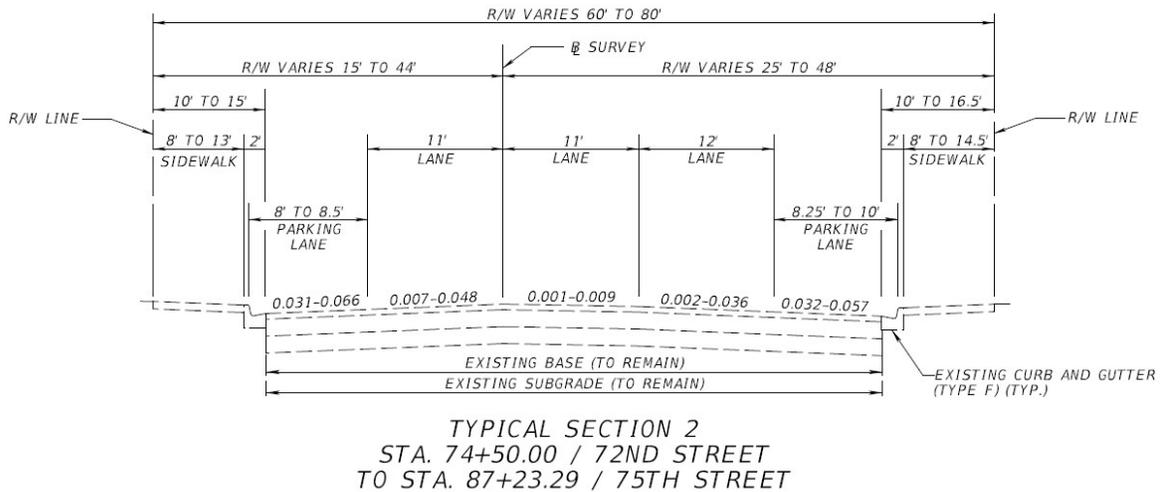
FIGURE 1-2 EXISTING TYPICAL SECTION 2

Existing Typical Section 2 (from W 73rd Street to 75th Street): This segment is a three-lane roadway with 8-10-foot parking lanes to face of curb, two 11-foot inside lanes, one 12-foot outside lane, type F curb and gutter, 8-13-foot concrete sidewalk on the left side, and 8-14.5-foot concrete sidewalk on the right side of the roadway.

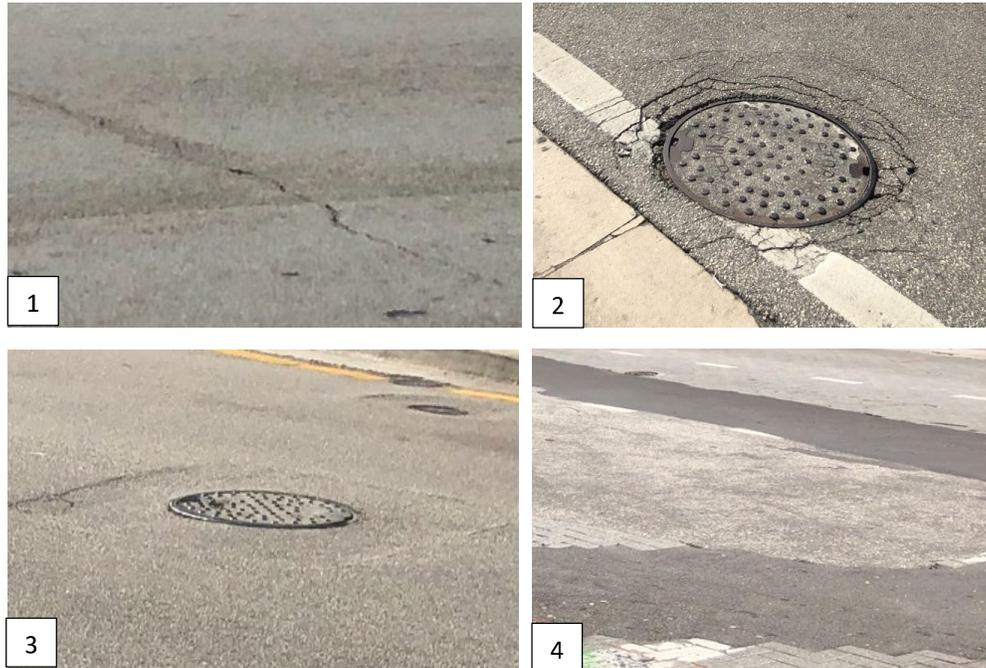
After conducting a field review on the pavement condition (PC), surface deteriorations were encountered, such as minor cracking, utility cuts, and pavement depression around manholes and valves. The pavement condition was reviewed in the Pavement Condition Survey (PCS) Ratings by State Materials Office (SMO) 2022. According to the PCS, the survey resulted in a ride evaluation of 4.6 with no projection. The cracking evaluation resulted in 6.5 with no projection. The rutting evaluation resulted in 8.0 with no project. The existing pavement will be 15 years by 2027. Refer to Appendix D-1. Figure 2-1 illustrates samples of the surface deteriorations encountered during the field review.

Figure 2-1 EXISTING PAVEMENT CONDITION
(1-2. CRACKING, 3. DEPRESSION, 4. UTILITY CUT)

Assume milling and resurfacing 2.5 inches for the purpose of this scoping report. Milling recommendation is to be provided by the FDOT State Materials Office.

- Mill and resurface the existing roadway pavement.
- Upgrade deficient pedestrian curb ramps and detectable warning surfaces.
- Reconstruct damaged sidewalk segments.

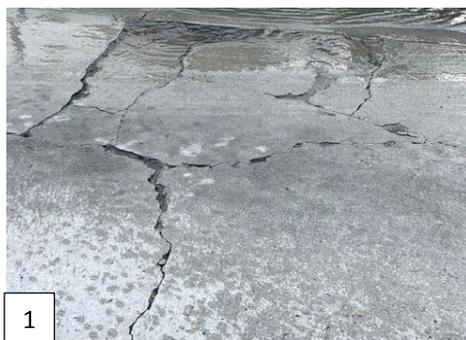
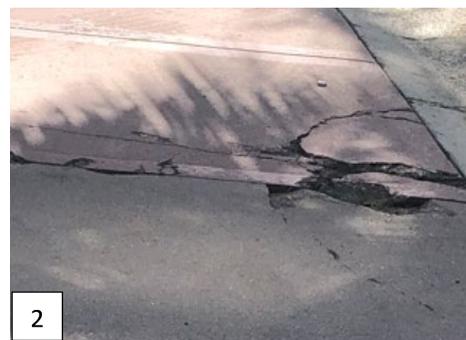
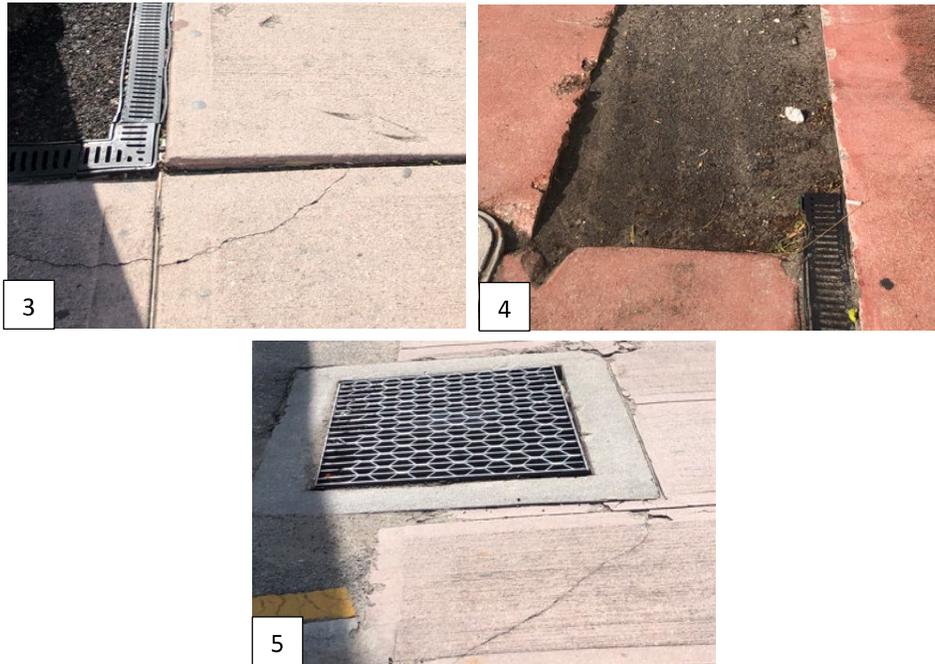
four feet or greater may be retained within any context classification. During the field review, cracking, ADA/pedestrians issues/tripping hazards, and substandard clear width were noted. The existing ditch bottom inlet at station 34+60 LT appears to be Type F encroaching on the sidewalk posing a safety hazard for pedestrians. If an ADA-approved grate is not available, suggest modifying the top of the existing ditch bottom inlet to offset the grate away from the sidewalk.

Existing planters with missing trees or damaged Addapave surface treatment (tree pit walking surface) are tripping/safety hazards. According to communication with the City of Miami Beach Department of Public Works, the planters will be addressed in the spring of FY2023 as part of a palm tree restoration project.

There are locations that do not meet the criteria for clear width of sidewalk and are summarized in Table 2-6. Unobstructed sidewalk width is less than 4 feet in several planters. Where feasible, objects obstructing clear paths on sidewalks should be relocated to meet FDM/ADA requirements. A Design Variation for Unobstructed Sidewalk Width is required for objects that cannot be feasibly relocated. The location of the deficient sidewalks can be found in the exhibits of Section 3.11.

Figure 2-2 SIDEWALK DEFICIENCIES
 (1-2. CRACKING, 3-4. TRIP HAZARD, 5. NON-ADA GRATE)

- Modify the top of the existing ditch bottom inlet at station 34+60 LT to move the grating away from sidewalk.
- Regrade the curb and gutters around intersection returns where standing water was observed in the ADA ramps (NW return of 71 Street, NW return of 72 Street, SE return of 75 Street).

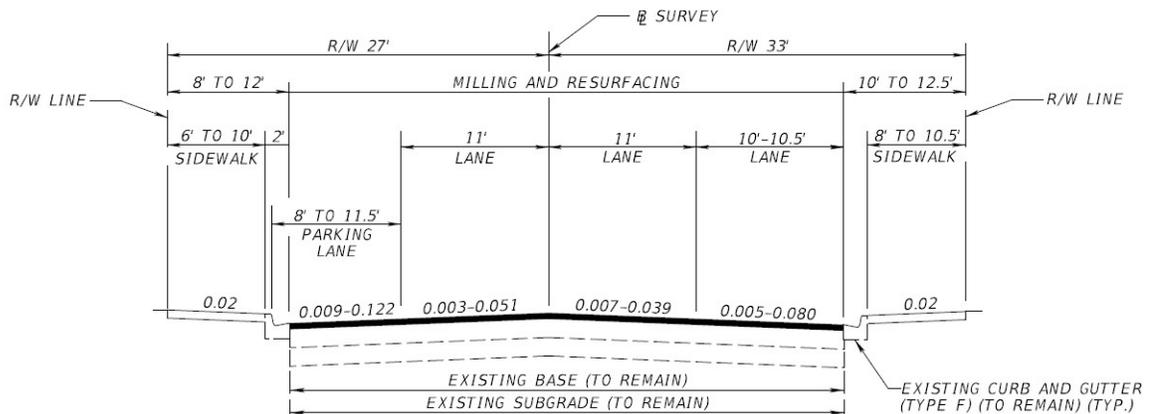
FIGURE 3-1 RECOMMENDED TYPICAL SECTION 1

Proposed Typical Section 1 (from W 63rd Street to 73rd Street): This segment is a three-lane roadway with one 8-11.5-foot parking lane to face of curb, two 11-foot inside lanes, one 10-10.5-foot outside lane, type F curb and gutter, 6-10-foot concrete sidewalk on the left side, and 8-10.5-foot concrete sidewalk on the right side of the roadway.

TYPICAL SECTION 1
 STA. 27+97.00 / 63RD STREET
 TO STA. 74+50.00 / 72ND STREET

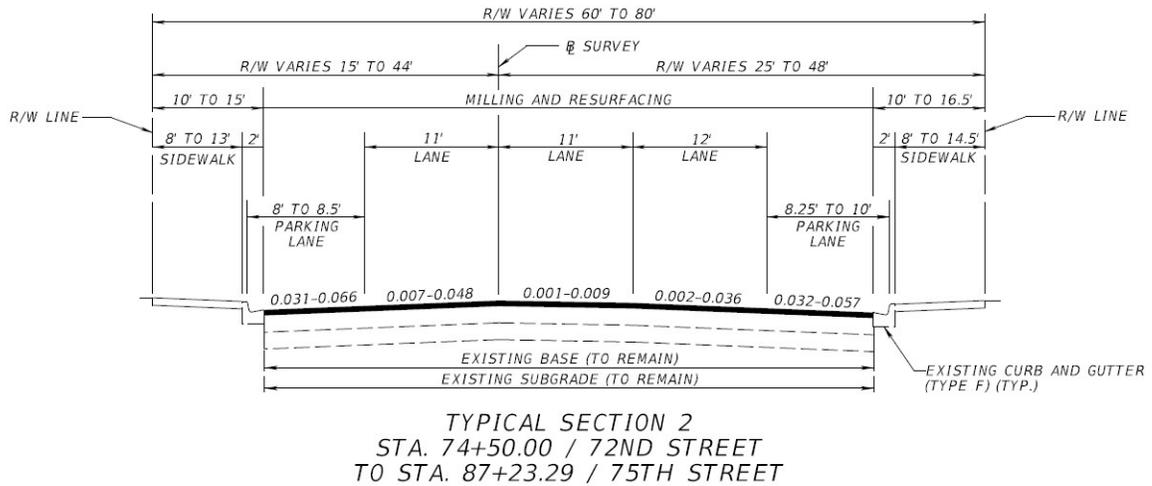
FIGURE 3-2 RECOMMENDED TYPICAL SECTION 2

Proposed Typical Section 2 (from W 73rd Street to 75th Street): This segment is a three-lane roadway with 8-10-foot parking lanes to face of curb, two 11-foot inside lanes, one 12-foot outside lane, type F curb and gutter, 8-13-foot concrete sidewalk on the left side, and 8-14.5-foot concrete sidewalk on the right side of the roadway.

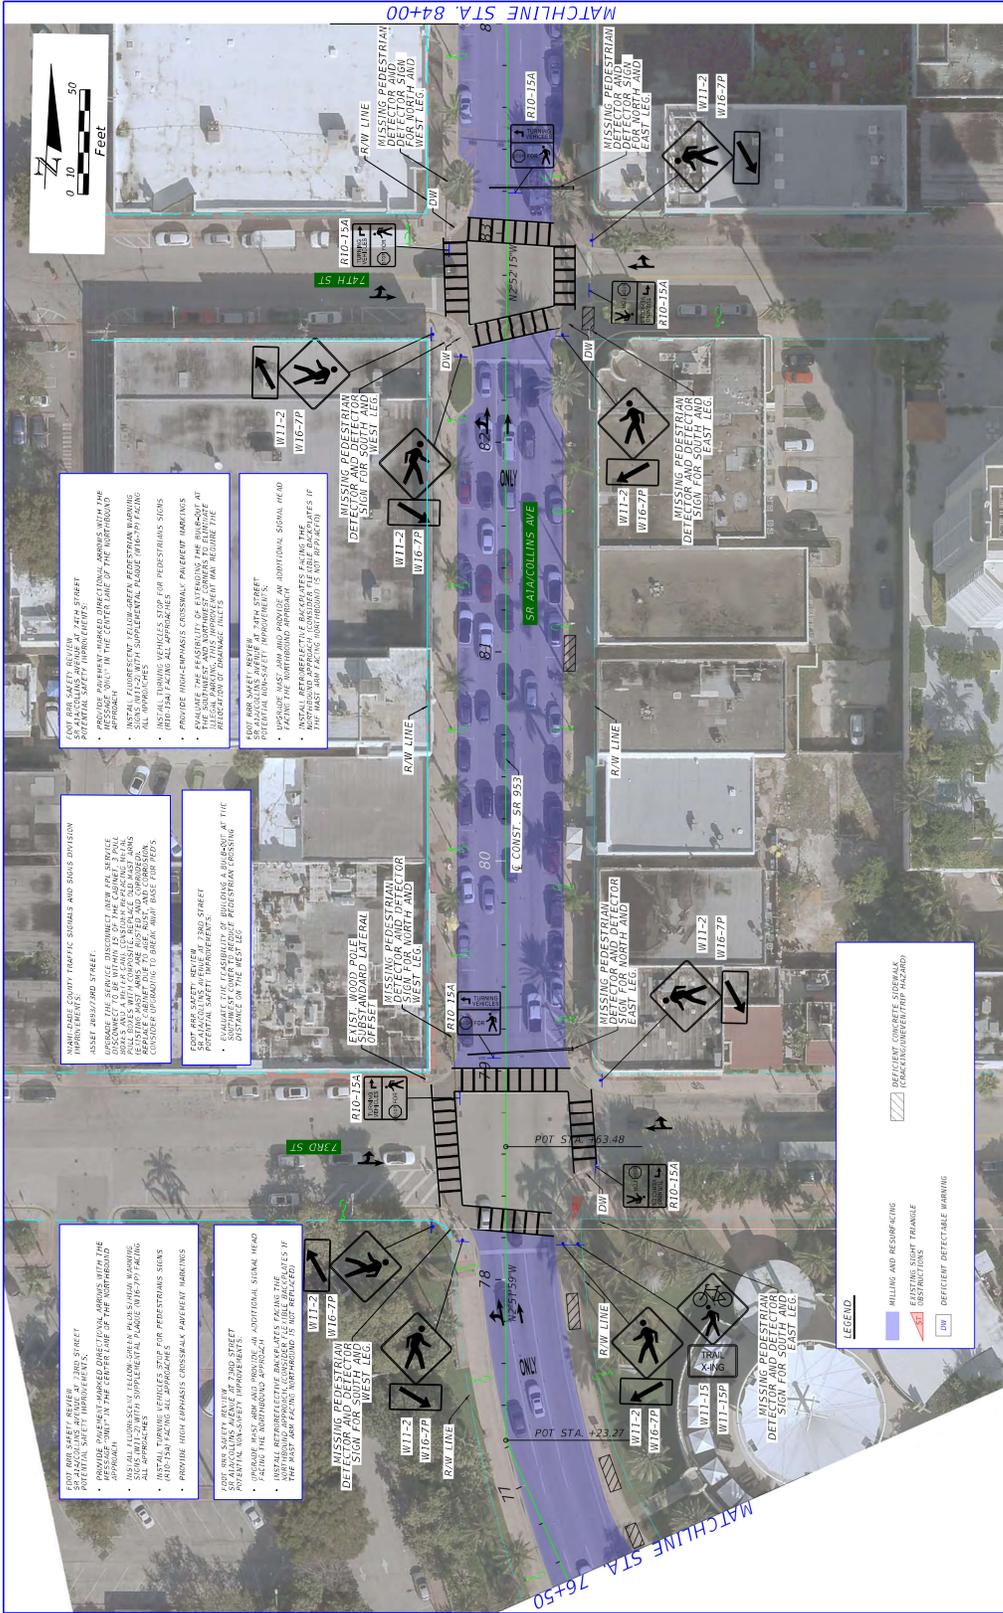
3.12 Deficiencies and Recommendations Exhibit

The Exhibit below summarizes the existing deficiencies and recommended improvements.

- PROVIDE PLACEMENT MARKED DIRECTIONAL ARROWS WITH THE APPROVAL "ONLY" IN THE CENTER LINE OF THE ROADWAY APPROACH.
- INSTALL FLUORESCENT YELLOW-GREEN PEDESTRIAN WARNING SIGN (W11-2) SUPPLEMENTAL PLACED (W16-7P) FACING ALL APPROACHES.
- INSTALL TURNING VEHICLES STOP FOR PEDESTRIAN SIGNS (W11-2) FACING ALL APPROACHES.
- PROVIDE HIGH-EMBRASS CONSSALK PARALLEL MARKINGS.
