# FINAL SCOPING REPORT

SR A1A/COLLINS AVENUE FROM SR 907/W 63RD STREET TO 75TH STREET

(87060000 - MP 8.640 - 9.782)

March 2024

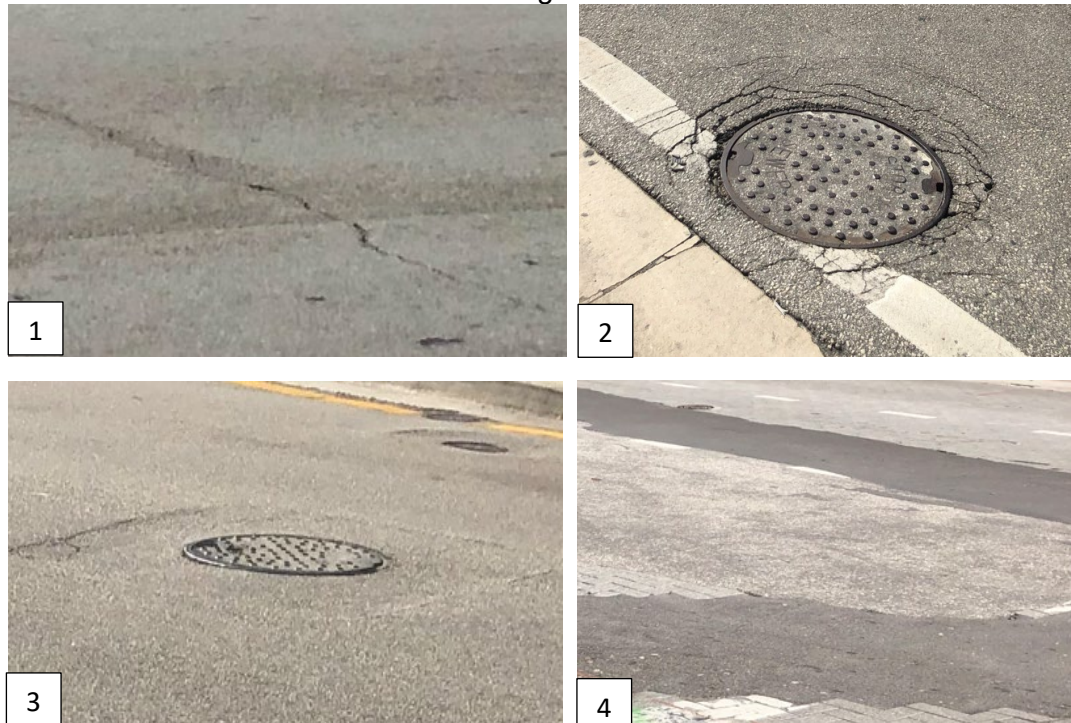
**Figure 2-1 EXISTING PAVEMENT CONDITION**  
(1-2. CRACKING, 3. DEPRESSION, 4. UTILITY CUT)

After conducting a field review on the pavement condition (PC), surface deteriorations were encountered, such as minor cracking, utility cuts, and pavement depression around manholes and valves. The pavement condition was reviewed in the Pavement Condition Survey (PCS) Ratings by State Materials Office (SMO) 2022. According to the PCS, the survey resulted in a ride evaluation of 4.6 with no projection. The cracking evaluation resulted in 6.5 with no projection. The rutting evaluation resulted in 8.0 with no project. The existing pavement will be 15 years by 2027. Refer to Appendix D-1. Figure 2-1 illustrates samples of the surface deteriorations encountered during the field review.

Assume milling and resurfacing 2.5 inches for the purpose of this scoping report. Milling recommendation is to be provided by the FDOT State Materials Office.

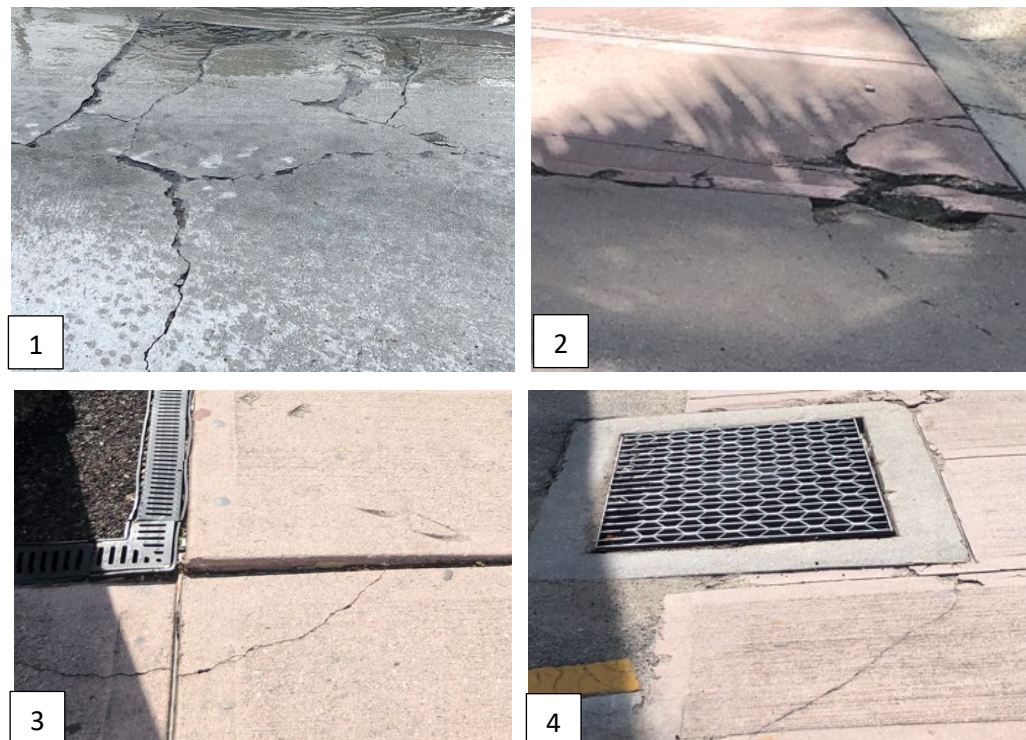
**Figure 2-2 SIDEWALK DEFICIENCIES**  
(1-2. CRACKING, 3. TRIP HAZARD, 4. NON-ADA GRATE)

The existing ditch bottom inlet at station 34+60 LT appears to be Type F and is encroaching onto the sidewalk posing a safety hazard for pedestrians. If an ADA-approved grate is not available, suggest modifying the top of the existing ditch bottom inlet to offset the grate away from the sidewalk.

There are locations that do not meet the criteria for clear width of sidewalk and are summarized in Table 2-6. Unobstructed sidewalk width is less than 4 feet in several planters. Where feasible, objects obstructing clear paths on sidewalks should be relocated to meet FDM/ADA requirements. A Design Variation for Unobstructed Sidewalk Width is required for new features.
