COMMISSION MEMORANDUM

SUBJECT: REFERRAL TO THE PUBLIC SAFETY AND NEIGHBORHOOD QUALITY OF LIFE COMMITTEE TO DISCUSS THE POTENTIAL IMPLEMENTATION OF A BICYCLE LANE ON THE WEST SIDE OF COLLINS AVENUE AS PART OF AN UPCOMING FLORIDA DEPARTMENT OF TRANSPORTATION ("FDOT") RESURFACING, RESTORATION, AND REHABILITATION ("RRR") PROJECT ON STATE ROAD ("SR") A1A/COLLINS AVENUE FROM SR 907/W 63 STREET TO 75 STREET.

Figure 1-1 EXISTING TYPICAL SECTION 1	6
Figure 1-2 EXISTING TYPICAL SECTION 2	6
Figure 1-3 PROJECT LOCATION MAP	8
Figure 2-1 EXISTING PAVEMENT CONDITION	10
Figure 2-2 SIDEWALK DEFICIENCIES	19
Figure 3-1 RECOMMENDED TYPICAL SECTION 1	44
Figure 3-2 RECOMMENDED TYPICAL SECTION 2	45

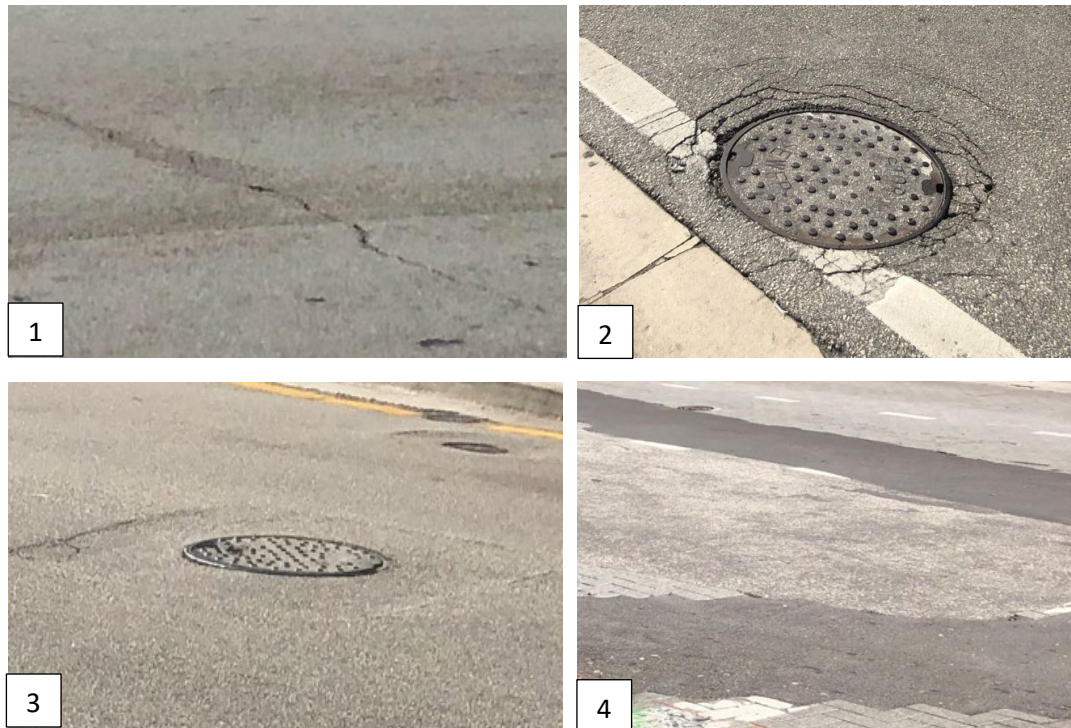
Figure 2-1 EXISTING PAVEMENT CONDITION
(1-2. CRACKING, 3. DEPRESSION, 4. UTILITY CUT)

After conducting a field review on the pavement condition (PC), surface deteriorations were encountered, such as minor cracking, utility cuts, and pavement depression around manholes and valves. The pavement condition was reviewed in the Pavement Condition Survey (PCS) Ratings by State Materials Office (SMO) 2022. According to the PCS, the survey resulted in a ride evaluation of 4.6 with no projection. The cracking evaluation resulted in 6.5 with no projection. The rutting evaluation resulted in 8.0 with no project. The existing pavement will be 15 years by 2027. Refer to Appendix D-1. Figure 2-1 illustrates samples of the surface deteriorations encountered during the field review.

Assume milling and resurfacing 2.5 inches for the purpose of this scoping report. Milling recommendation is to be provided by the FDOT State Materials Office.

- Mill and resurface the existing roadway pavement.
- Upgrade deficient pedestrian curb ramps and detectable warning surfaces.
- Reconstruct damaged sidewalk segments.

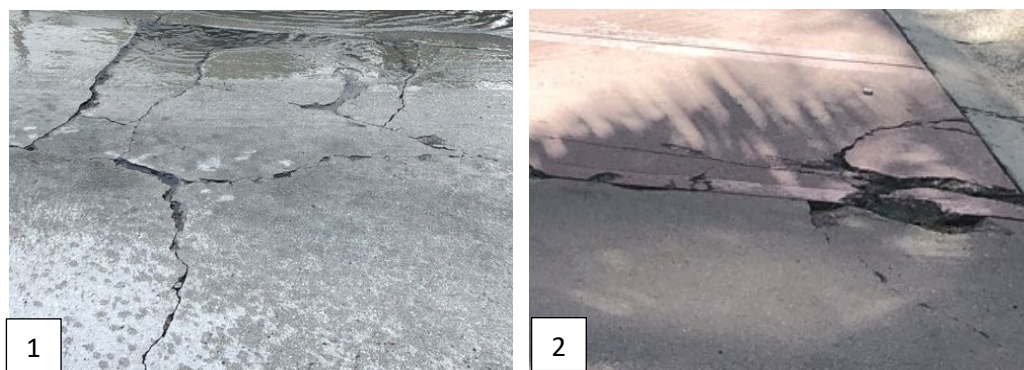
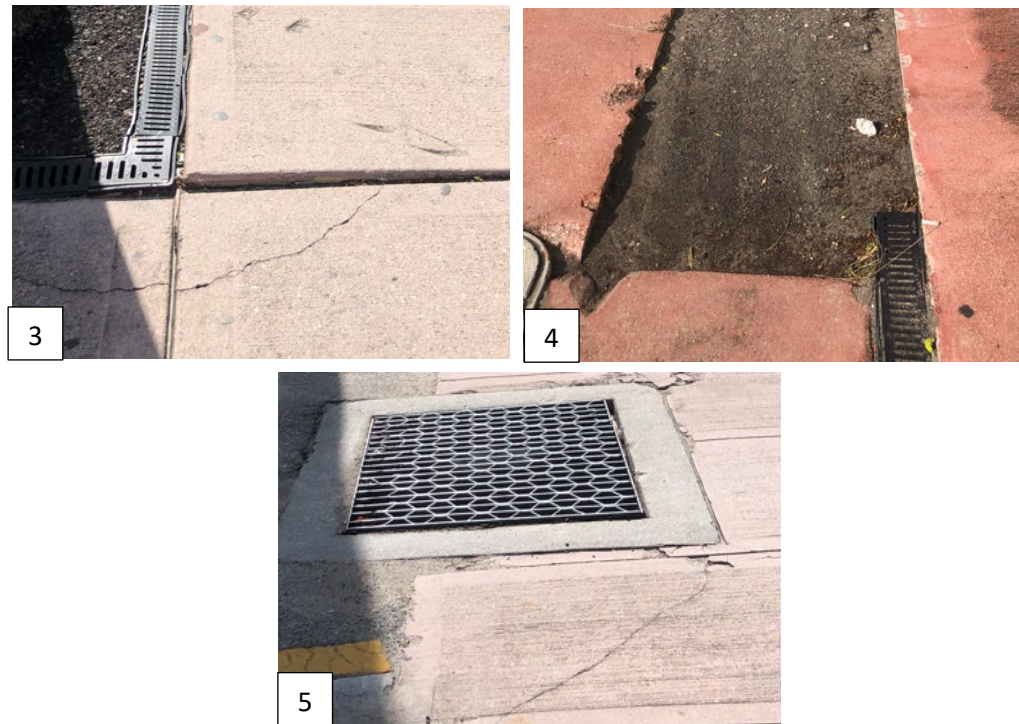
Figure 2-2 SIDEWALK DEFICIENCIES
(1-2. CRACKING, 3-4. TRIP HAZARD, 5. NON-ADA GRATE)

four feet or greater may be retained within any context classification. During the field review, cracking, ADA/pedestrians issues/tripping hazards, and substandard clear width were noted. The existing ditch bottom inlet at station 34+60 LT appears to be Type F encroaching on the sidewalk posing a safety hazard for pedestrians. If an ADA-approved grate is not available, suggest modifying the top of the existing ditch bottom inlet to offset the grate away from the sidewalk.

There are locations that do not meet the criteria for clear width of sidewalk and are summarized in Table 2-6. Unobstructed sidewalk width is less than 4 feet in several planters. Where feasible, objects obstructing clear paths on sidewalks should be relocated to meet FDM/ADA requirements. A Design Variation for Unobstructed Sidewalk Width is required for objects that cannot be feasibly relocated. The location of the deficient sidewalks can be found in the exhibits of Section 3.11.

- Modify the top of the existing ditch bottom inlet at station 34+60 LT to move the grating away from sidewalk.
- Regrade the curb and gutters around intersection returns where standing water was observed in the ADA ramps (NW return of 71 Street, NW return of 72 Street, SE return of 75 Street).
