1020 PENNSYLVANIA AVENUE
MIAMI BEACH, FL 33139

On August 29, 2013, Mr. Victor Rodriguez, on behalf of Mr. Manfred Knoll president of MFK Group, retained Raul Vivas, P.E. to inspect and evaluate the Pennsylvania property located at 1220 Pennsylvania Avenue in Miami Beach, Florida. The purpose of our inspection and evaluation was to determine the existing condition of the structure and serviceability for human occupancy. Our professional opinions are based upon observations and knowledge of structural behavior of a masonry bearing wall construction.

CONCLUSIONS AND REPAIR RECOMMENDATIONS

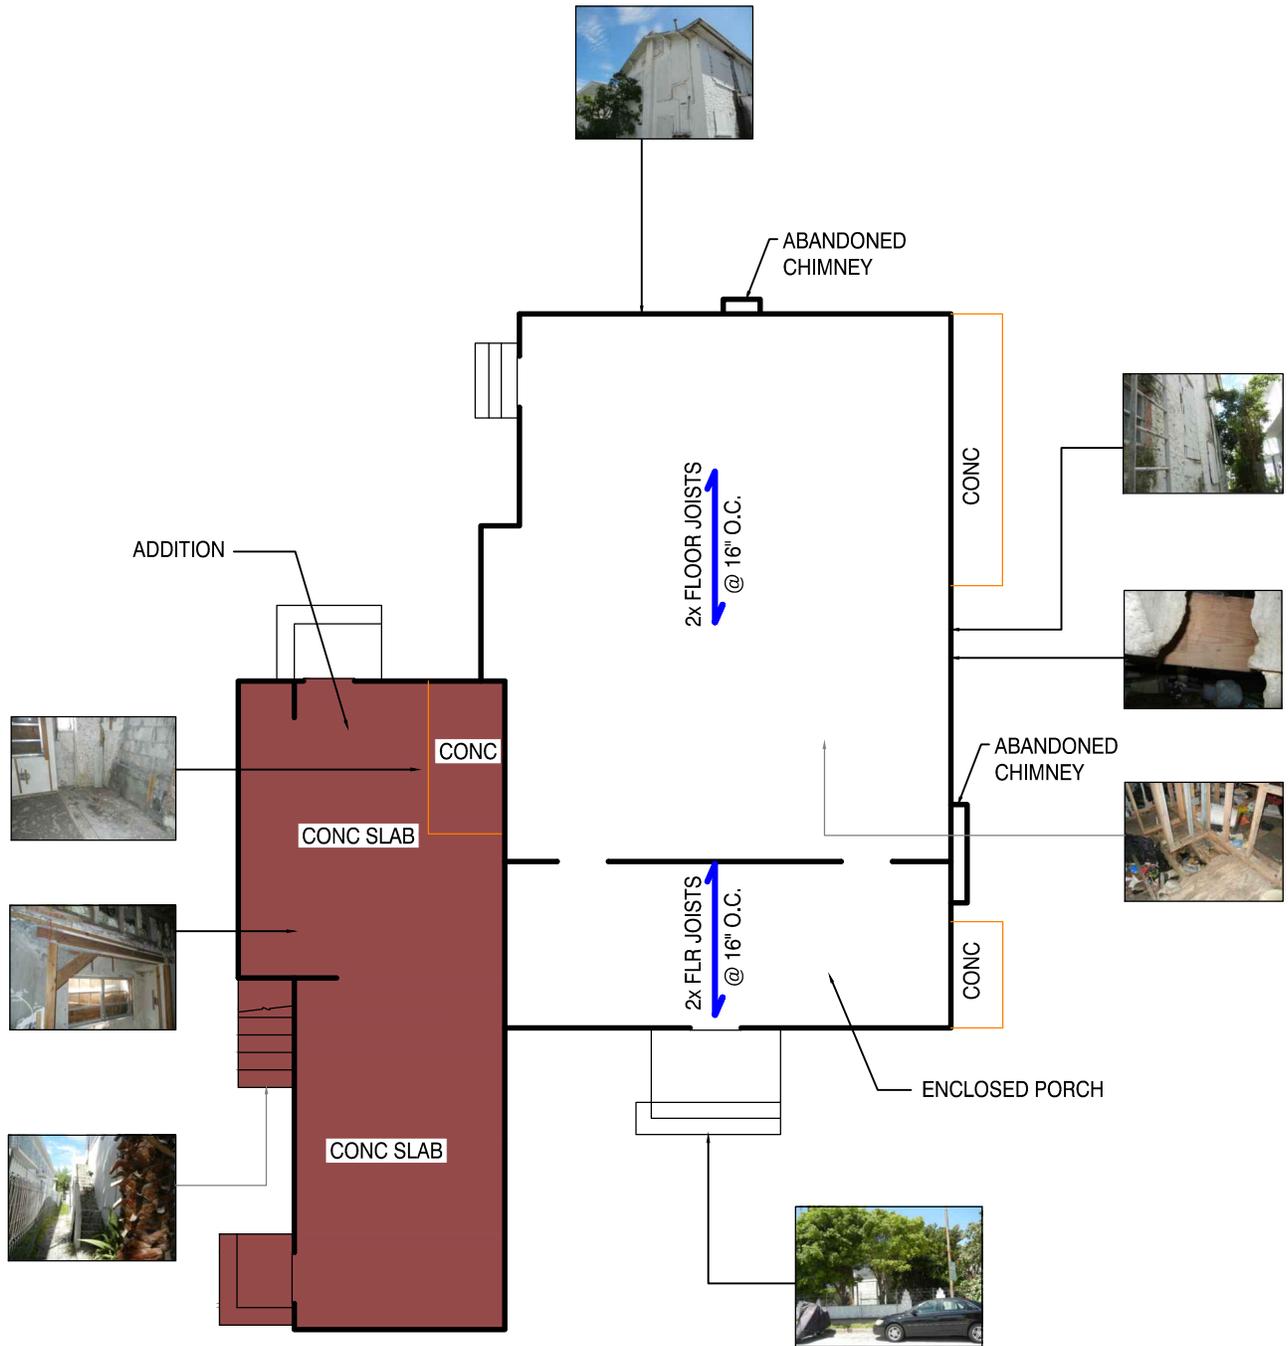
FIRST FLOOR PLAN

- The perimeter masonry bearing wall present several areas of patching or repairs. Is visible masonry cracks, opening masonry in-fills

- Floor joists and floor sheathing are deteriorated by termites and humidity. The floor framing is placed raised over a crawl space which does not have proper ventilation.

- Some openings in the masonry wall show unstable condition caused by lack of reinforcement. No proper or adequate retrofit procedure were provided at the time the openings were created. Interior CMU walls depict an original structural layout which in some degree were altered on its role as part of the building envelope. Besides, the portion of the building structure located at the east and south of the structure that we considered was an addition at certain time of the life of the structure, uses the area under the stairs that access to the second floor. To extend the area of the addition a portion of the perimeter bearing wall was demolished and reached the exterior face of the stair wall. That opening shows no reinforcement or retrofit to count for gravity loads from second and roof levels.

At the time of the inspection the CMU block walls were safely standing in place. We did not note settlement of the structure based upon cursory observation of the soil/structure interface and corners of the structure. However, existing condition of floor framing in the first and second floor is clear indication that the structure is not in serviceable condition for human occupancy. The floor framings shall be replaced and repaired where acceptable. New floor sheathing shall be installed. The floor framing shall be connected to the masonry bearing wall. The existing bearing walls do not have concrete tie beam; appropriate shoring shall be designed and provided to allow implementation and construction of new concrete tie beam. The concrete tie beam shall be placed

The building openings will require new impact windows. The existing openings do not present adequate construction condition to accept new window frames and transmit forces to the building diaphragms. The existing masonry openings shall be reinforced and retrofitted accordingly. The new reinforcement of the opening jambs shall frame to a new concrete tie beam.

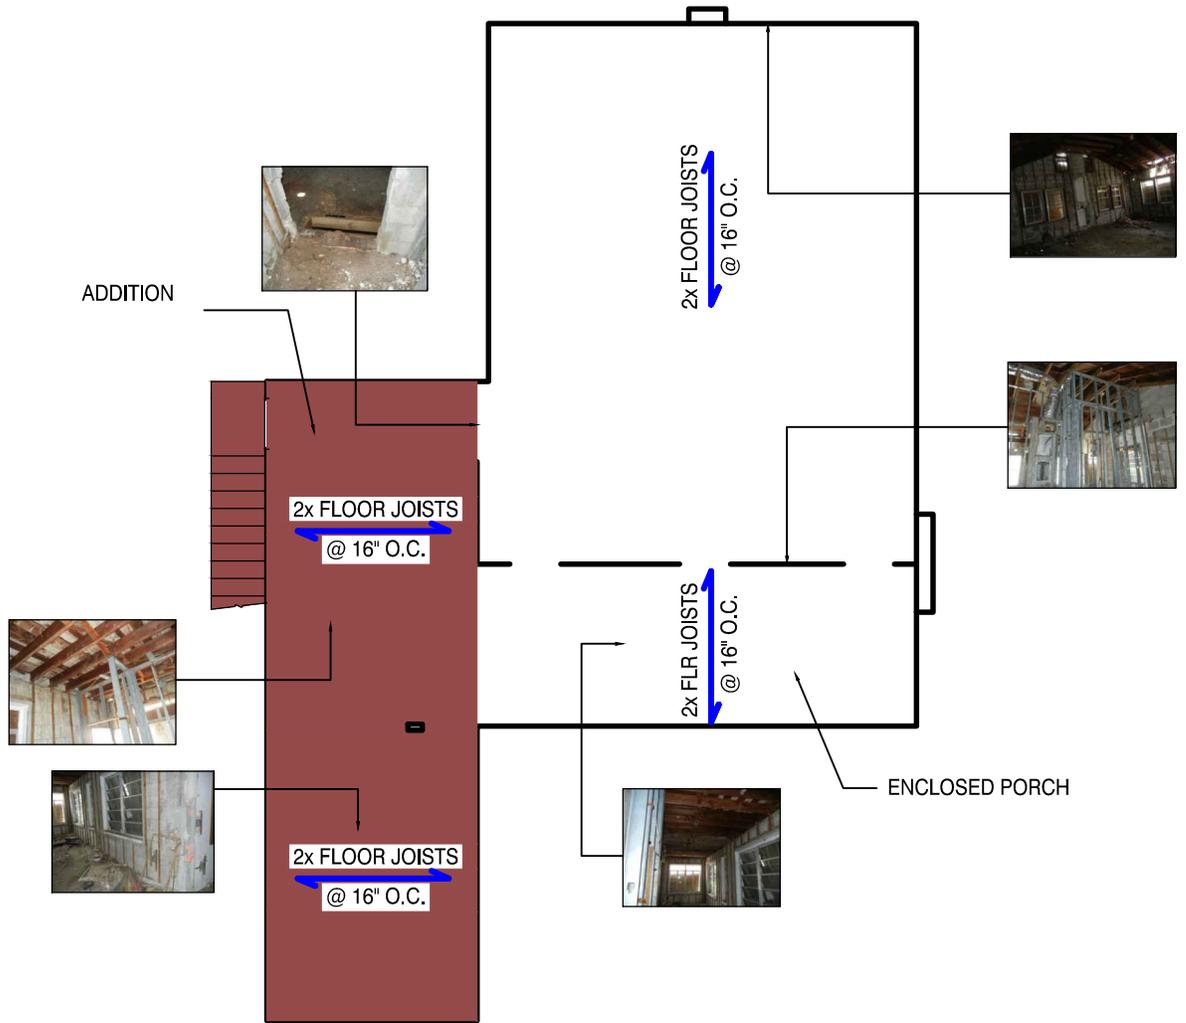
SECOND FLOOR PLAN

- A substantial number of floor joists in the second floor present sign of deterioration caused by termites and humidity. Also the floor sheathing is severely damaged or deteriorated by the same source of joist damage.

- The roof rafters are in fair condition for the most part. However, the roof sheathing evidence progressive deterioration.

- Second floor walls at the west and north side walls are considered high walls. We assumed those walls are unreinforced. Cracks are evident in the exterior side of the wall.
