Arborist Report

94 Palm Avenue

Miami Beach

11/14/2022

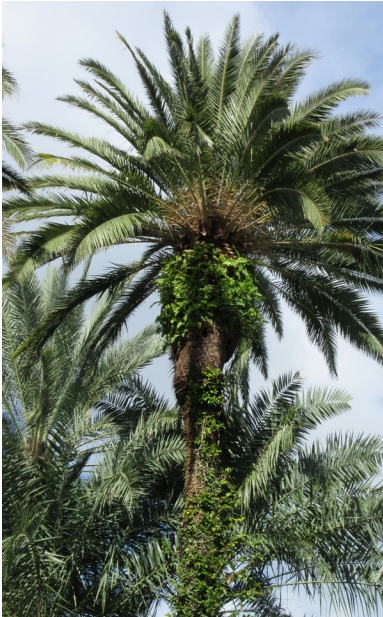
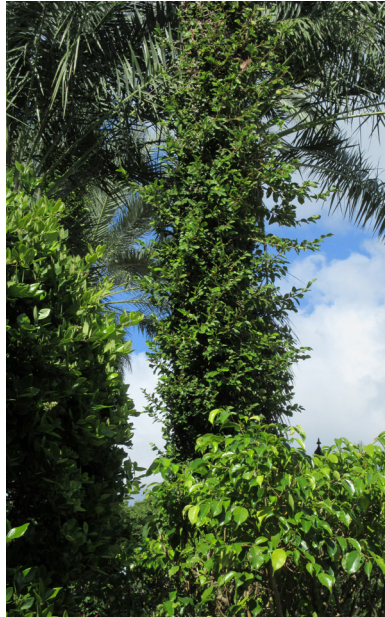
Condition -
GOOD

Tree #7 is a Canary Island Date Palm located at the front of the property. It is in good condition. Vines are growing on the trunk.

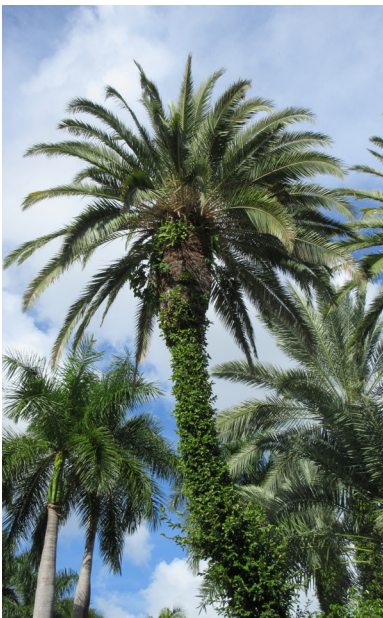
Condition -
GOOD

Tree #8 is a Canary Island Date Palm located at the front of the property. It is in good condition. Vines are growing on the trunk.

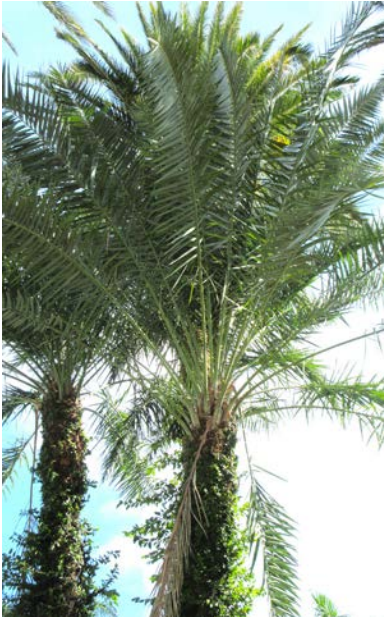
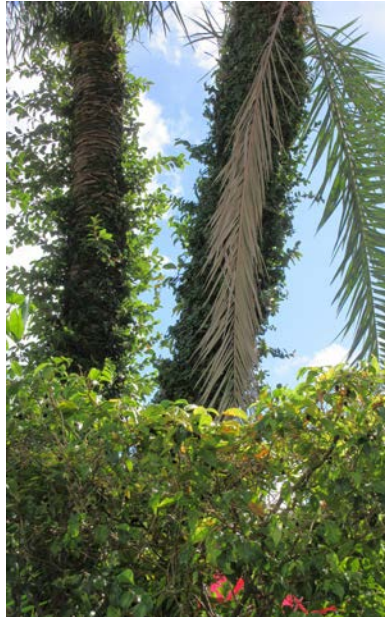
Condition -
FAIR

Tree #9 is a Date Palm located at the front of the property. It is in fair condition and is competing with the nearby trees. Vines are on the trunk.

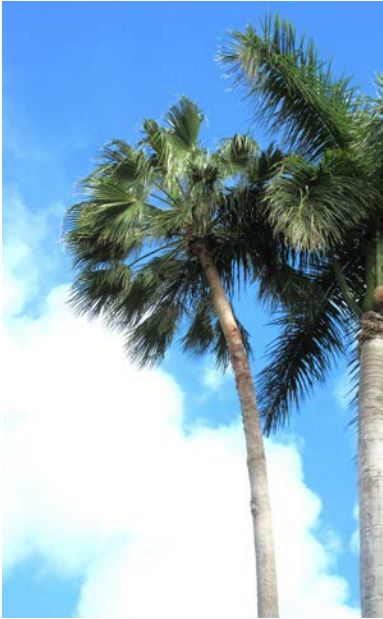
Condition -
GOOD

Tree #15 is a Washingtonia Palm located at the front of the property. It is in good condition.

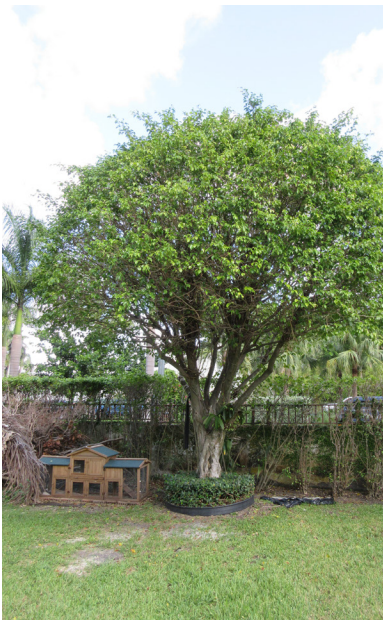
Condition -
FAIR

Tree #16 is a Weeping Fig located towards the northwest corner of the property. It is in fair condition. The canopy has been shaped and there is thrips damage to the foliage.

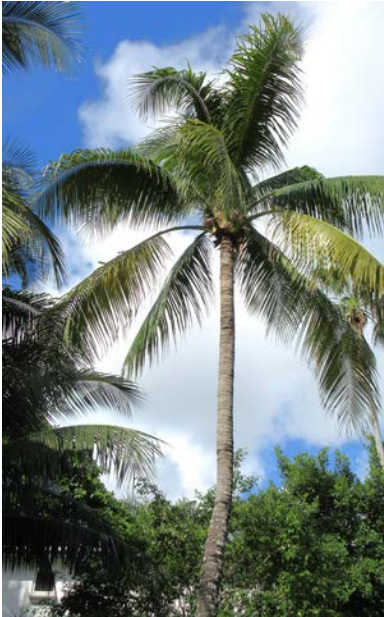
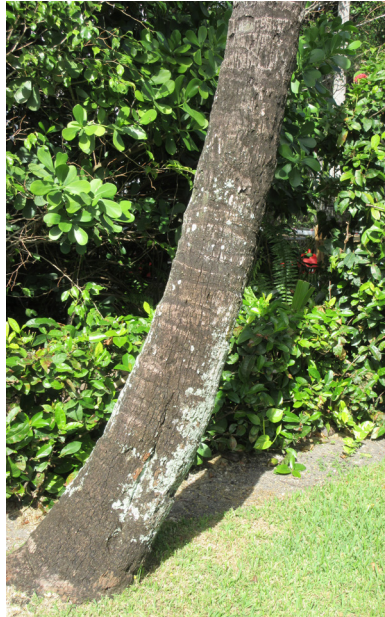
Condition -
FAIR

Tree #17 is a Coconut Palm located towards the northwest corner of the property. It is in fair condition with a thin canopy and yellowing fronds.

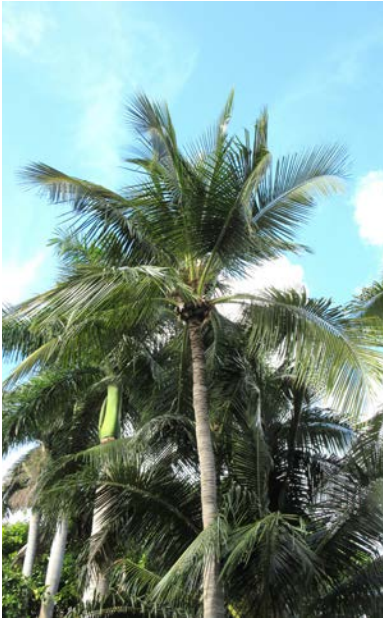
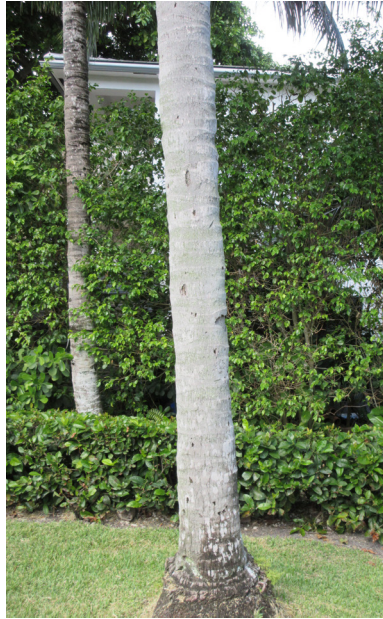
Condition -
FAIR

Tree #19 is a Coconut Palm located towards the northwest corner of the property. It is in fair condition with a thin canopy. There are climbing spike injuries to the trunk.

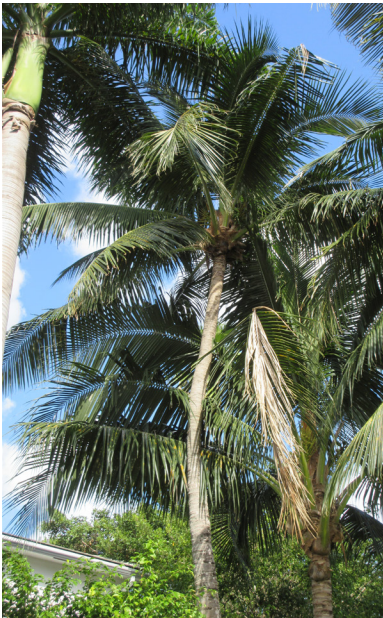
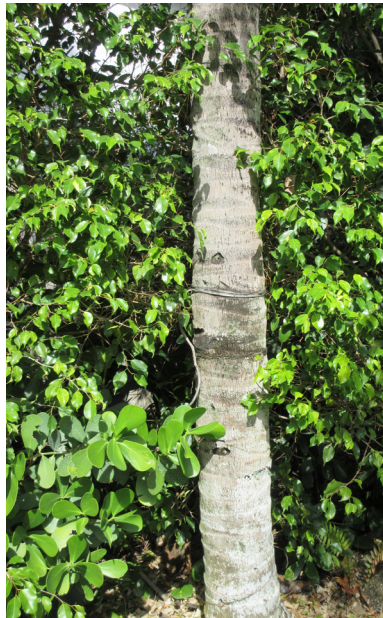
Condition -
GOOD

Tree #20 is a Coconut Palm located towards the northwest corner of the property. It is in good condition.

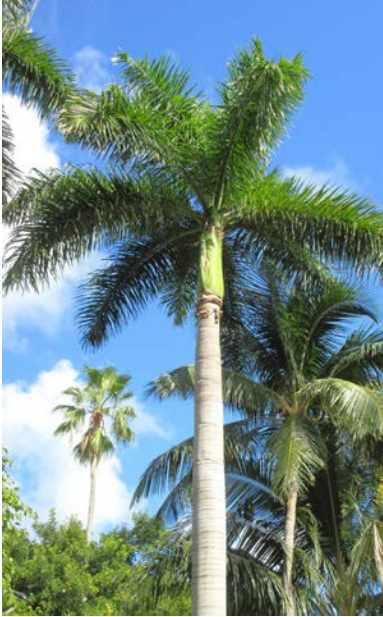
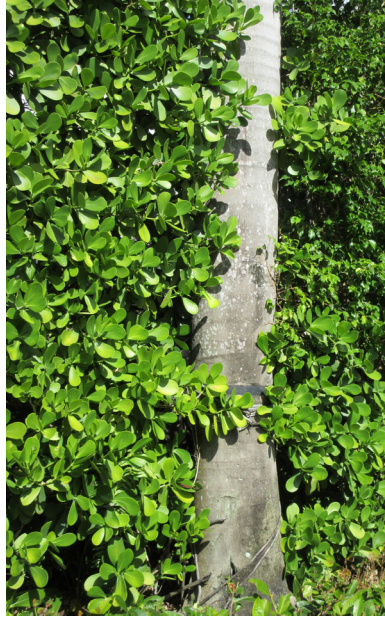
Condition -
GOOD

Tree #21 is a Royal Palm located towards the northwest corner of the property. It is in good condition.

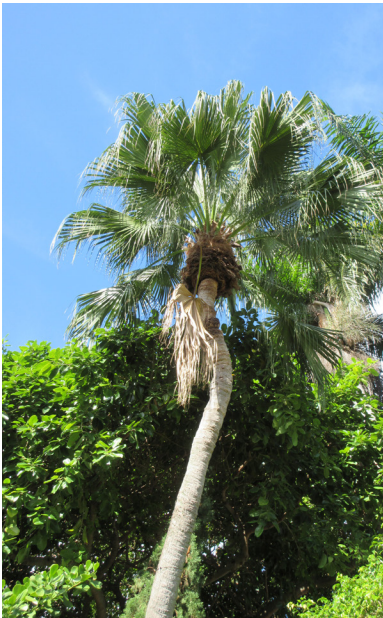
Condition -
FAIR

Tree #22 is a Chinese Fan Palm located on the west side of the property. It is in fair condition with a kinked trunk.

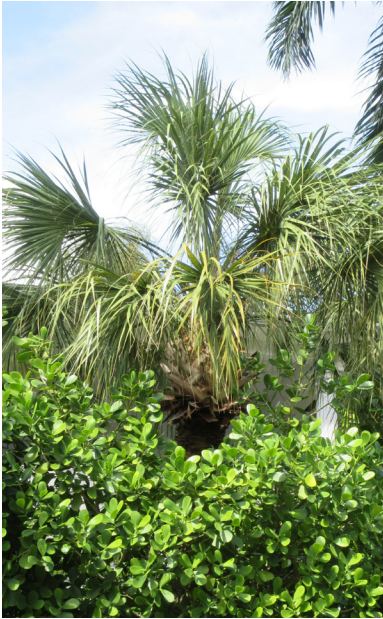
Condition -
POOR

Tree #23 is a Sabal Palm located on the west side of the property. It is in poor condition with a sharply pencilling trunk. Little canopy remains.

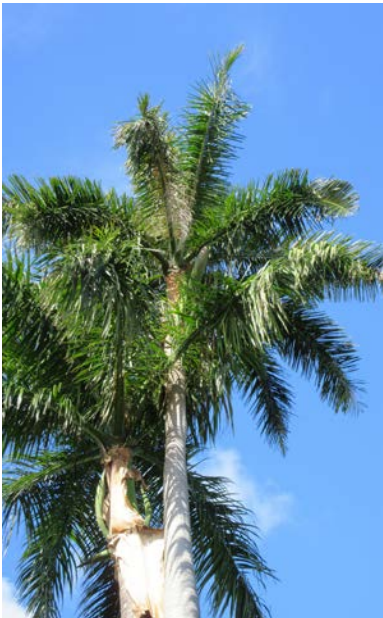
Condition -
FAIR

Tree #24 is a Royal Palm located on the west side of the property. It is in fair condition with a pencilling trunk and frizzled foliage.

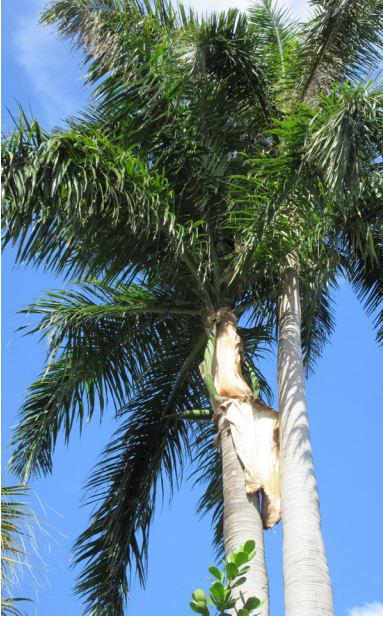
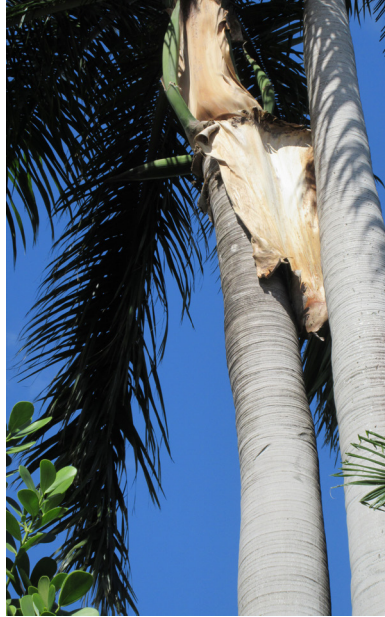
Condition -
GOOD

Tree #25 is a Royal Palm located on the west side of the property. It is directly next to Royal Palm #24 and is in good condition.

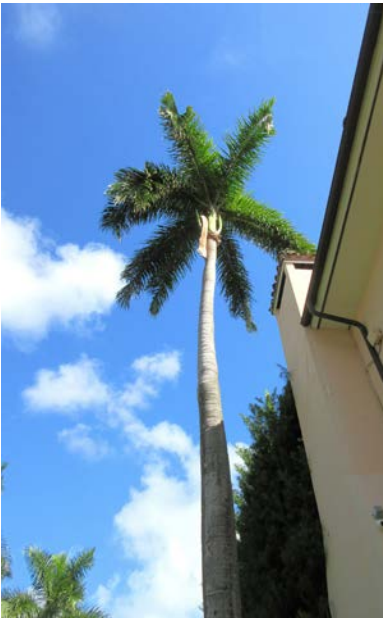
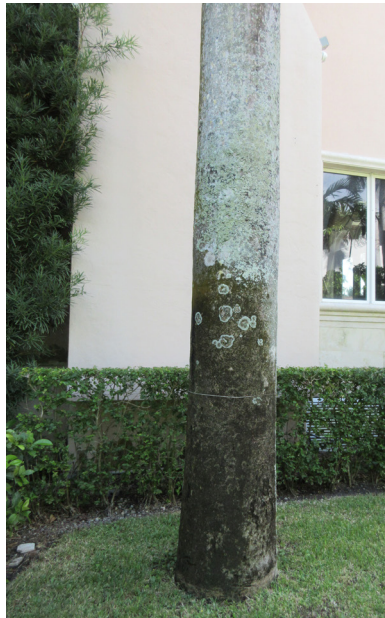
Condition -
GOOD

Tree #26 is a Royal Palm located on the west side of the house. It is in good condition.

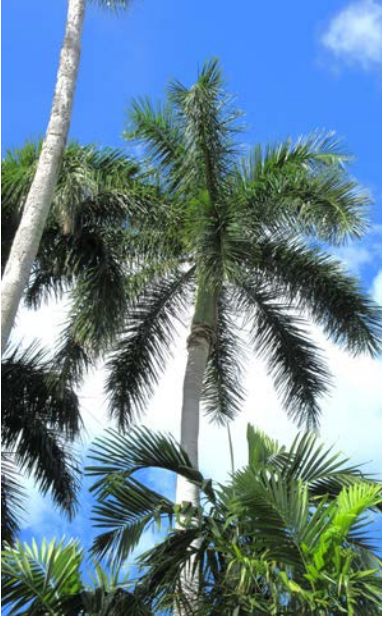
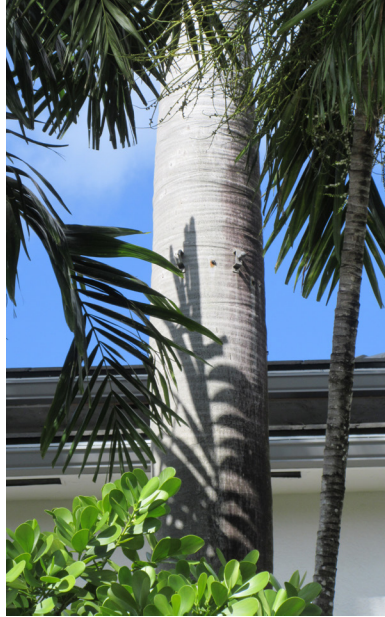
Condition -
FAIR

Tree #27 is a Royal Palm located on the west side of the property. It is in fair condition with a pencilling trunk.

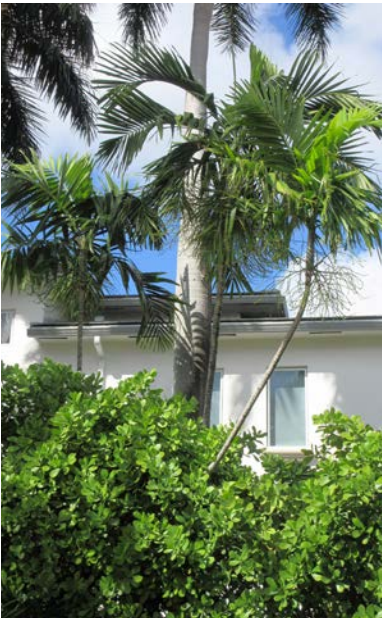
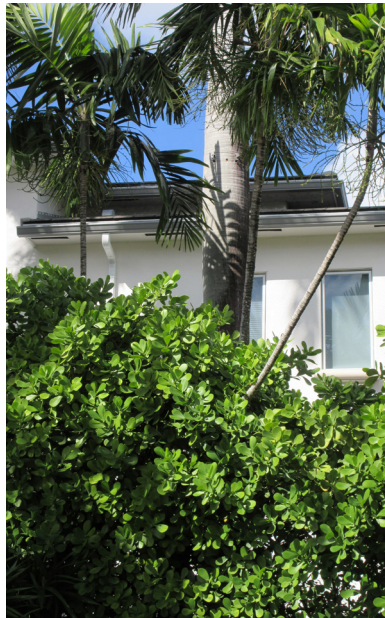
Condition -
FAIR

Tree #28 is a triple Alexander Palm located on the west side of the property. It is in fair condition.

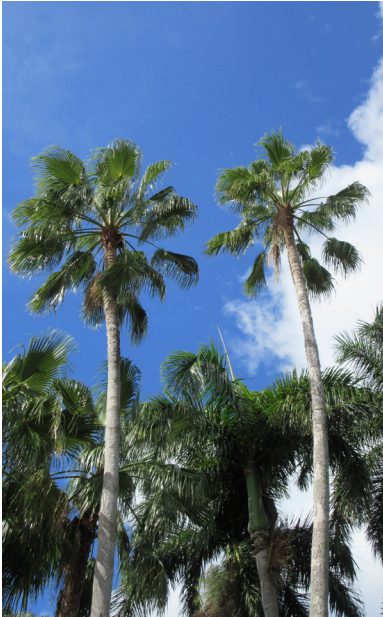
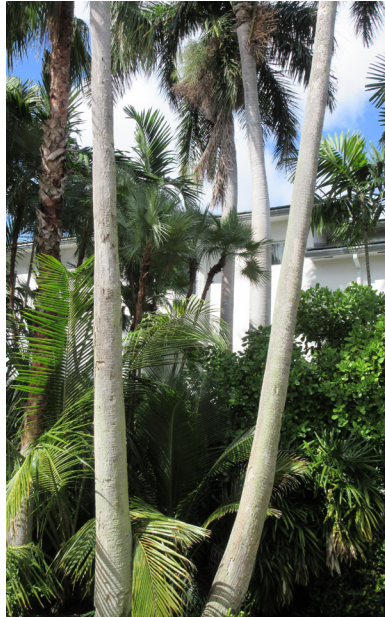
Condition -
GOOD

Tree #29 is a double Washingtonia Palm located on the west side of the property. It is in good condition.

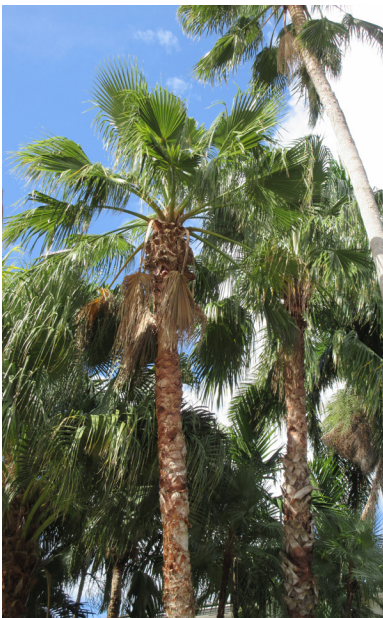
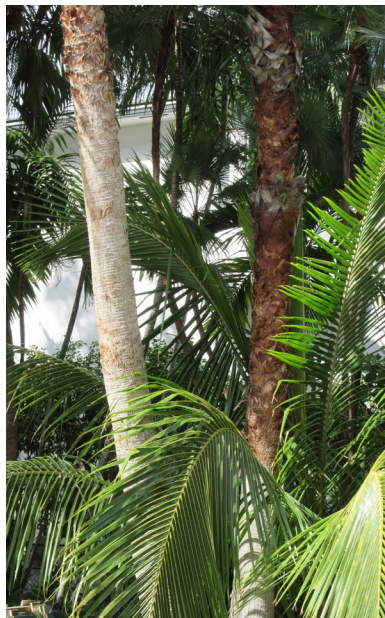
Condition -
GOOD

Tree #30 is a double Washingtonia Palm located on the west side of the property. It is in good condition.

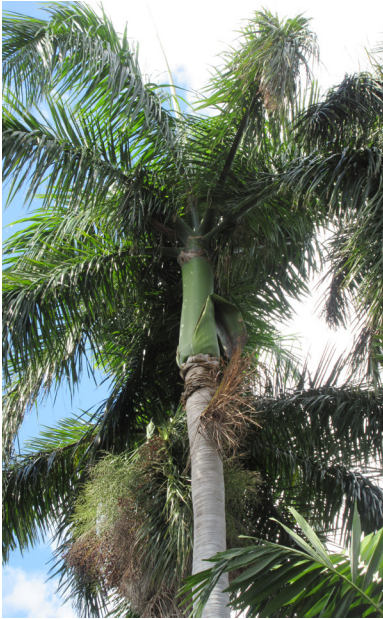
Condition -
FAIR

Tree #31 is a Royal Palm located on the west side of the property. It is in fair condition with a trunk that is narrowing.

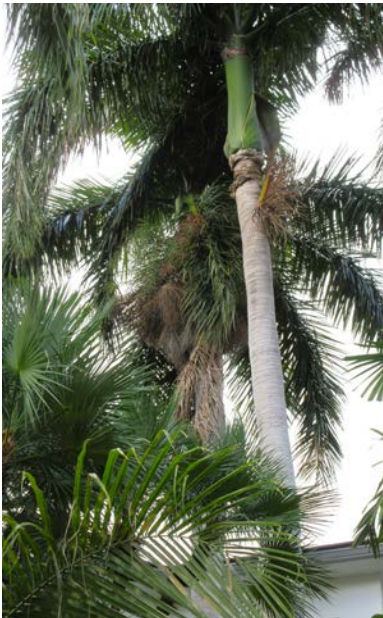
Tree #32 is a Royal Palm located on the border of the western neighbor's property. The propertyline chainlink fence is separated due to the tree. It is in fair condition.

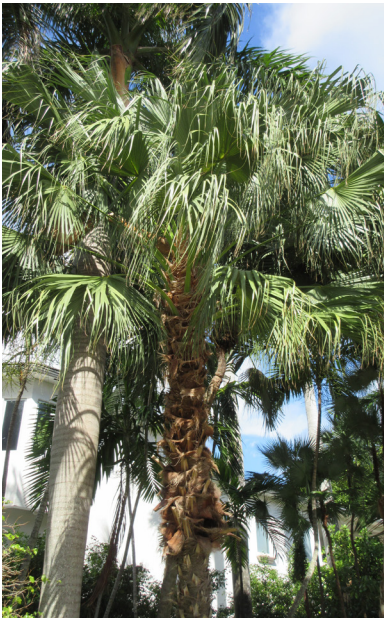
Tree #34 is a Chinese Fan Palm located on the western side of the property. It is in good condition.

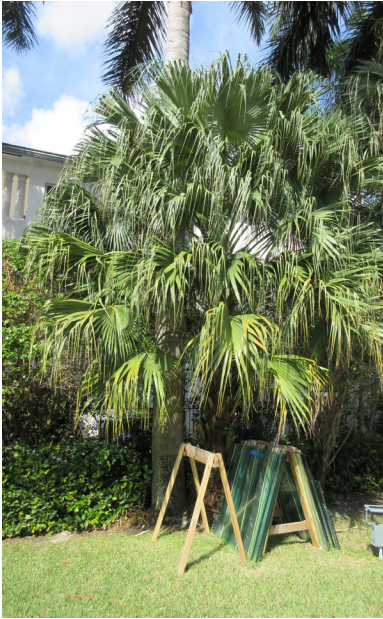
Tree #35 is a Chinese Fan Palm located on the western side of the property. It is in fair condition with off-color fronds.

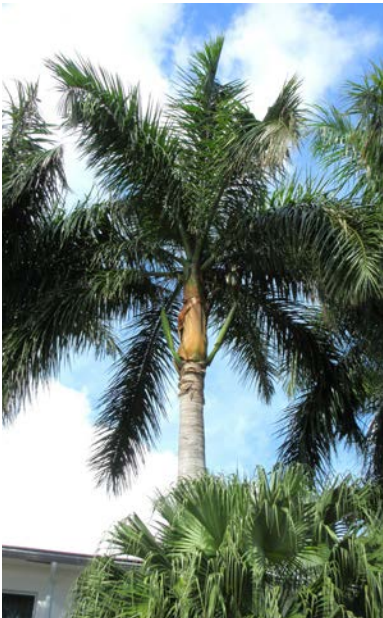
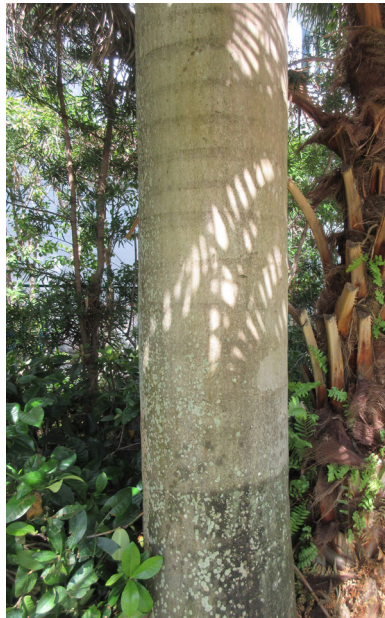
Tree #36 is a Royal Palm located on the western side of the property. It is in good condition.

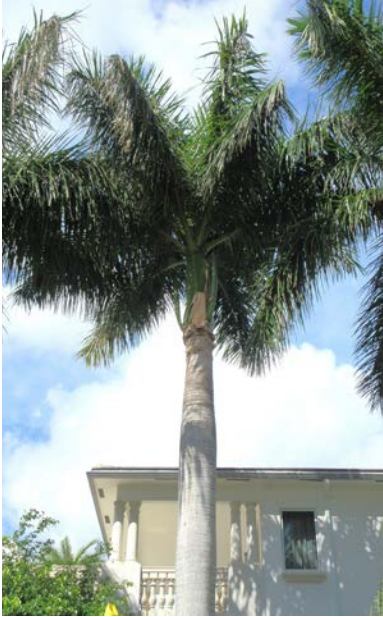
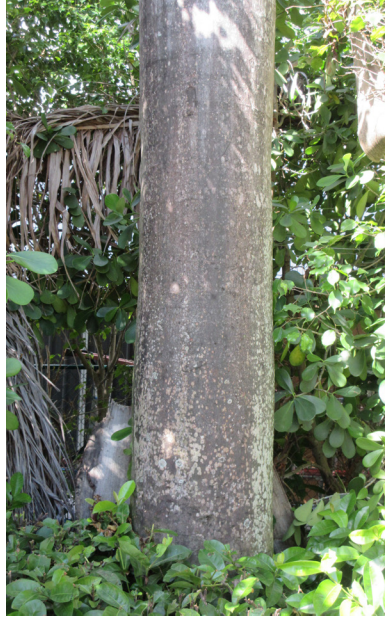
Tree #37 is a Royal Palm located on the western side of the property. It is in good condition. The lower fronds have been overpruned.

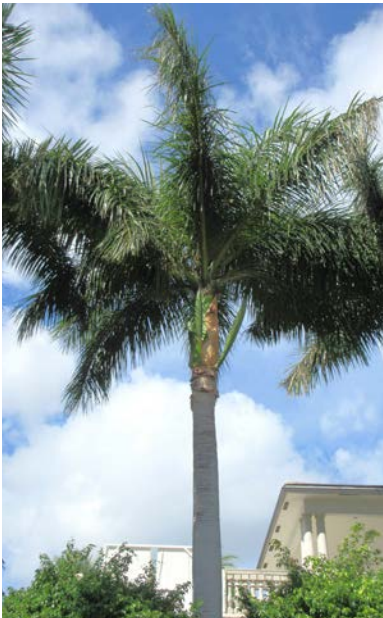
Tree #38 is a Royal Palm located on the western side of the property. It is in good condition. The lower fronds have been overpruned.

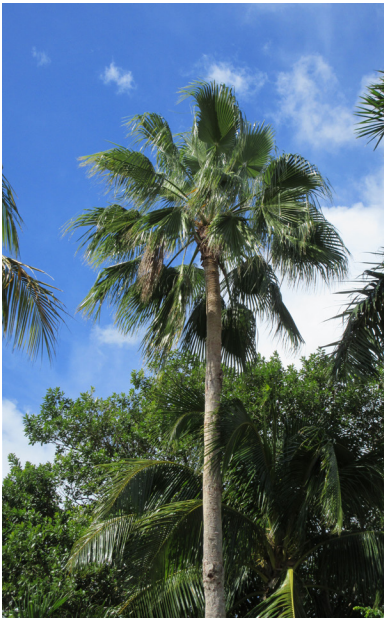
Tree #40 is a Washingtonia Palm located towards the southwest corner of the property. It is in good condition.

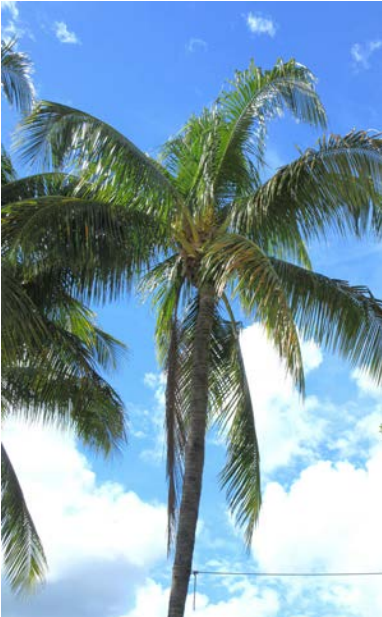
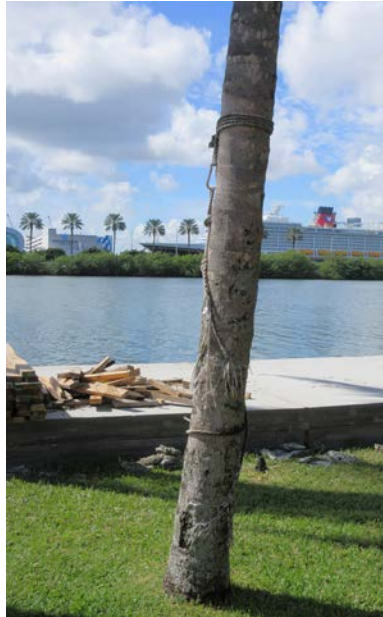
Tree #41 is a Coconut Palm located towards the southwest corner of the property. It is in fair condition with yellowing fronds and nails in the trunk.

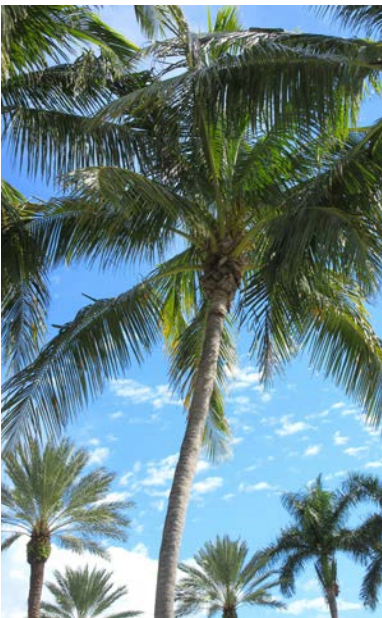
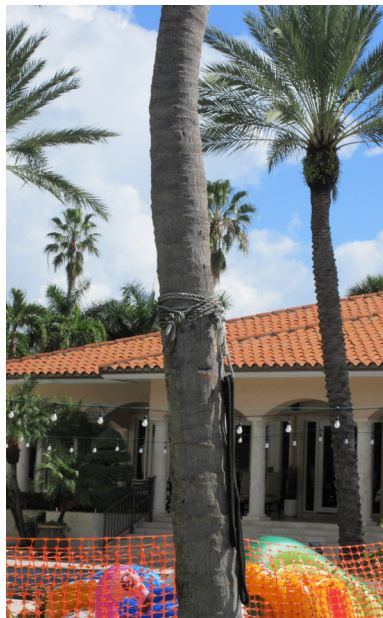
Tree #42 is a Coconut Palm located towards the southwest corner of the property. It is in fair condition with yellowing fronds.

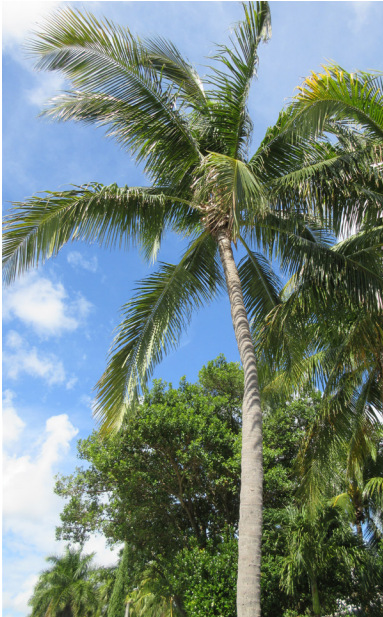
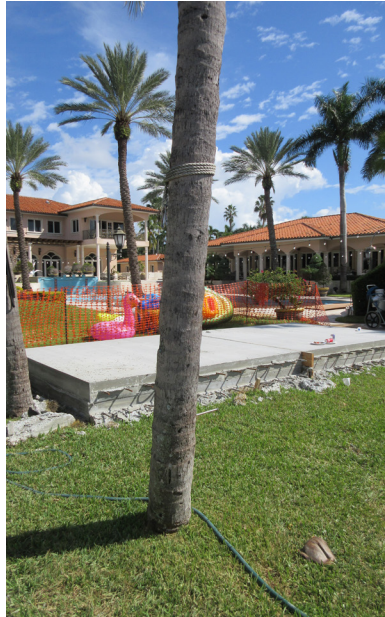
Tree #43 is a Coconut Palm located towards the southwest corner of the property. It is in fair condition with yellowing fronds and nails in the trunk. There is a trunk constriction.

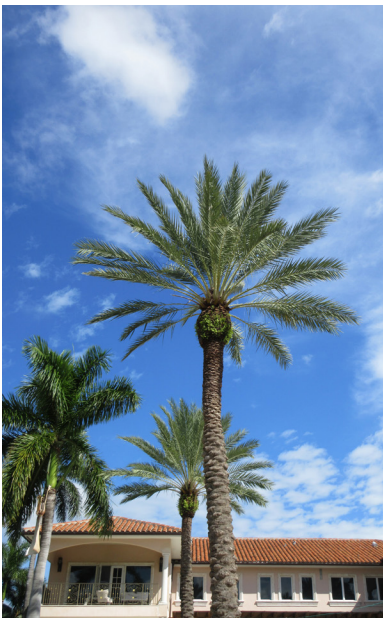
Tree #44 is a Date Palm located next to the pool. It is growing in a raised planter with limited rooting space. The tree is good condition.

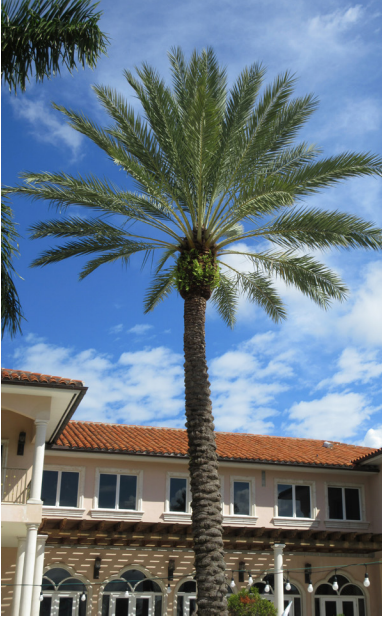
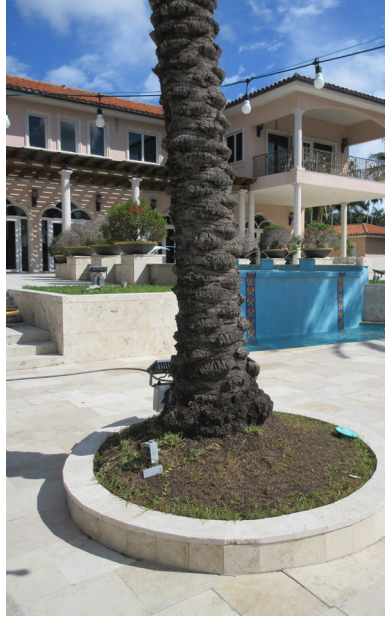
Tree #45 is a Date Palm located next to the pool. It is growing in a raised planter with limited rooting space. The tree is good condition.

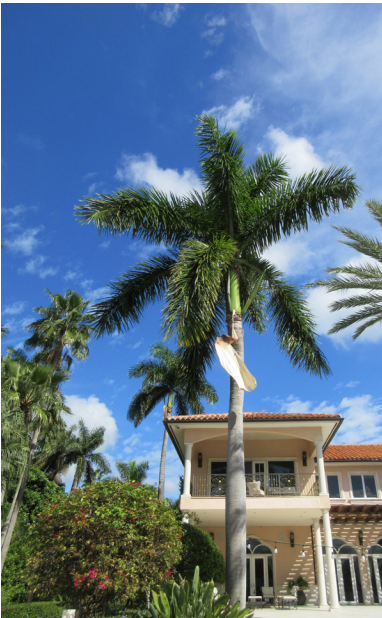
Tree #46 is a Royal Palm located next to the pool. It is in good condition.

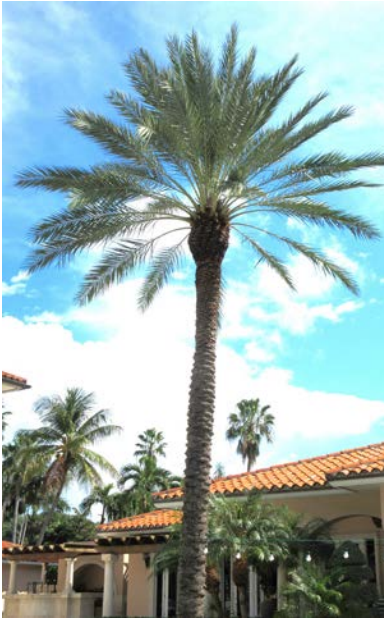
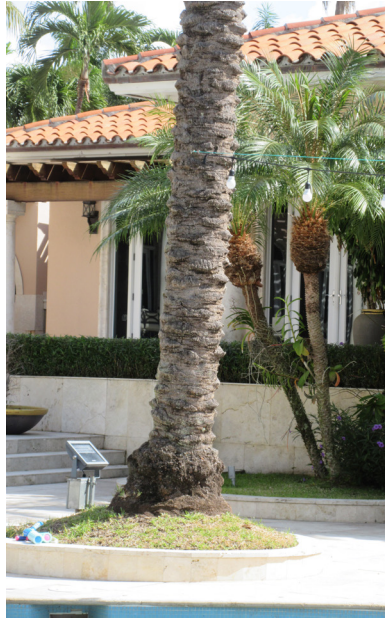
Tree #47 is a Date Palm located next to the pool. It is growing in a raised planter with limited rooting space. The tree is good condition.

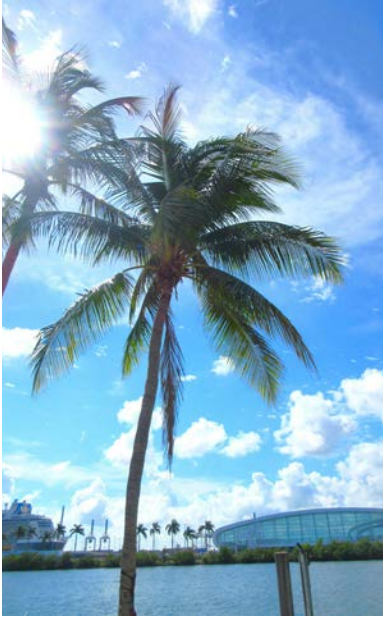
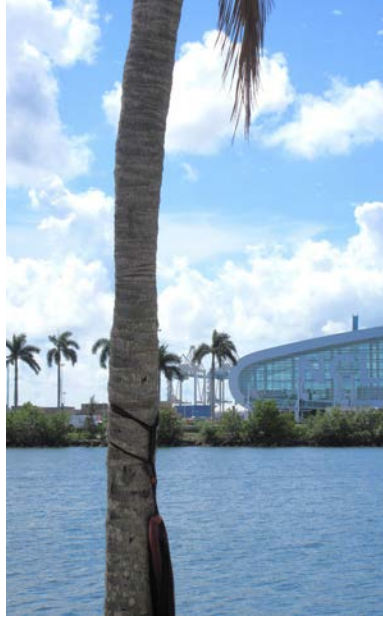
Tree #49 is a Coconut Palm located in the southeast corner of the property. It is in good condition with some trunk irregularities.

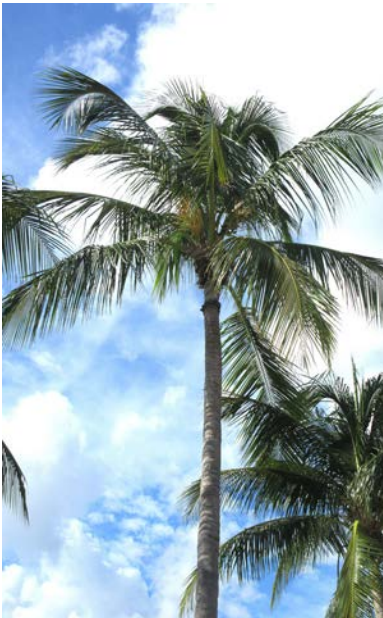
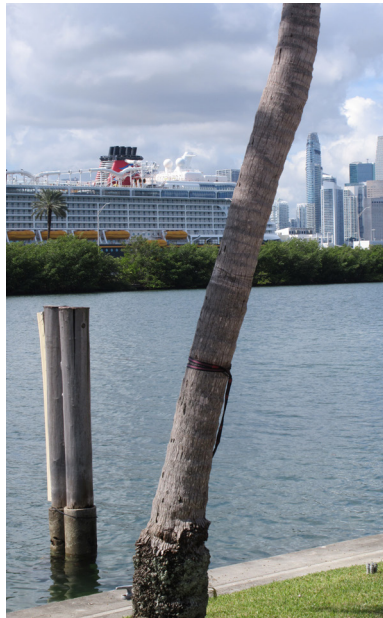
Tree #50 is a Coconut Palm located in the southeast corner of the property. It is in fair condition with a thin canopy.

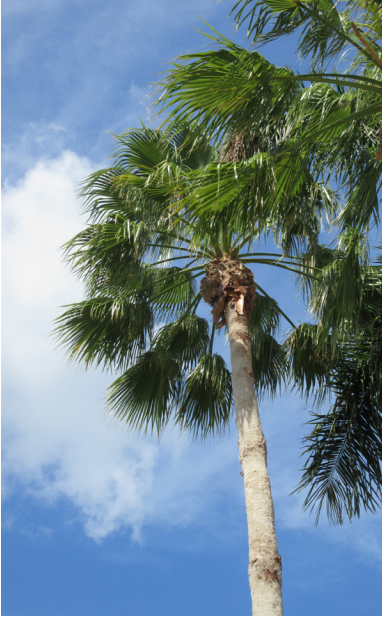
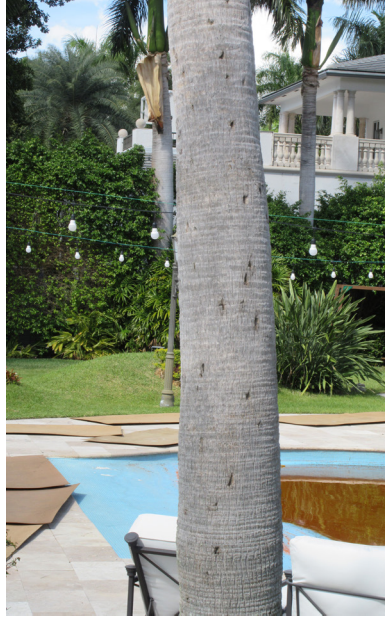
Tree #53 is a Washingtonia Palm located towards the southeast corner of the property. It is in good condition. There are climbing spike injuries to the trunk.

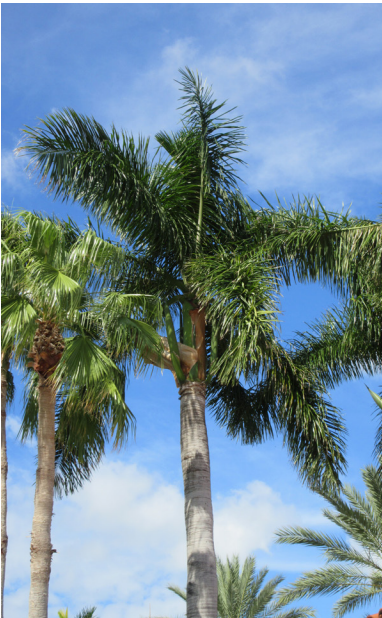
Tree #54 is a Royal Palm located towards the southeast corner of the property. It is in good condition.

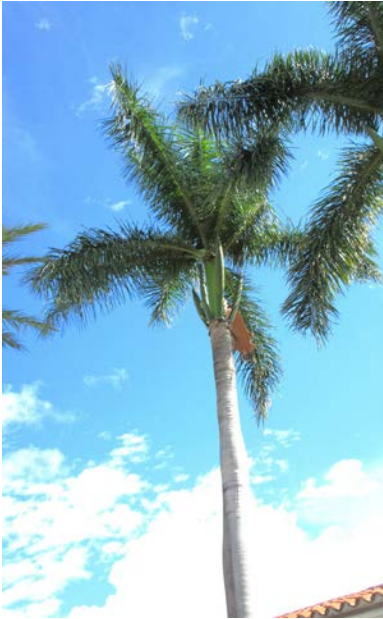
Tree #55 is a Royal Palm located towards the southeast corner of the property. It is in good condition.

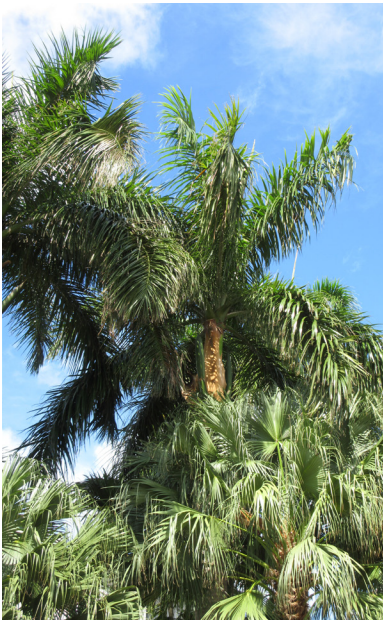
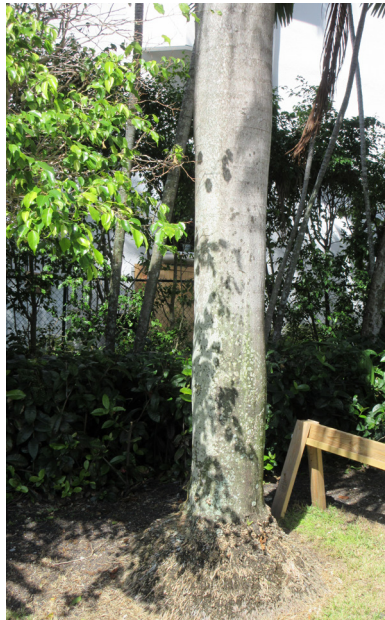
Tree #56 is a Royal Palm located on the western side of the property. It is in good condition.

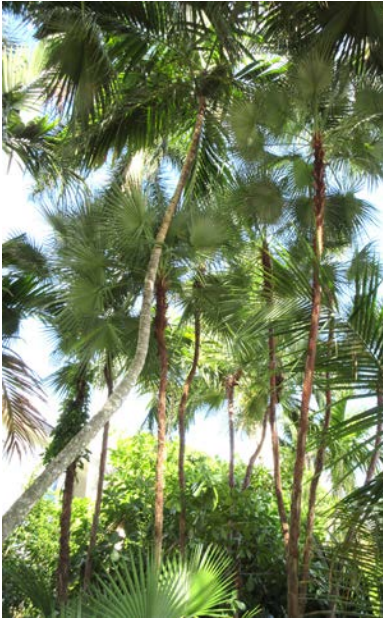
Tree #57 is a Purotis Palm located on the western side of the property. It is in fair condition and is competing with the nearby trees.

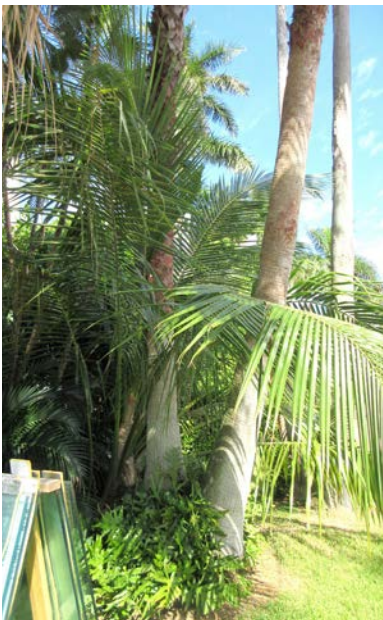
Tree #58 is a small Coconut Palm located on the western side of the property. It is in good condition.

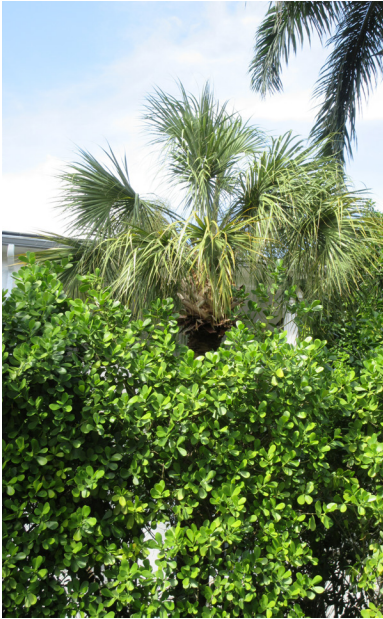
Tree #59 is a Sabal Palm located on the western side of the property. It is in fair condition with a thin, off-color canopy.

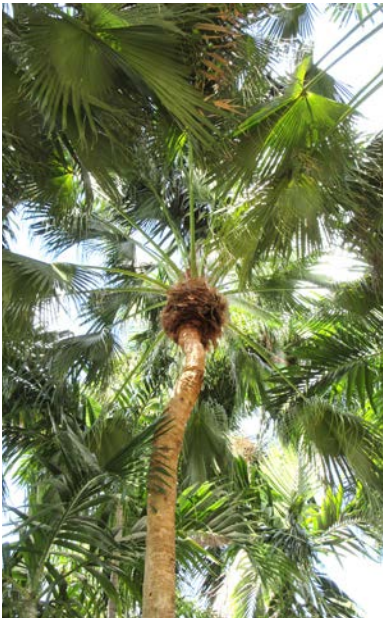
Tree #60 is a Washingtonia Palm located on the western side of the property. It is in poor condition with a thin canopy. The trunk narrows and curves. The tree is competing with the nearby vegetation.

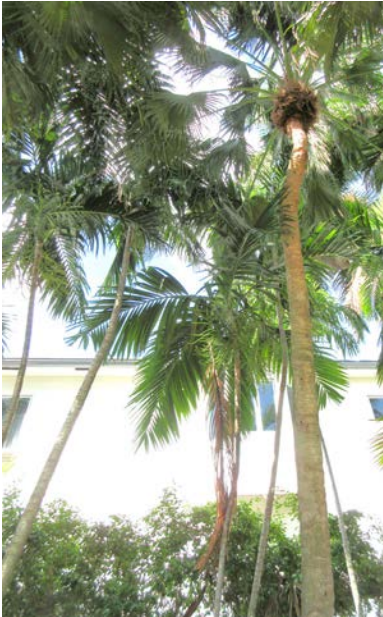
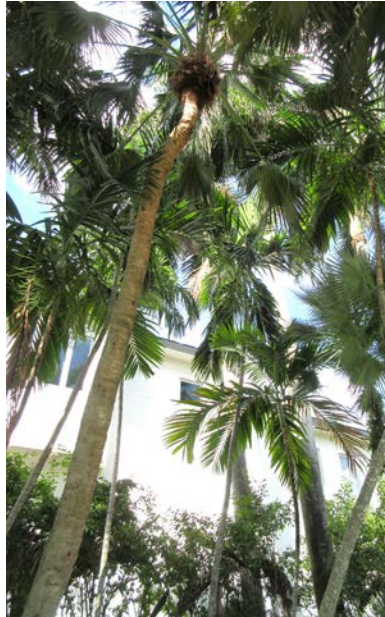
Tree #61 is a cluster of nine Alexander Palms located on the western side of the property. Overall they are in fair condition and are competing with the nearby vegetation.

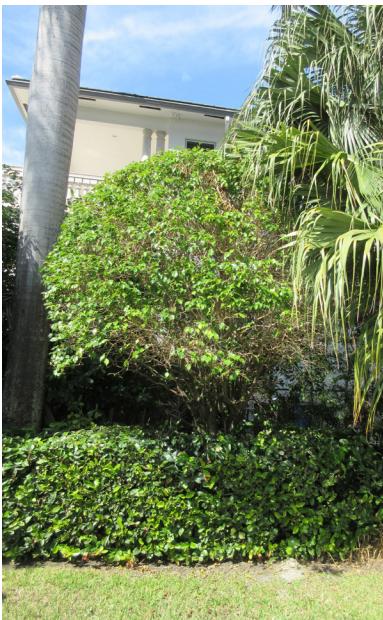
Tree #62 is a Weeping Fig located on the western side of the property. It is multi-trunked and in fair condition. The canopy has been shaped and there is thrips damage to the foliage.

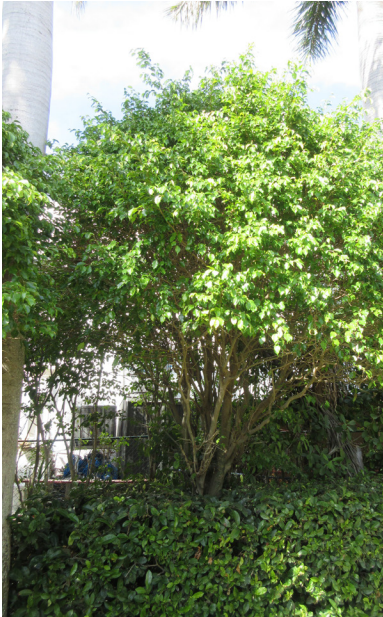
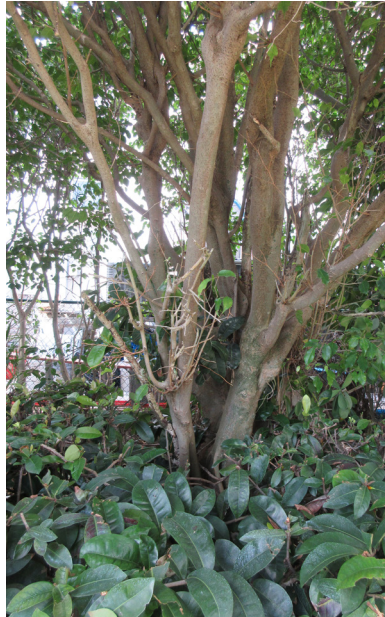
Tree #63 is a Weeping Fig located on the western side of the property. It is multi-trunked and in good condition. The canopy has been shaped and there is thrips damage to the foliage.

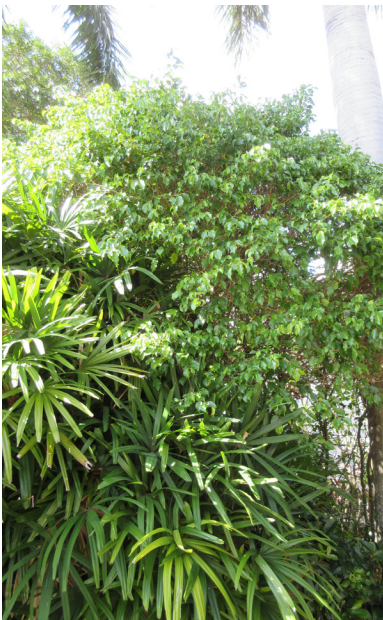
Tree #64 is a Weeping Fig located on the western side of the property. It is multi-trunked and in good condition. The canopy has been shaped and there is thrips damage to the foliage.

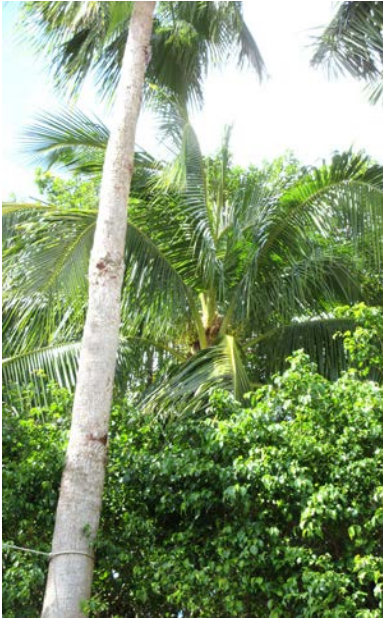
Tree #65 is a Coconut Palm located in the southwestern corner of the property. It is in good condition.

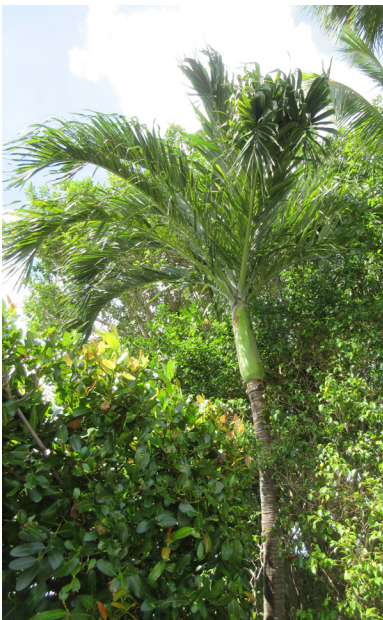
Tree #66 is a Christmas Palm located in the southwestern corner of the property. It is in good condition with some yellow spotting on the fronds.

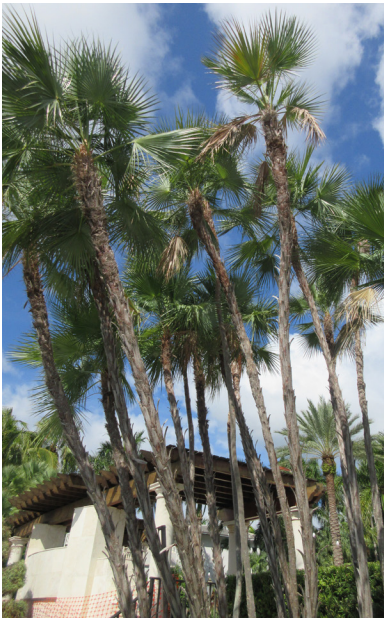
Tree #68 is a Paurotis Palm located at the rear of the property. It is in good condition.

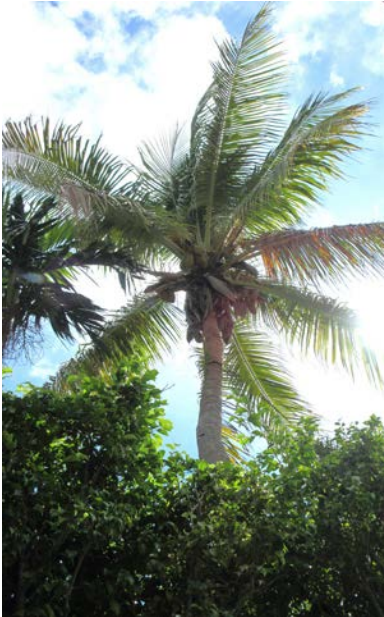
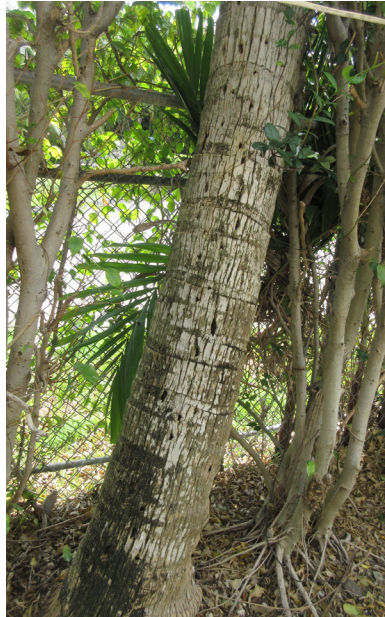
Tree #69 is a Coconut Palm located on the eastern side of the property. It is in fair condition with climbing spike injuries to the trunk. The canopy overhangs the eastern neighbor's property.

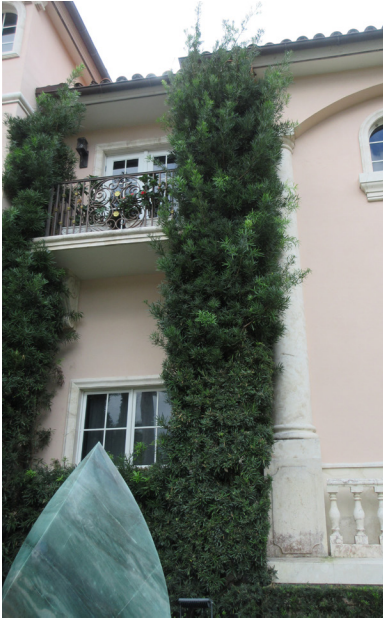
Tree #73 is a Podocarpus located at the front of the house. It is in good condition with dense foliage.

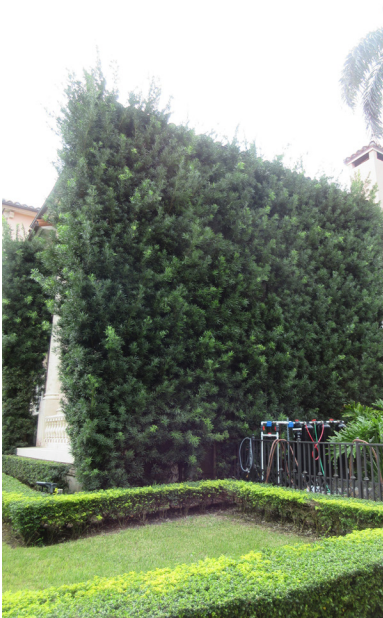
Tree #74 is a Podocarpus hedge located on the western side of the house. It is in good condition.

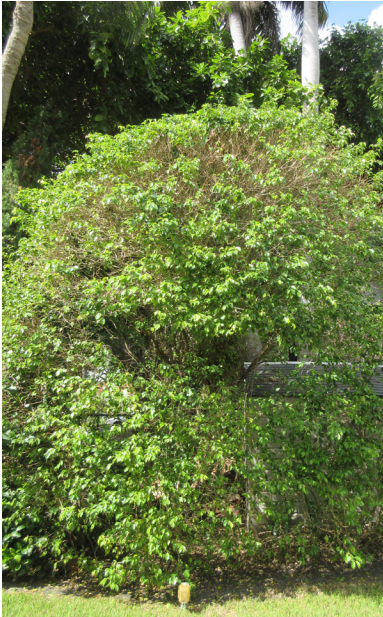
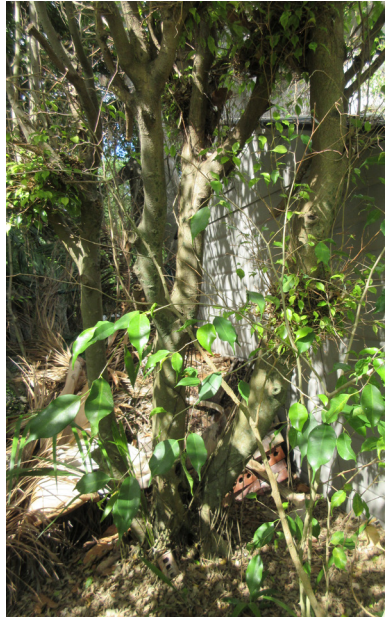
Tree #75 is a Weeping Fig located on the western side of the property. It is multi-trunked and in fair condition. The canopy has been shaped and there is thrips damage to the foliage.

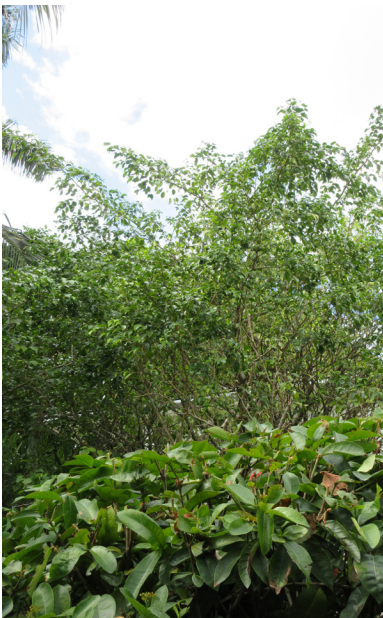
Tree #76 is a Weeping Fig located on the western side of the property. It is multi-trunked and in fair condition. The canopy is thin and there is thrips damage to the foliage.
