RE: **Request for After-the-Fact Certificate of Appropriateness for Demolition** - Letter of Intent for After-the-fact Certificate of Appropriateness for Demolition regarding 1525 Lenox Avenue, Miami Beach

1525 Lenox Avenue

STRUCTURAL CONDITION ASSESSMENT
1525 Lenox Ave
Miami Beach, Florida

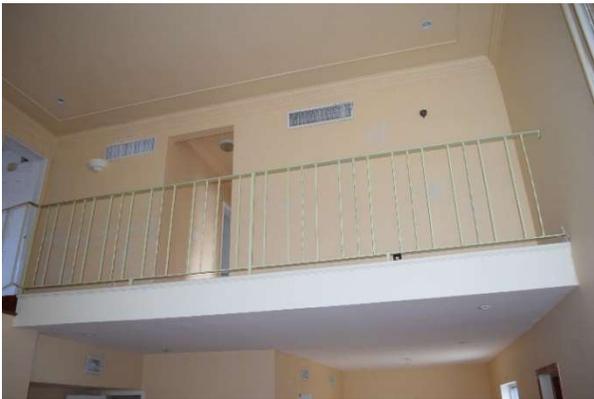
The floor appears to be marble tile (Figure 67) and extends into the one-story living room space. (Figure 68) A stair with decorative metal balustrade (Figure 69) leads to the upper level walkway that overlooks the two-story space below. (Figure 70)

Figure 70. Detail of upper level walkway overlooking two-story space, February 2024.
