PROPERTY INSPECTION CHECKLIST

DATE: 03-05-2025

TENANT NAME: North Shore Library 7505 Collins Ave

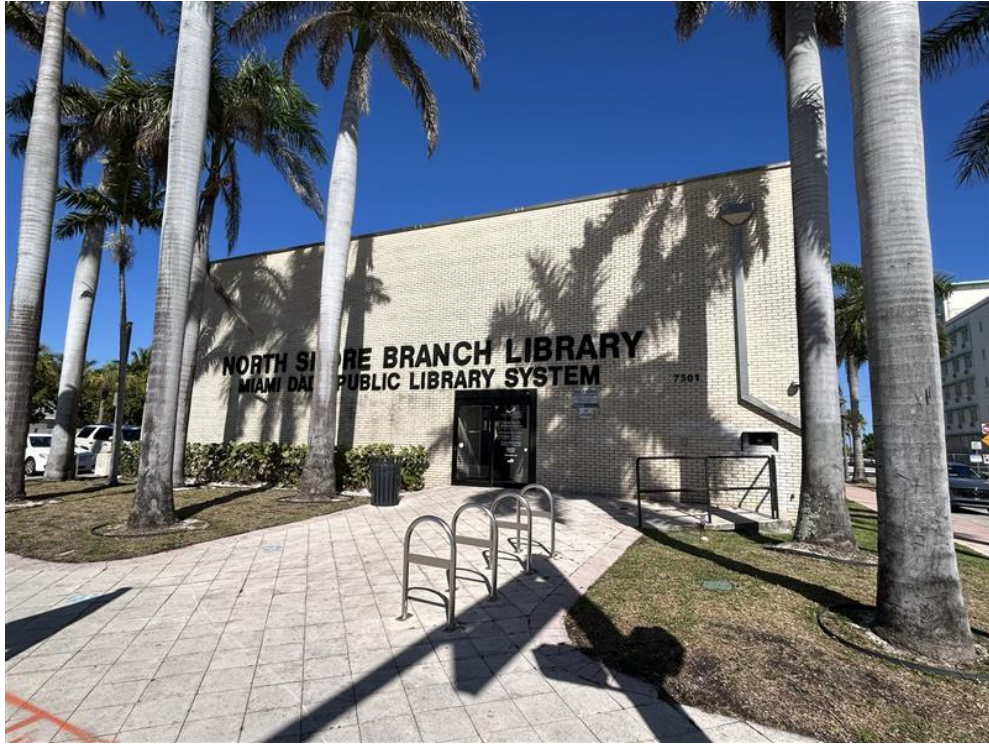
In summary, the exterior requires several improvements. The façade and sidewalks need thorough pressure cleaning, and the façade itself requires a fresh coat of paint. The window glass needs a thorough cleaning, while the window and door frames are in poor condition, with rust present on the top of some window frames. The handrail also requires a fresh coat of paint. Although the landscaping is in good condition, there is potential for further improvement.
