Assessment of Enterococci in Groundwater and Stormwater at the Miami Beach Park View Canal

March 11, 2025

University of Miami Team: Ayaaz (Johann) Amirali, Cristina Fayad Martinez, Aarohi Talati, Diego Lopez Oranday, Larissa Montas, Isabela Puente, Rivka Reiner, Matthew Roca,
Helena Solo-Gabriele

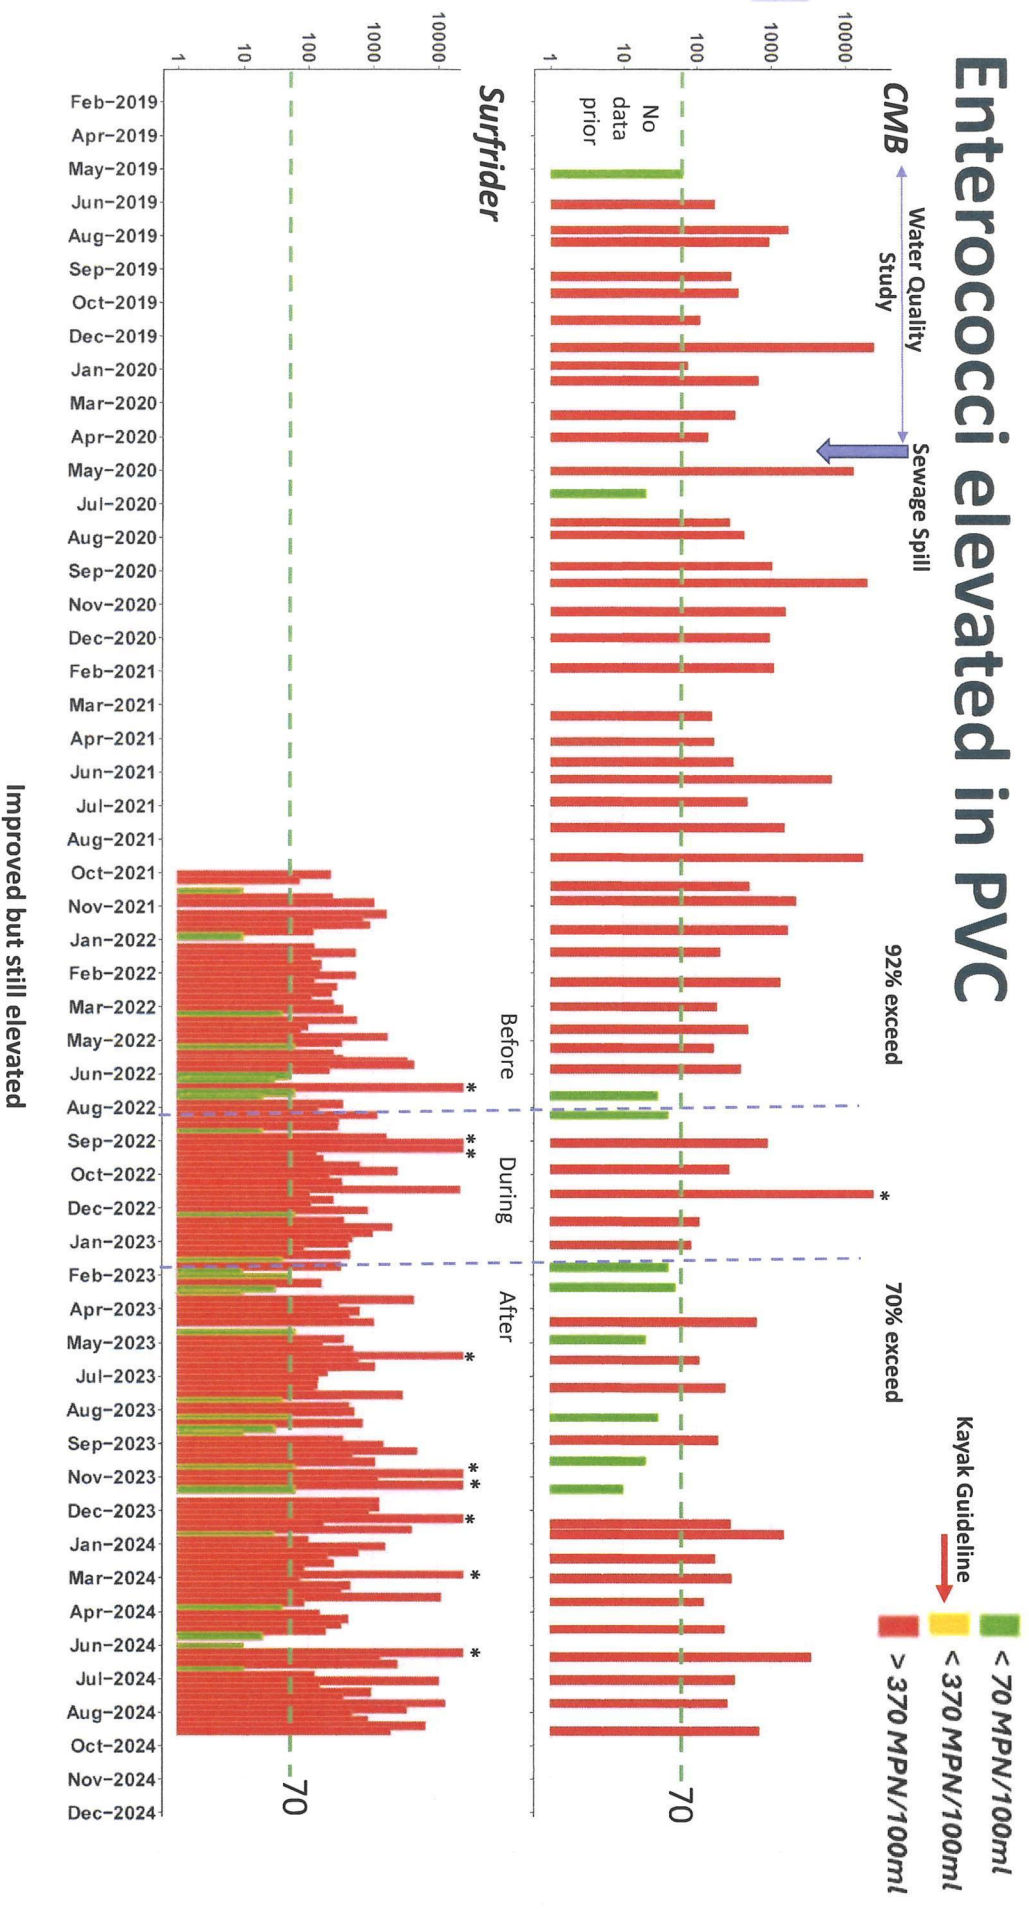
Enterococci elevated in PVC

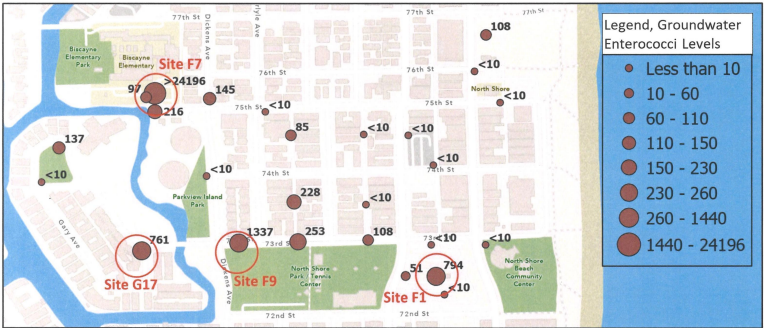
Results of Enterococci in Groundwater
