## COMMITTEE MEMORANDUM

TITLE: **DISCUSS THE POTENTIAL IMPLEMENTATION OF A BICYCLE LANE ON THE WEST SIDE OF COLLINS AVENUE AS PART OF AN UPCOMING FLORIDA DEPARTMENT OF TRANSPORTATION (“FDOT”) RESURFACING, RESTORATION, AND REHABILITATION (“RRR”) PROJECT ON STATE ROAD (“SR”) A1A/COLLINS AVENUE FROM SR 907/W 63 STREET TO 75 STREET.**

The project is in the City of Miami Beach, Miami-Dade County. The project limits are along SR A1A/Collins Avenue from SR 907/W 63rd Street to 75th Street (8.640-9.782). The Project Location Map is shown in Figure 1-3.

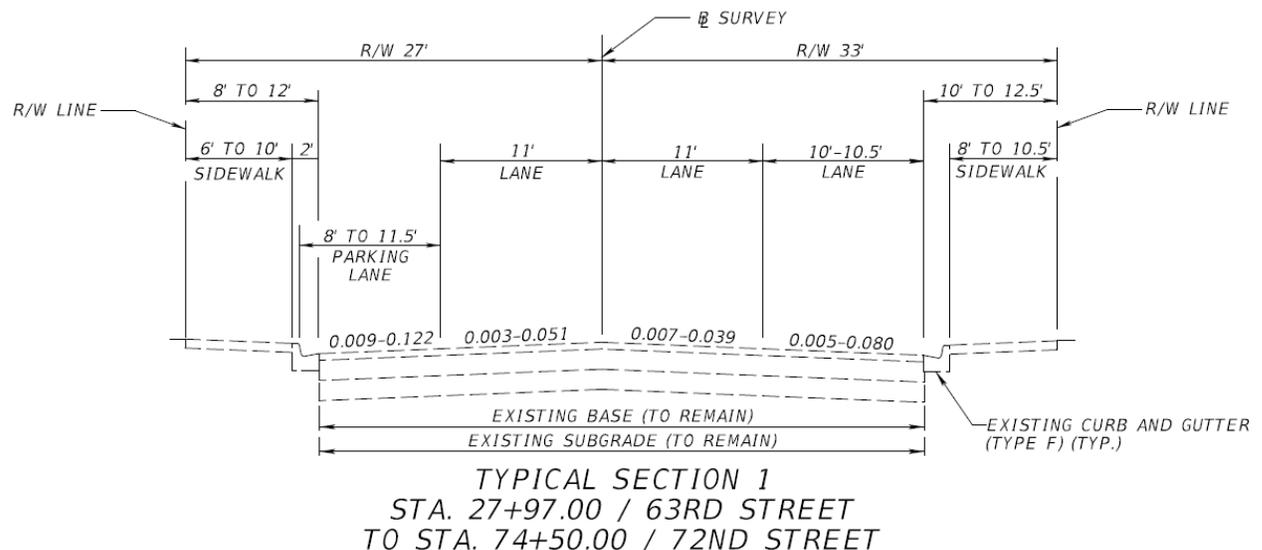
**FIGURE 1-1 EXISTING TYPICAL SECTION 1**

**Existing Typical Section 1 (from W 63<sup>rd</sup> Street to 73<sup>rd</sup> Street):** This typical section consists of a three-lane roadway with one 8-11.5-foot parking lane to face of curb, two 11-foot inside lanes, one 10-10.5-foot outside lane, type F curb and gutter, 6-10-foot concrete sidewalk on the left side, and 8-10.5-foot concrete sidewalk on the right side of the roadway.

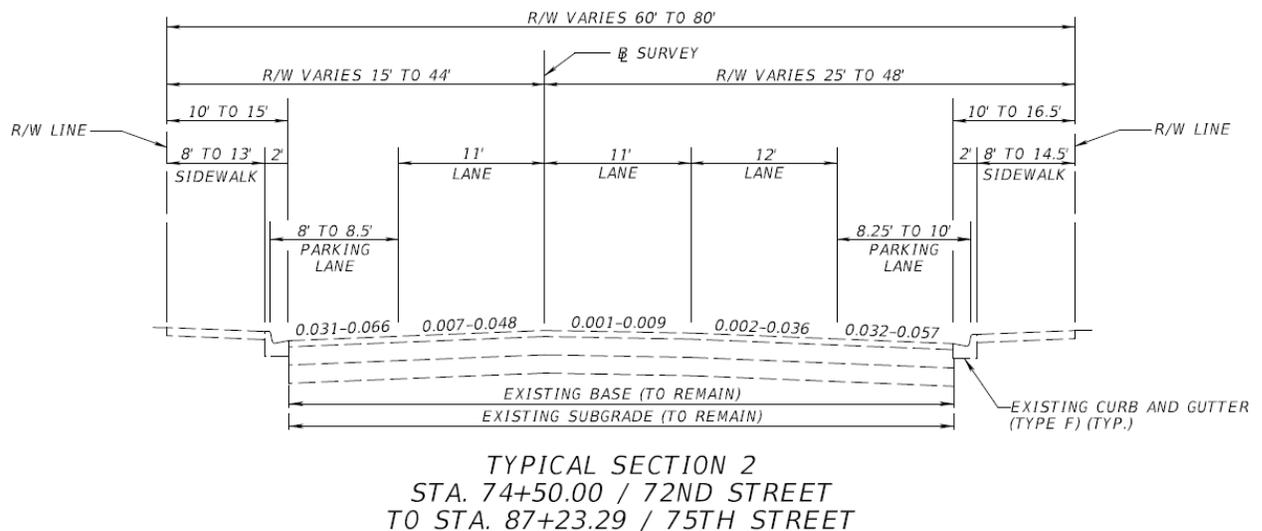
**FIGURE 1-2 EXISTING TYPICAL SECTION 2**

**Existing Typical Section 2 (from W 73<sup>rd</sup> Street to 75<sup>th</sup> Street):** This typical section consists of a three-lane roadway with 8-10-foot parking lanes to face of curb, two 11-foot inside lanes, one 12-foot outside lane, type F curb and gutter, 8-13-foot concrete sidewalk on the left side, and 8-14.5-foot concrete sidewalk on the right side of the roadway.

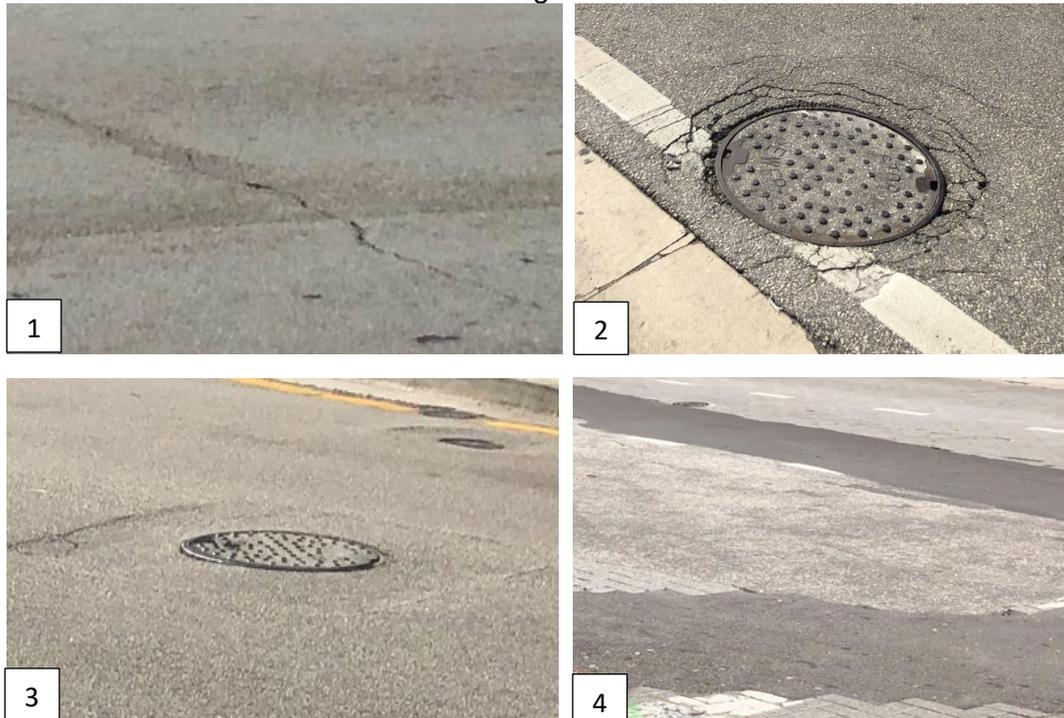
**Figure 2-1 EXISTING PAVEMENT CONDITION**  
(1-2. CRACKING, 3. DEPRESSION, 4. UTILITY CUT)

After conducting a field review on the pavement condition (PC), surface deteriorations were encountered, such as minor cracking, utility cuts, and pavement depression around manholes and valves. The pavement condition was reviewed in the Pavement Condition Survey (PCS) Ratings by State Materials Office (SMO) 2022. According to the PCS, the survey resulted in a ride evaluation of 4.6 with no projection. The cracking evaluation resulted in 6.5 with no projection. The rutting evaluation resulted in 8.0 with no project. The existing pavement will be 15 years by 2027. Refer to Appendix D-1. Figure 2-1 illustrates samples of the surface deteriorations encountered during the field review.

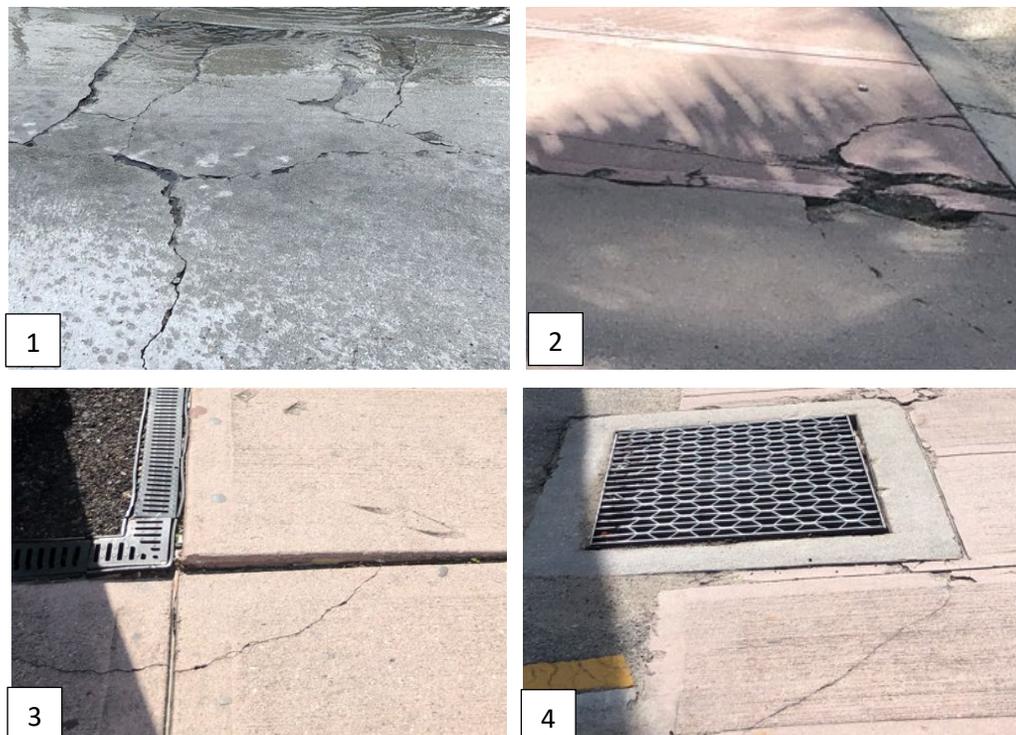
**Figure 2-2 SIDEWALK DEFICIENCIES**  
(1-2. CRACKING, 3. TRIP HAZARD, 4. NON-ADA GRATE)

There are locations that do not meet the criteria for clear width of sidewalk and are summarized in Table 2-6. Unobstructed sidewalk width is less than 4 feet in several planters. Where feasible, objects obstructing clear paths on sidewalks should be relocated to meet FDM/ADA requirements. A Design Variation for Unobstructed Sidewalk Width is required for new features.

The existing ditch bottom inlet at station 34+60 LT appears to be Type F and is encroaching onto the sidewalk posing a safety hazard for pedestrians. If an ADA-approved grate is not available, suggest modifying the top of the existing ditch bottom inlet to offset the grate away from the sidewalk.

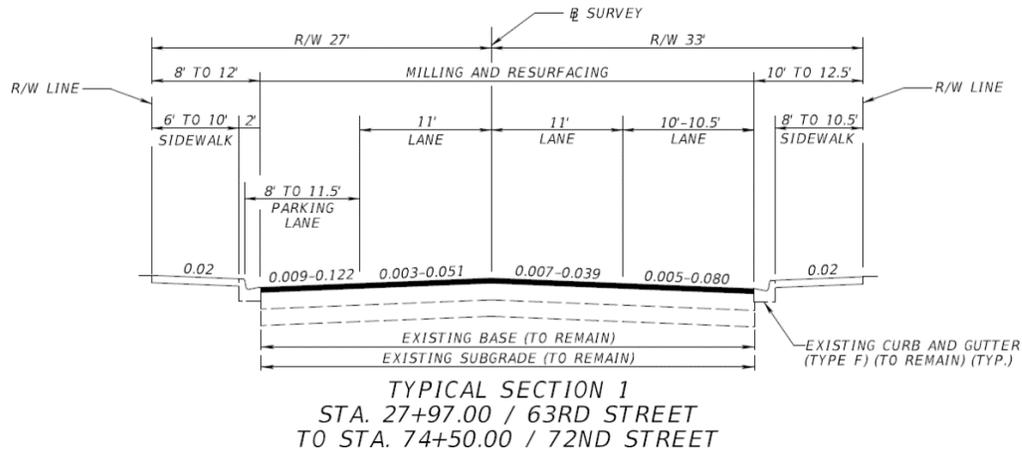
**FIGURE 3-1 RECOMMENDED TYPICAL SECTION 1**

**Proposed Typical Section 1 (from W 63<sup>rd</sup> Street to 73<sup>rd</sup> Street):** This typical section consists of a three-lane roadway with one 8-11.5-foot parking lane to face of curb, two 11-foot inside lanes, one 10-10.5-foot outside lane, type F curb and gutter, 6-10-foot concrete sidewalk on the left side, and 8-10.5-foot concrete sidewalk on the right side of the roadway.

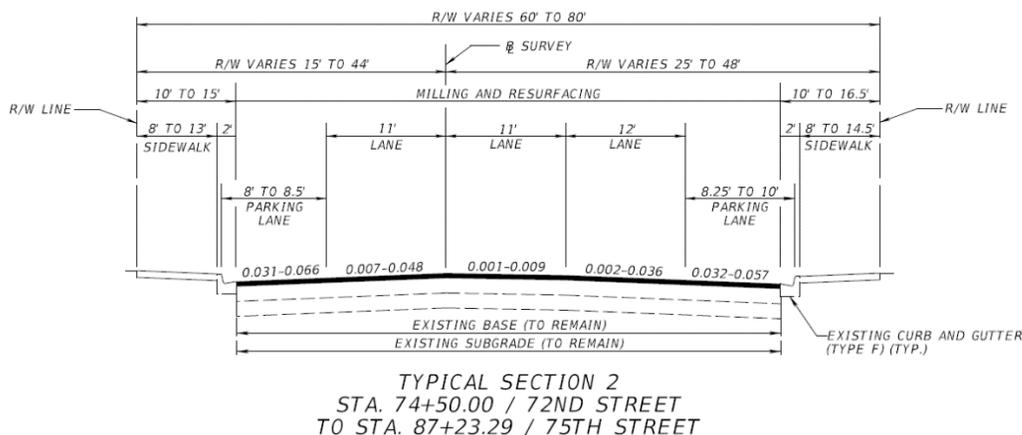
**FIGURE 3-2 RECOMMENDED TYPICAL SECTION 2**

**Proposed Typical Section 2 (from W 73<sup>rd</sup> Street to 75<sup>th</sup> Street):** This typical section consists of a three-lane roadway with 8-10-foot parking lanes to face of curb, two 11-foot inside lanes, one 12-foot outside lane, type F curb and gutter, 8-13-foot concrete sidewalk on the left side, and 8-14.5-foot concrete sidewalk on the right side of the roadway.

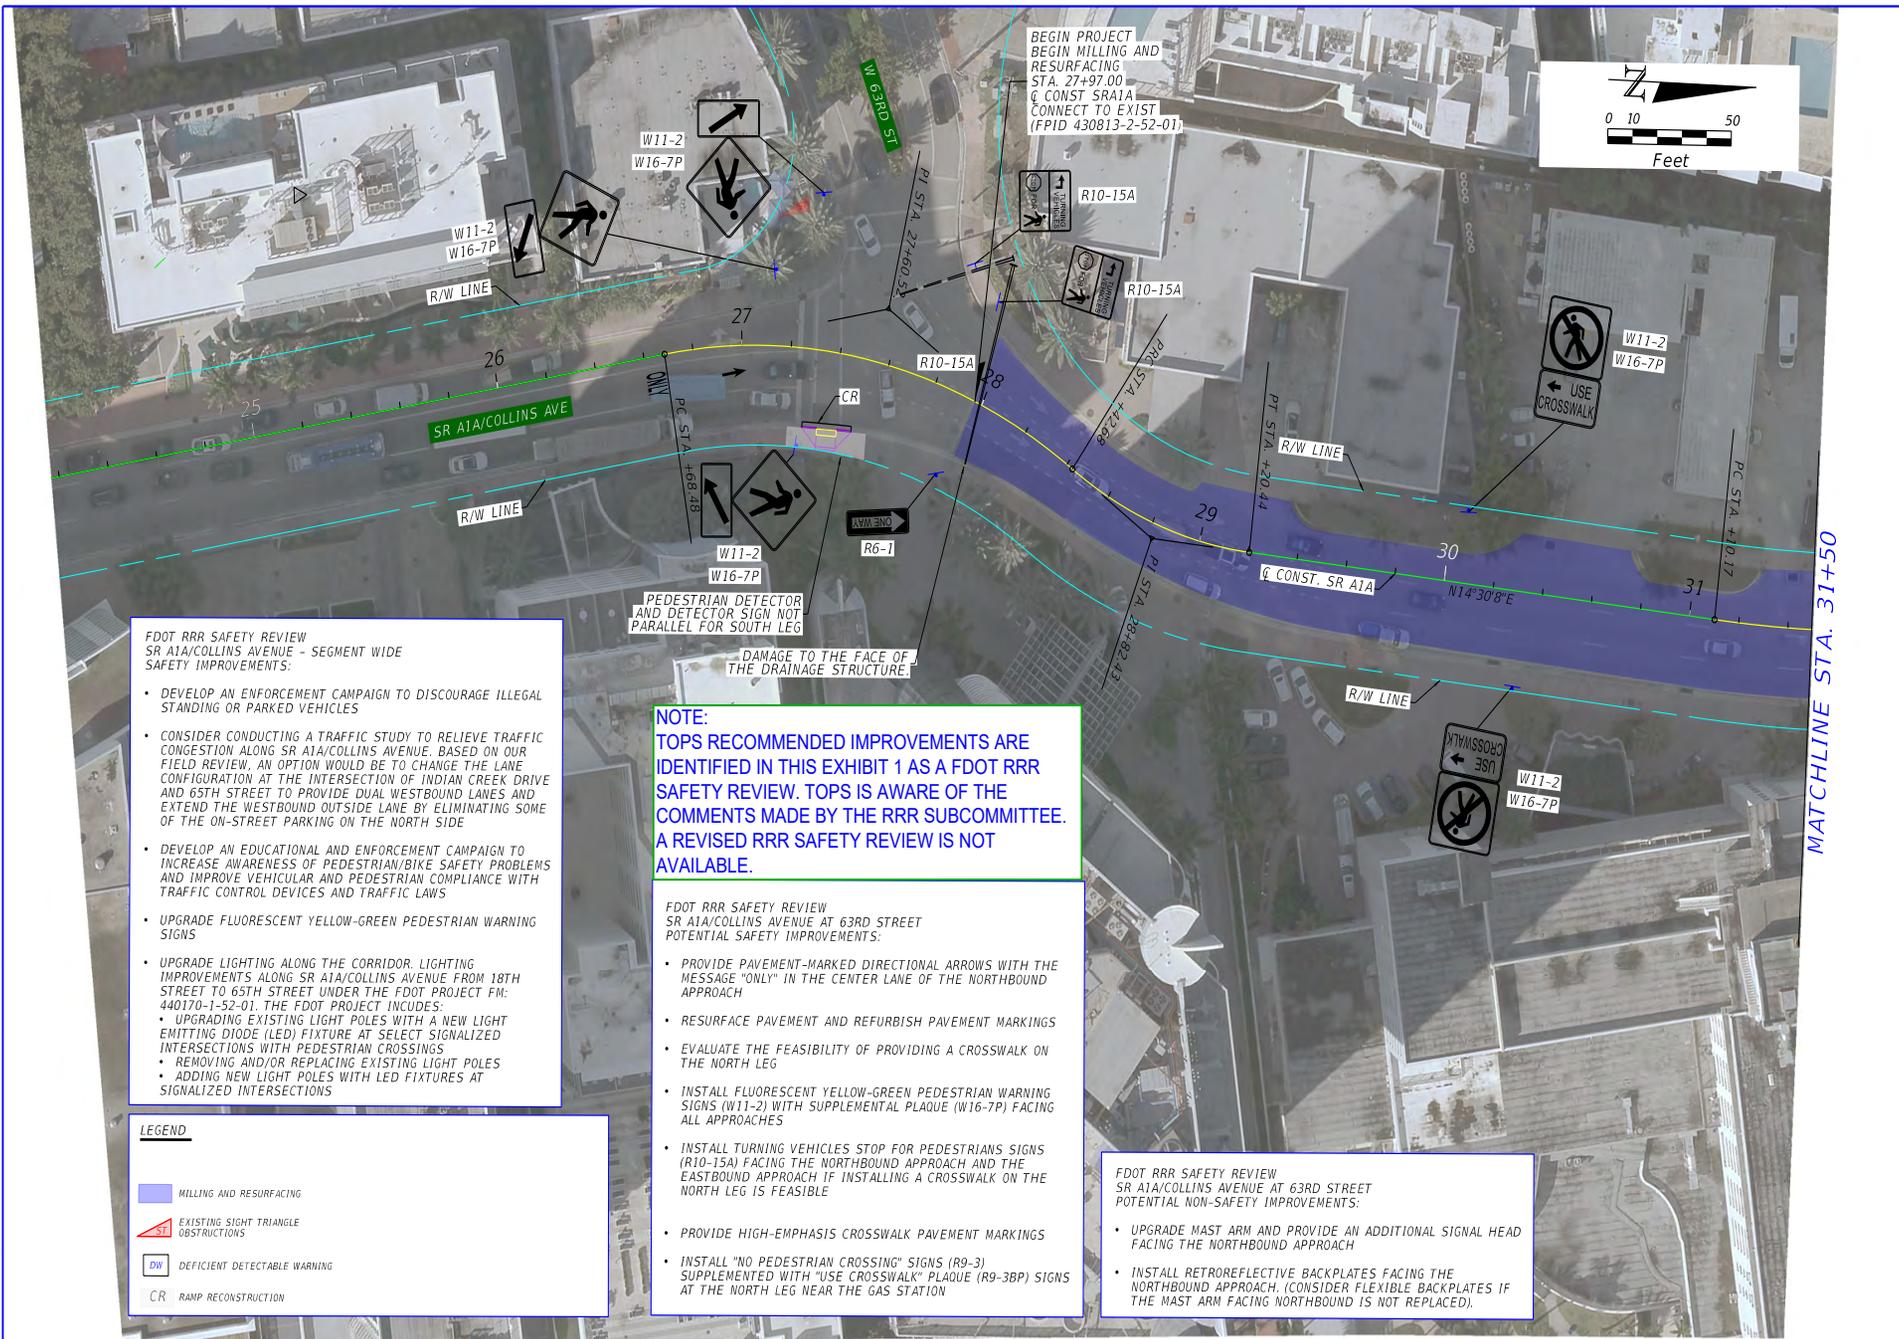
Exhibit 1 below summarizes the existing deficiencies and recommended improvements.

**FDOT RRR SAFETY REVIEW  
 SR A1A/COLLINS AVENUE - SEGMENT WIDE  
 SAFETY IMPROVEMENTS:**

- DEVELOP AN ENFORCEMENT CAMPAIGN TO DISCOURAGE ILLEGAL STANDING OR PARKED VEHICLES
- CONSIDER CONDUCTING A TRAFFIC STUDY TO RELIEVE TRAFFIC CONGESTION ALONG SR A1A/COLLINS AVENUE. BASED ON OUR FIELD REVIEW, AN OPTION WOULD BE TO CHANGE THE LANE CONFIGURATION AT THE INTERSECTION OF INDIAN CREEK DRIVE AND 65TH STREET TO PROVIDE DUAL WESTBOUND LANES AND EXTEND THE WESTBOUND OUTSIDE LANE BY ELIMINATING SOME OF THE ON-STREET PARKING ON THE NORTH SIDE

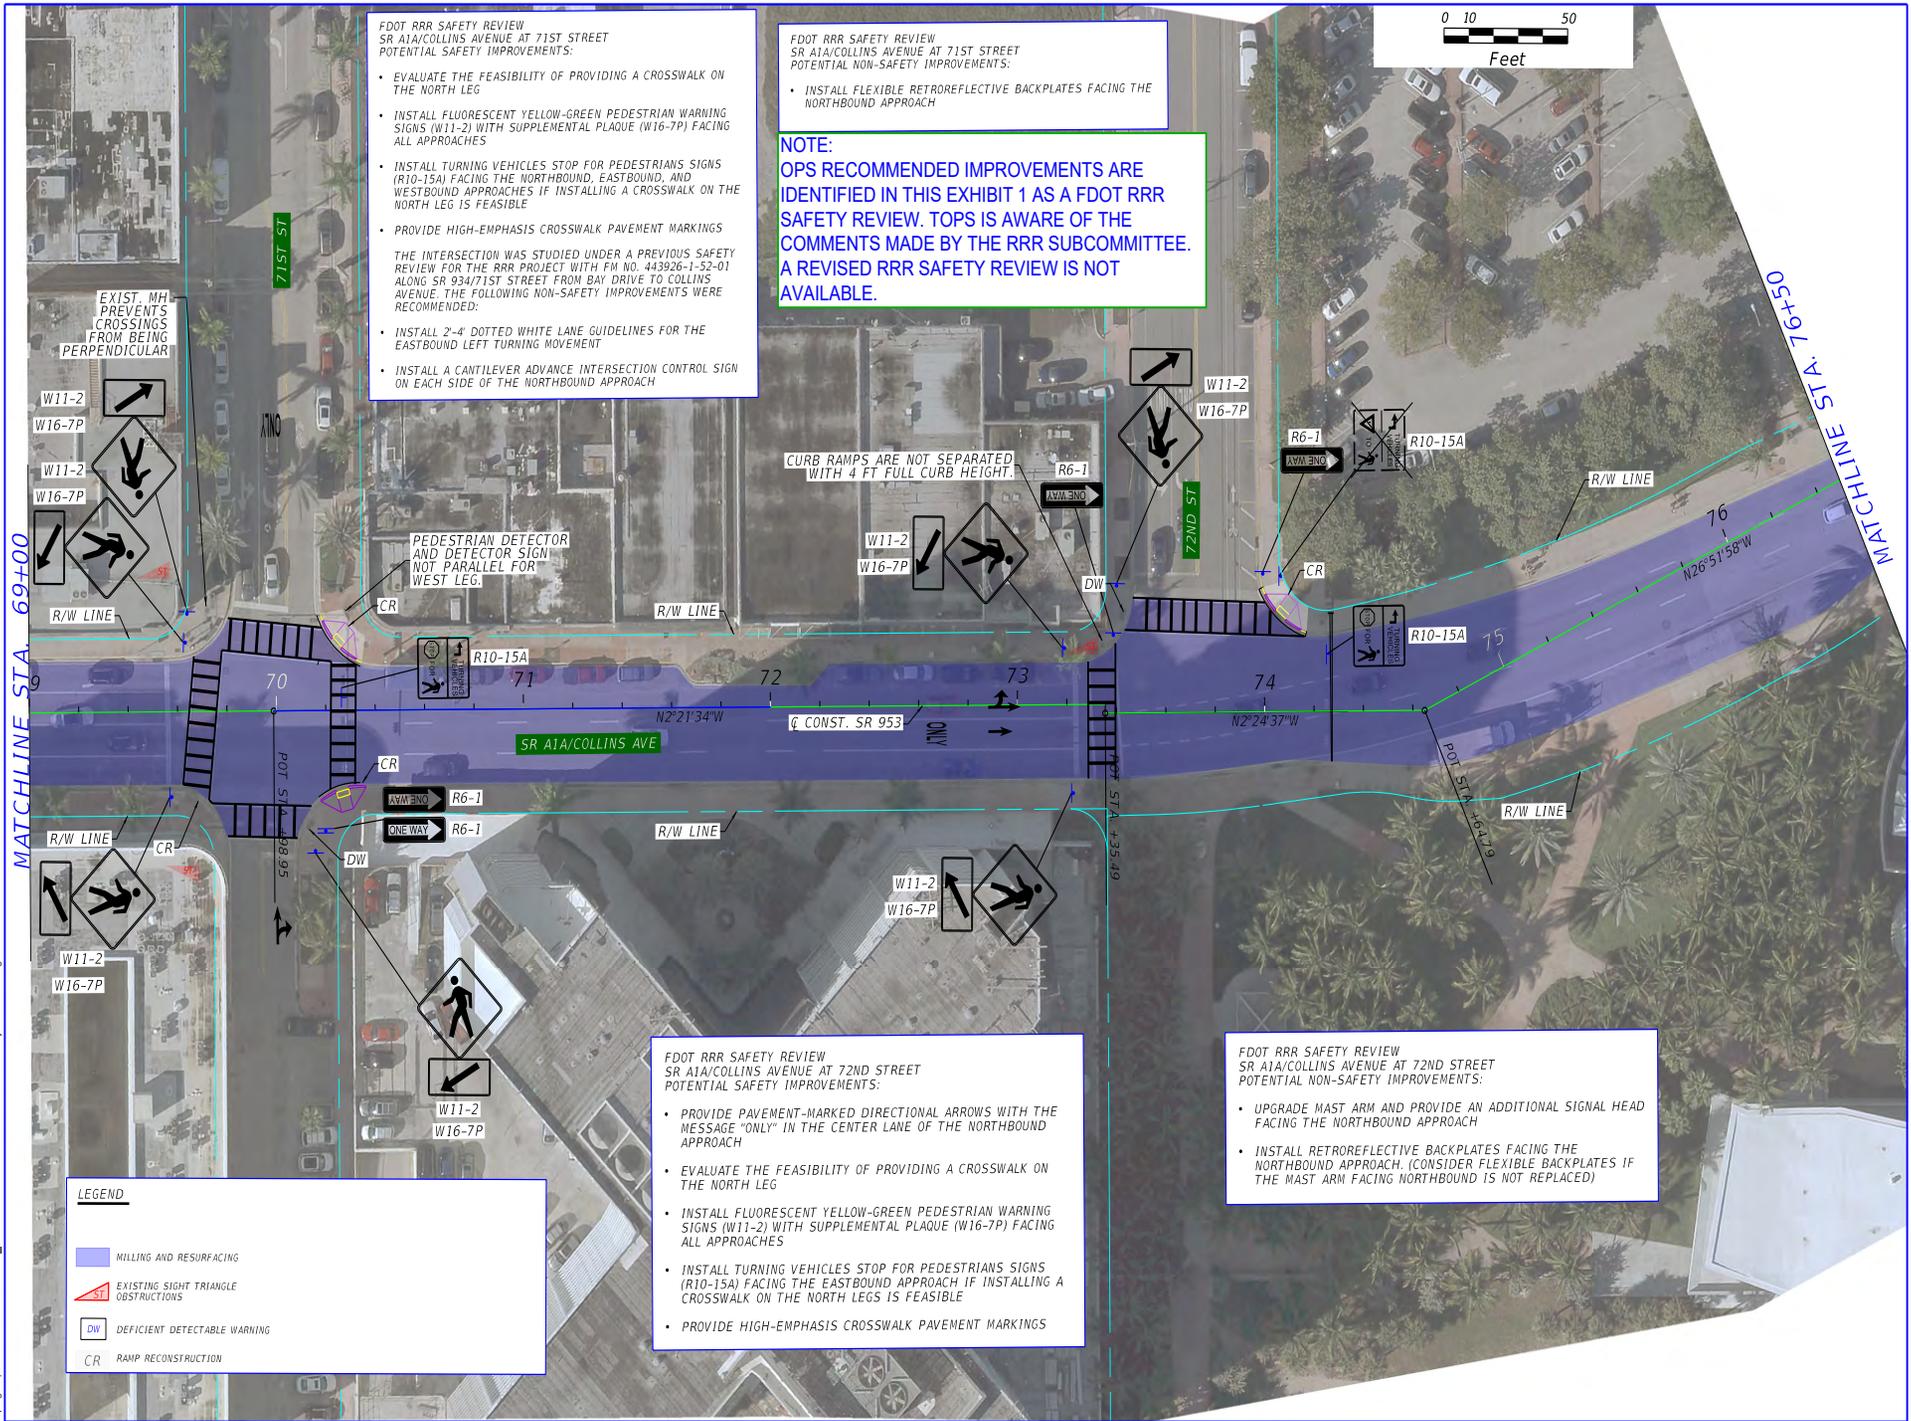
PEDESTRIAN DETECTOR AND DETECTOR SIGN NOT PARALLEL FOR WEST LEG.

CURB RAMP ARE NOT SEPARATED WITH 4 FT FULL CURB HEIGHT.

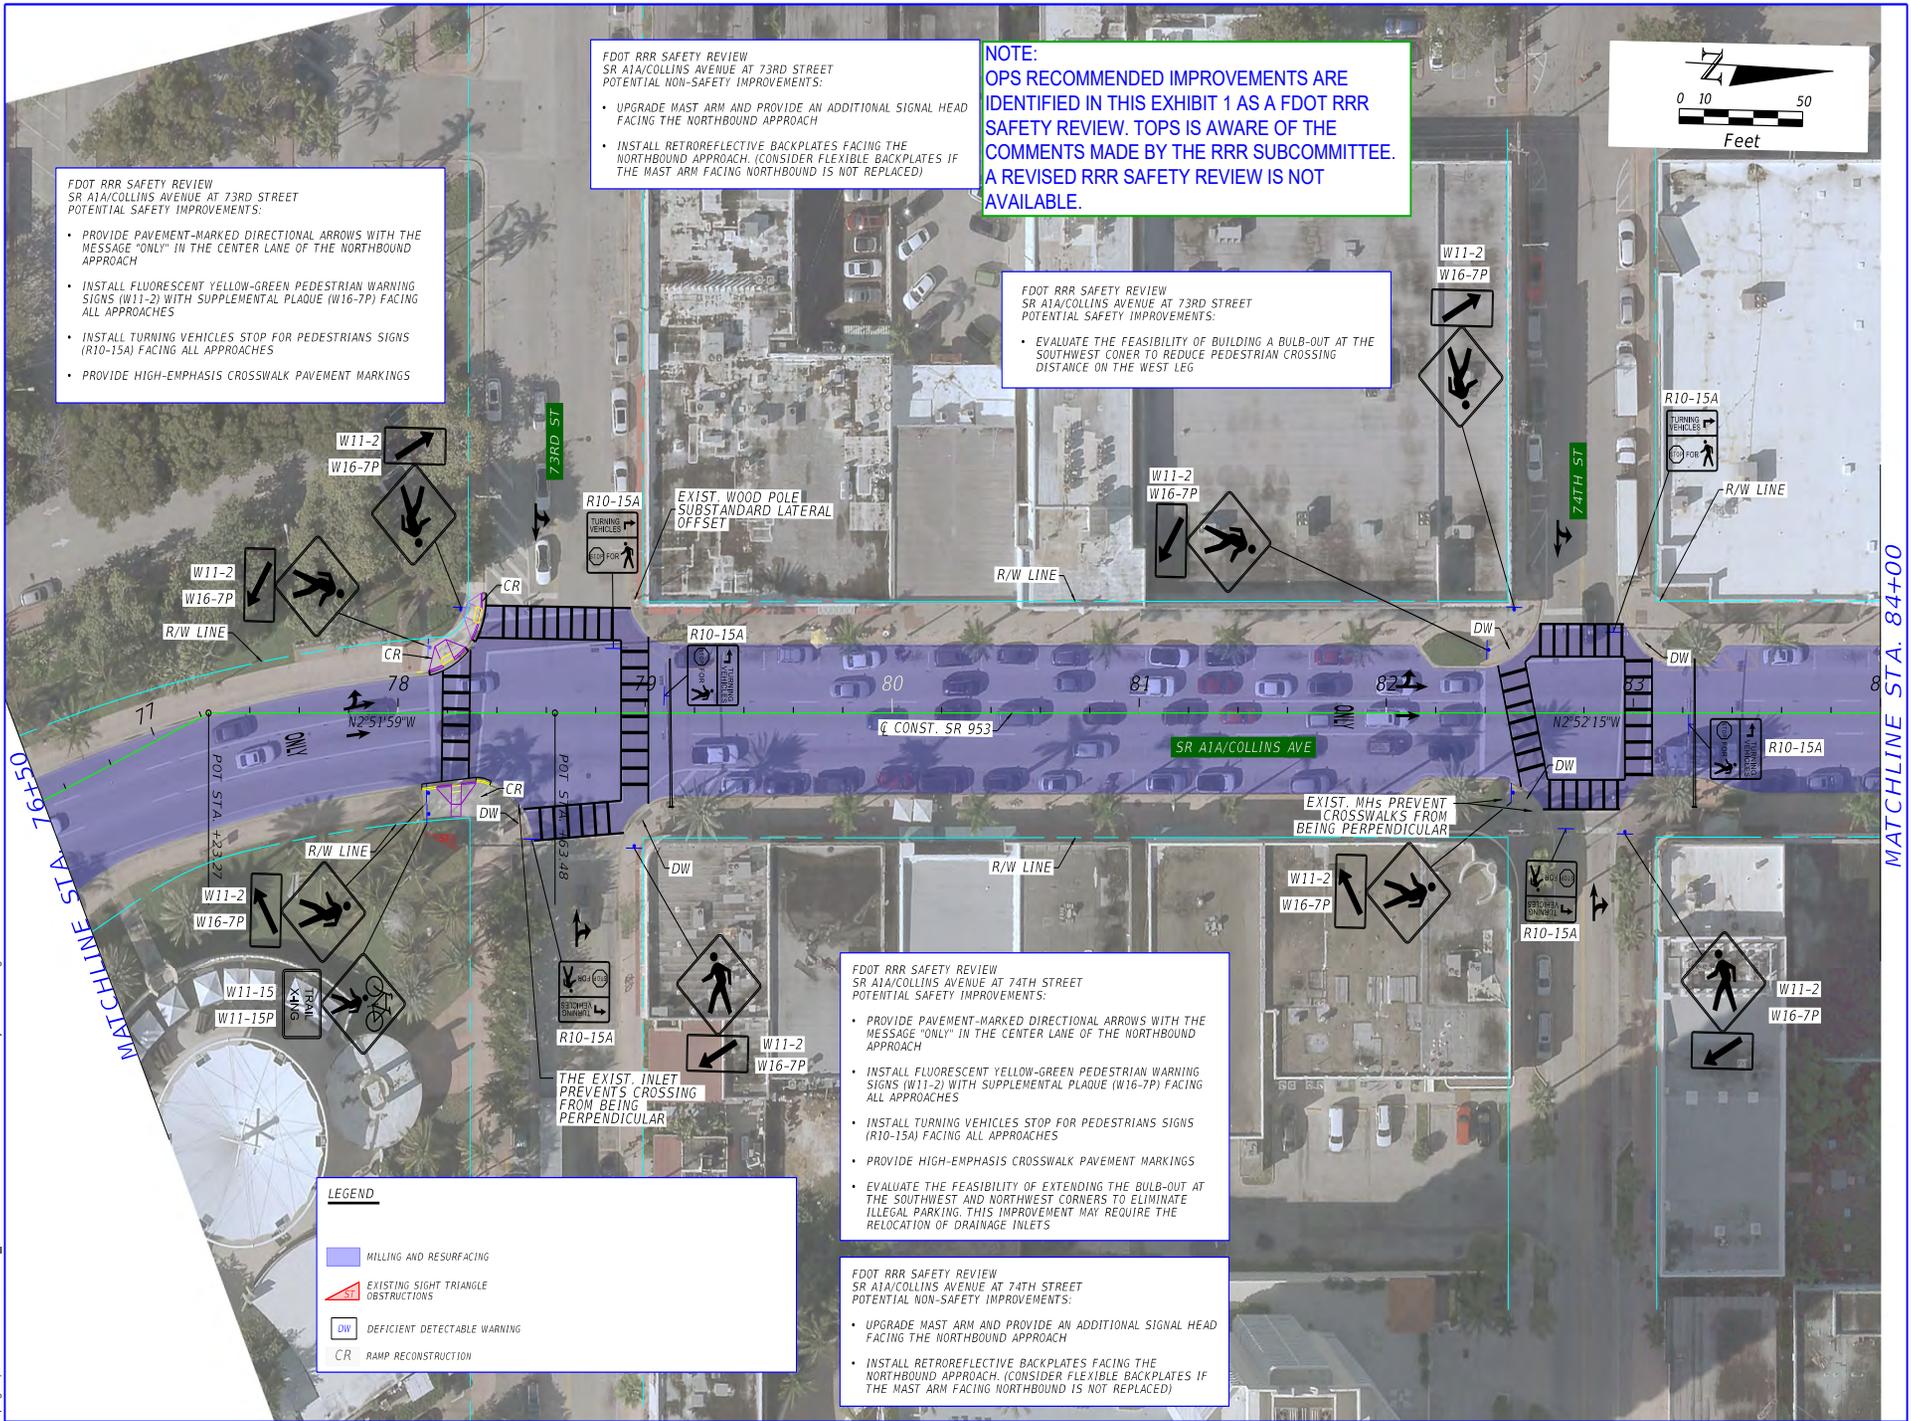
**FDOT RRR SAFETY REVIEW**  
SR A1A/COLLINS AVENUE AT 73RD STREET  
POTENTIAL SAFETY IMPROVEMENTS:

- PROVIDE PAVEMENT-MARKED DIRECTIONAL ARROWS WITH THE MESSAGE "ONLY" IN THE CENTER LANE OF THE NORTHBOUND APPROACH
- INSTALL FLUORESCENT YELLOW-GREEN PEDESTRIAN WARNING SIGNS (W11-2) WITH SUPPLEMENTAL PLAQUE (W16-7P) FACING ALL APPROACHES
- INSTALL TURNING VEHICLES STOP FOR PEDESTRIANS SIGNS (R10-15A) FACING ALL APPROACHES
- PROVIDE HIGH-EMPHASIS CROSSWALK PAVEMENT MARKINGS
