19. DISCUSS THE POTENTIAL IMPLEMENTATION OF A BICYCLE LANE ON THE WEST SIDE OF COLLINS AVENUE AS PART OF AN UPCOMING FLORIDA DEPARTMENT OF TRANSPORTATION ("FDOT") RESURFACING, RESTORATION, AND REHABILITATION ("RRR") PROJECT ON STATE ROAD ("SR") A1A/COLLINS AVENUE FROM SR 907/W 63 STREET TO 75 STREET.

# FINAL SCOPING REPORT

SR A1A/COLLINS AVENUE FROM SR 907/W 63RD STREET TO 75TH STREET

(87060000 - MP 8.640 - 9.782)

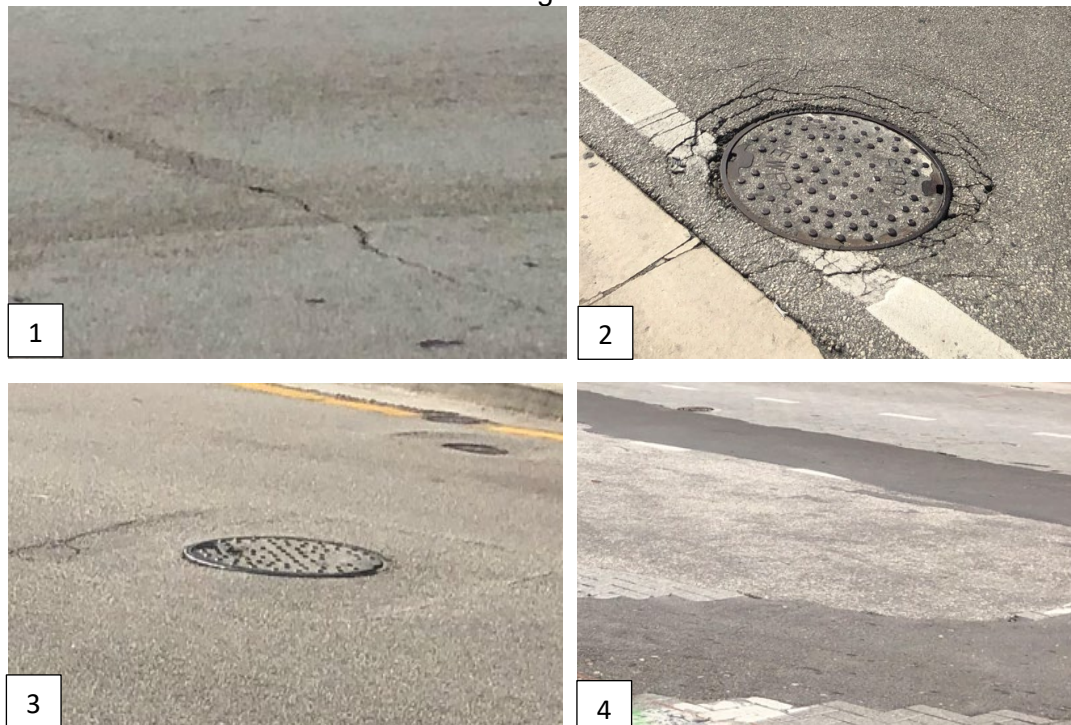
After conducting a field review on the pavement condition (PC), surface deteriorations were encountered, such as minor cracking, utility cuts, and pavement depression around manholes and valves. The pavement condition was reviewed in the Pavement Condition Survey (PCS) Ratings by State Materials Office (SMO) 2022. According to the PCS, the survey resulted in a ride evaluation of 4.6 with no projection. The cracking evaluation resulted in 6.5 with no projection. The rutting evaluation resulted in 8.0 with no project. The existing pavement will be 15 years by 2027. Refer to Appendix D-1. Figure 2-1 illustrates samples of the surface deteriorations encountered during the field review.

**Figure 2-1 EXISTING PAVEMENT CONDITION**  
(1-2. CRACKING, 3. DEPRESSION, 4. UTILITY CUT)

Assume milling and resurfacing 2.5 inches for the purpose of this scoping report. Milling recommendation is to be provided by the FDOT State Materials Office.

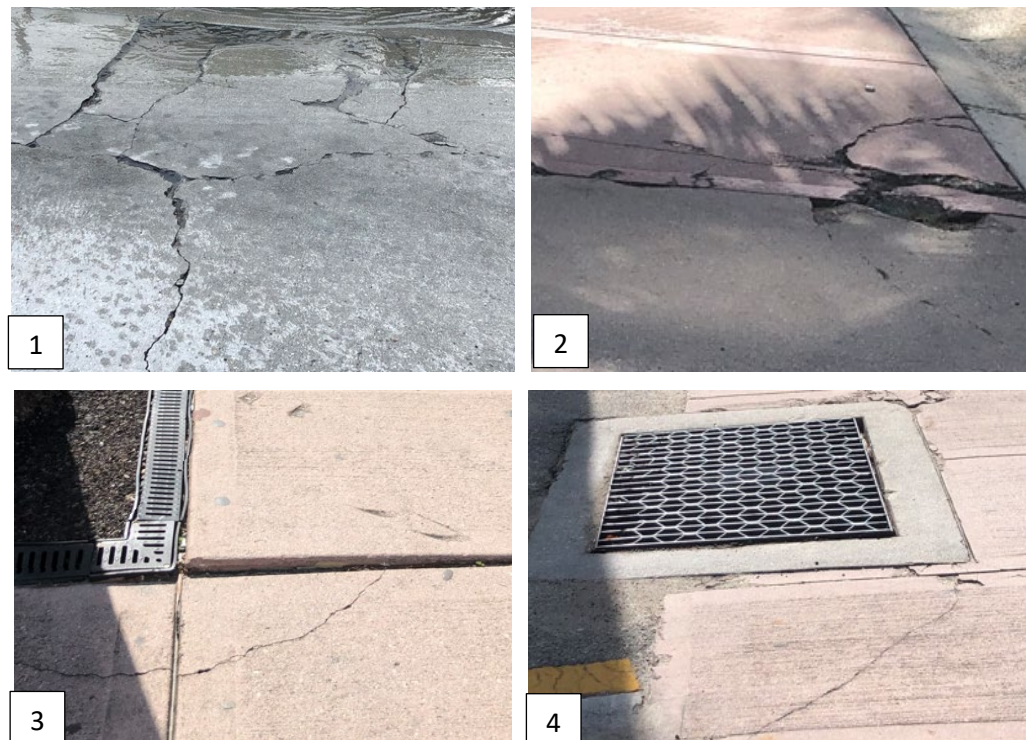
The existing ditch bottom inlet at station 34+60 LT appears to be Type F and is encroaching onto the sidewalk posing a safety hazard for pedestrians. If an ADA-approved grate is not available, suggest modifying the top of the existing ditch bottom inlet to offset the grate away from the sidewalk.

There are locations that do not meet the criteria for clear width of sidewalk and are summarized in Table 2-6. Unobstructed sidewalk width is less than 4 feet in several planters. Where feasible, objects obstructing clear paths on sidewalks should be relocated to meet FDM/ADA requirements. A Design Variation for Unobstructed Sidewalk Width is required for new features.

**Figure 2-2 SIDEWALK DEFICIENCIES**  
(1-2. CRACKING, 3. TRIP HAZARD, 4. NON-ADA GRATE)
